LOWER HUDSON RIVER BASIN
GOSHEN RESERVOIR NO. 1 DAM
ORANGE COUNTY, NEW YORK
INVENTORY NO. N.Y. 488
PHASE I INSPECTION REPORT
NATIONAL DAM SAFETY PROGRAM

PHASE I INSPECTION REPORT
NATIONAL DAM SAFETY PROGRAM
GOSHEN RESERVOIR NO.1 DAM
I.D. NO. NY 488
D.E.C. NO. 179B-3163
LOWER HUDSON RIVER BASIN
ORANGE COUNTY, N.Y.

Name of Dam:	Goshen Reservoir No. 1 Dam (I.D. No. NY 488)
State Located:	New York
County Located	Orange
Stream:	Rio Grande Creek
Date of Inspection:	November 20, 1980

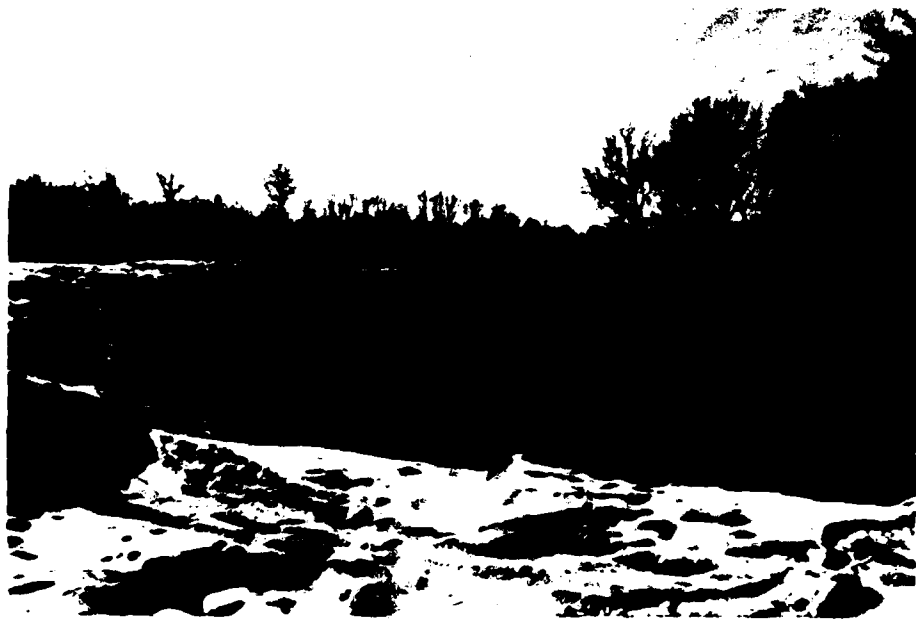
PHOTO # 2: DOWNSTREAM SLOPE AT EMBANKMENT
