GARNET LAKE DAM

WARREN COUNTY, NEW YORK
INVENTORY NO. N.Y. 1167

**PHASE I INSPECTION REPORT
NATIONAL DAM SAFETY PROGRAM**

AUGUST, 1981

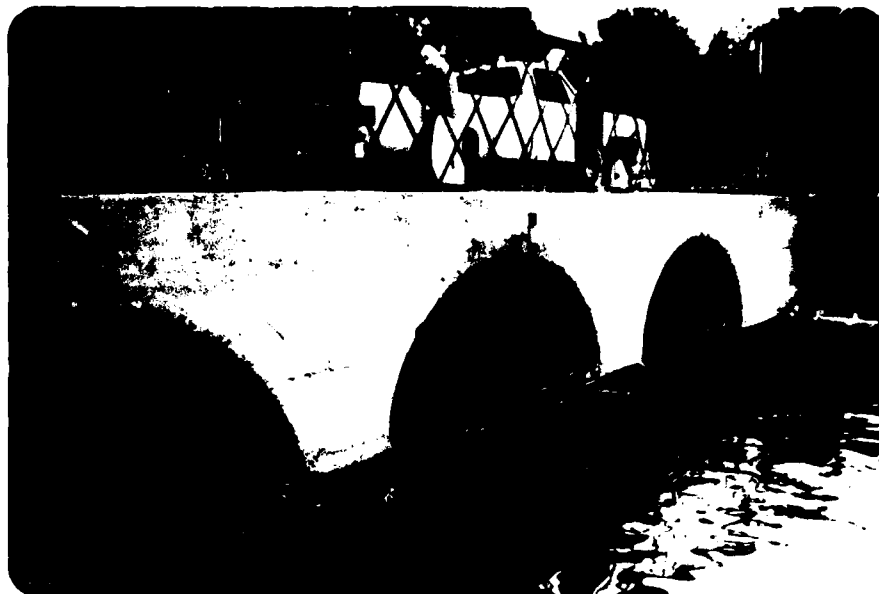
UPSTREAM HEADWALL TO PIPE-ARCHES;
NOTE CONTROL MECHANISM FOR RESERVOIR DRAIN

Present Condition (Describe): CONTROL MECHANISM ON UPSTREAM HEADWALL - IN FRONT OF MIDDLE PIPE - GATE HAS NOT BEEN OPENED IN 20 YEARS - PROBABLY INOPERABLE OUTLET COULD NOT BE LOCATED

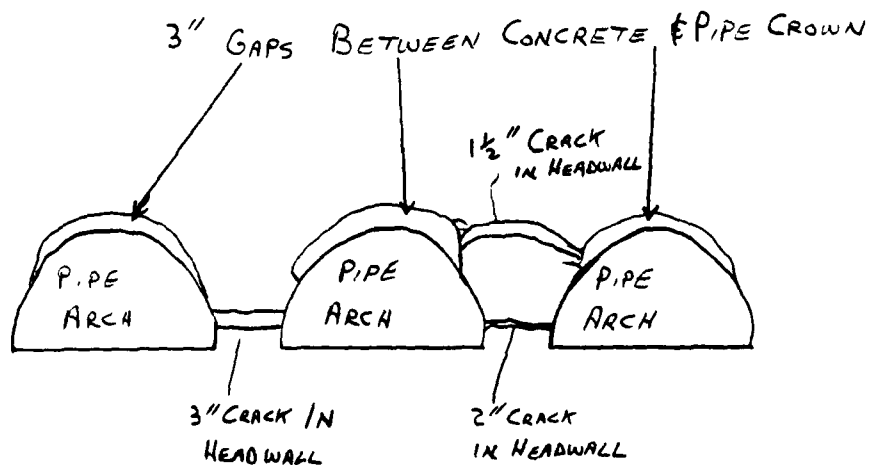
CONDITION OF DOWNSTREAM HEADWALL

- a. Concrete Surfaces SATISFACTORY- NO SPALLING OR SURFACE DETERIORATION NOTED
- b. Structural Cracking SERIOUS CRACKING ON DOWNSTREAM HEADWALL CRACKS OF UPTO 3" IN WIDTH NOTED (SEE DIAGRAM BELOW)
- c. Movement - Horizontal & Vertical Alignment (Settlement) MOVEMENT OF DOWNSTREAM HEADWALL HAS RESULTED IN 3" GAPS BETWEEN PIPE CROWN & THE WALL
- d. Junctions with Abutments or Embankments 1" CRACKS NOTED BETWEEN DOWNSTREAM APRON & SIDEWALLS - SOME LOSS OF CONCRETE IN THIS AREA
