SSI 8115-4

Testing of Shelter Design and Industrial Hardening Concepts at the Mill Race Event

Contract No. EMW-C-0611
Work Unit 1128D

SCIENTIFIC SERVICE, INC.

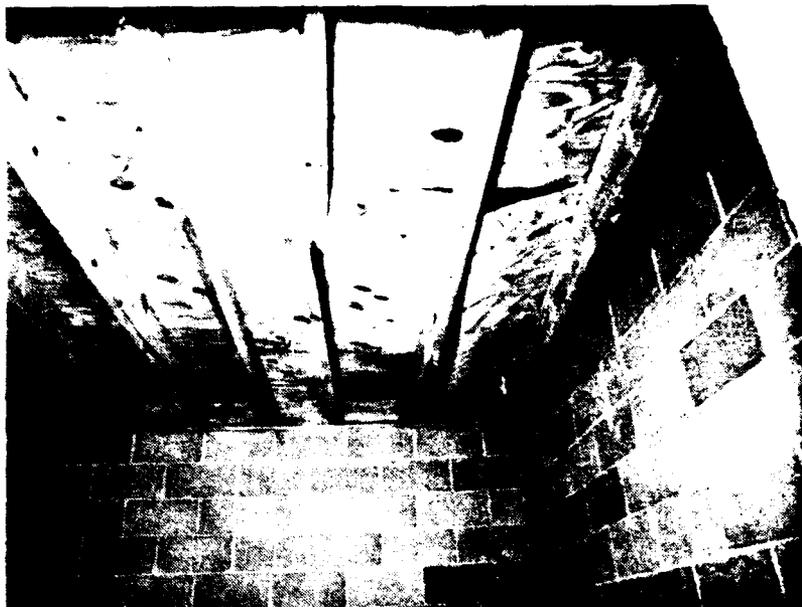
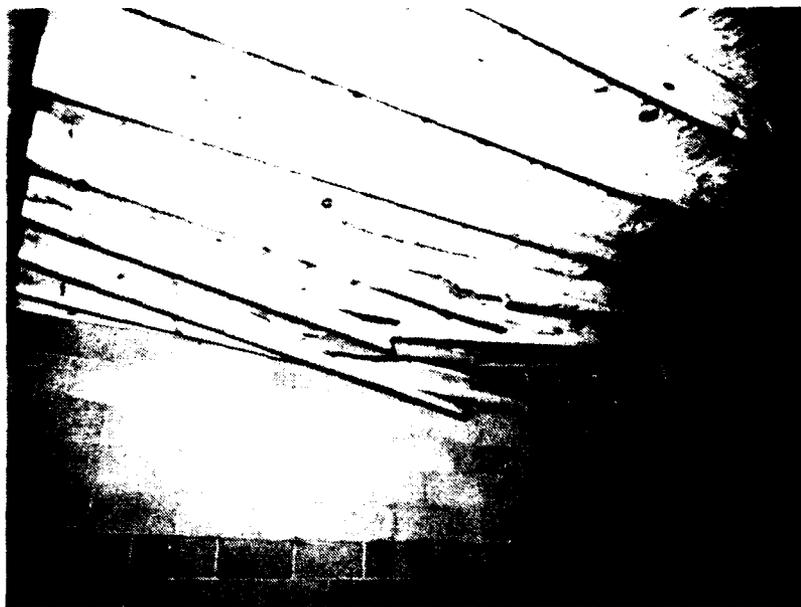
Fig. 4-10. Pretest Joist Failures.

Soon after the backfilling operation was completed, it was noticed that seven of the 2-in.-by-8-in. timber joists in the unshored section of the building had failed. These failed joists were replaced prior to the test. Figure 4-10 shows the failed portion of the ceiling prior to repair.

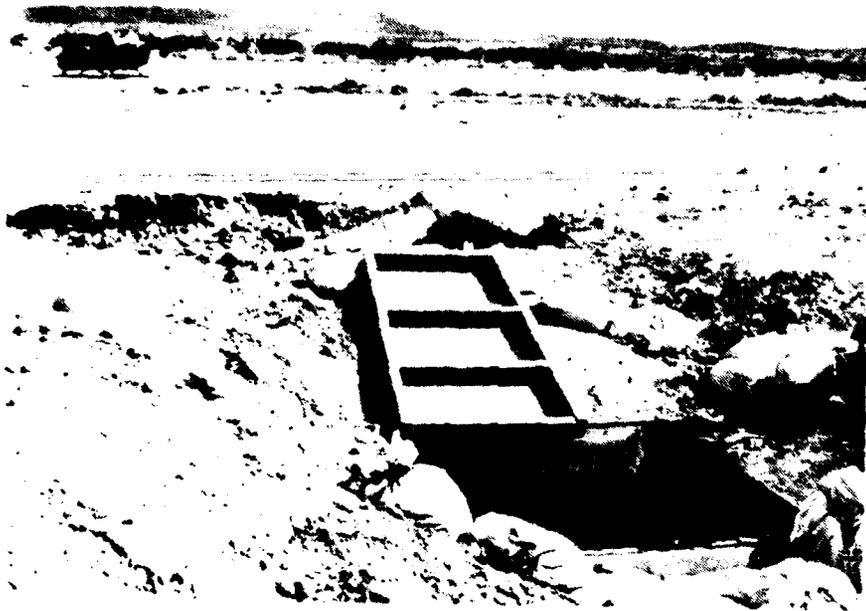
Fig. 4-14. Hatch, Posttest.

The closure over the hatch was not secured adequately to resist the positive interior pressure created by the failure of the adjacent bay. As in many of the experiments, this hatch was expedient and designed to permit ease of access immediately prior to the test. In order to perform as a viable shelter, it would be necessary to secure the hatch from the inside, as well as close off the doorway to the unshored bay.

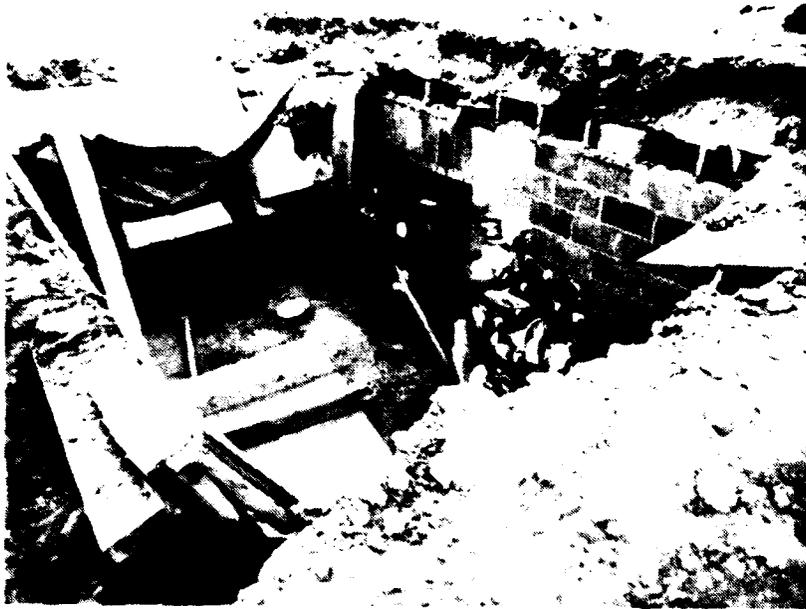
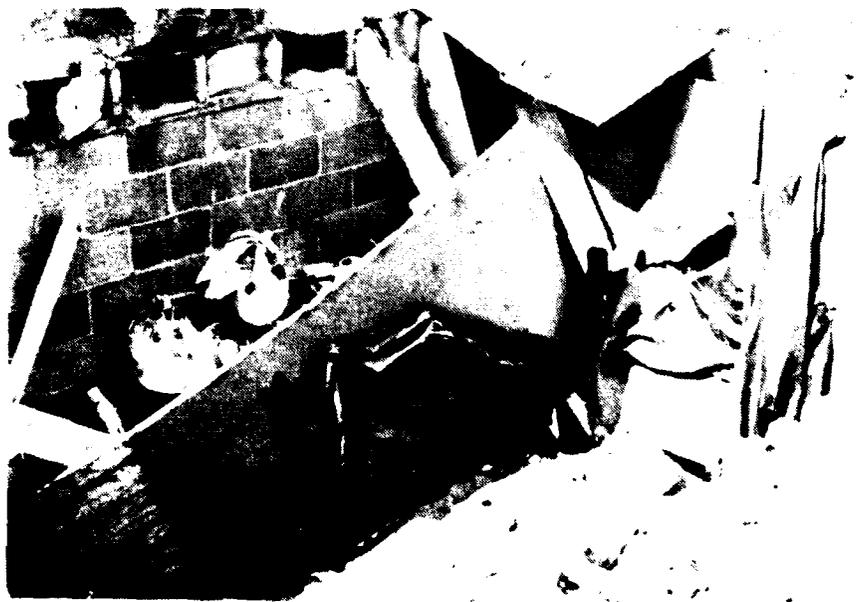
Fig. 4-15. Views of Failed Bay Looking Toward Unfailed Bay.

The initial observations of the building after the test indicated complete collapse of the unshored bay, and very little structural distress in the shored bay. The basement walls sustained no structural damage and no cracks were in evidence. The closure hatch, which was located in the shored bay, had been blown off, scattering both hatch section and the sandbags. Figure 4-14 shows the hatch after test. Figure 4-15 shows the failed bay looking toward the unfailed bay.

In the foreground of the lower photograph of Figure 4-15, completely covered with earth and debris, is one of the anthropomorphic dummies (18). This dummy was entirely covered to an average depth of 3.5 ft with earth and roof materials. It was found lying face down on the floor with its head near the pretest location, its feet and body displaced toward ground zero, and its legs bent forward at the knees. It had sustained multiple lacerations and extensive crushing injuries, including the breaking of both knee joints. The accelerometer reading indicated 10 g.

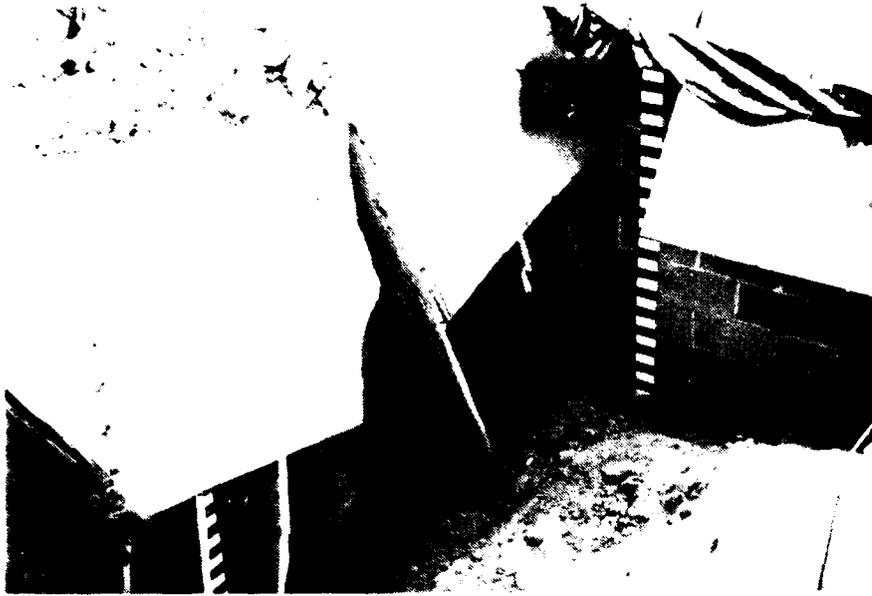
Fig. 4-16. Views of Failed Bay Looking Toward Exterior Wall.

Figure 4-16 shows views of the failed bay looking down toward the exterior wall. Both of these figures show dummy No. 23. Figure 4-17 is a closeup of dummy No. 23. The location of this dummy was the same as pretest, with earth and roof materials covering both legs to an average depth of 1.5 ft. The dummy was found to have sustained two deep lacerations on the head, the chest was crushed, and both legs were broken at the knee joints. The accelerometer reading on this dummy also indicated 10 g.

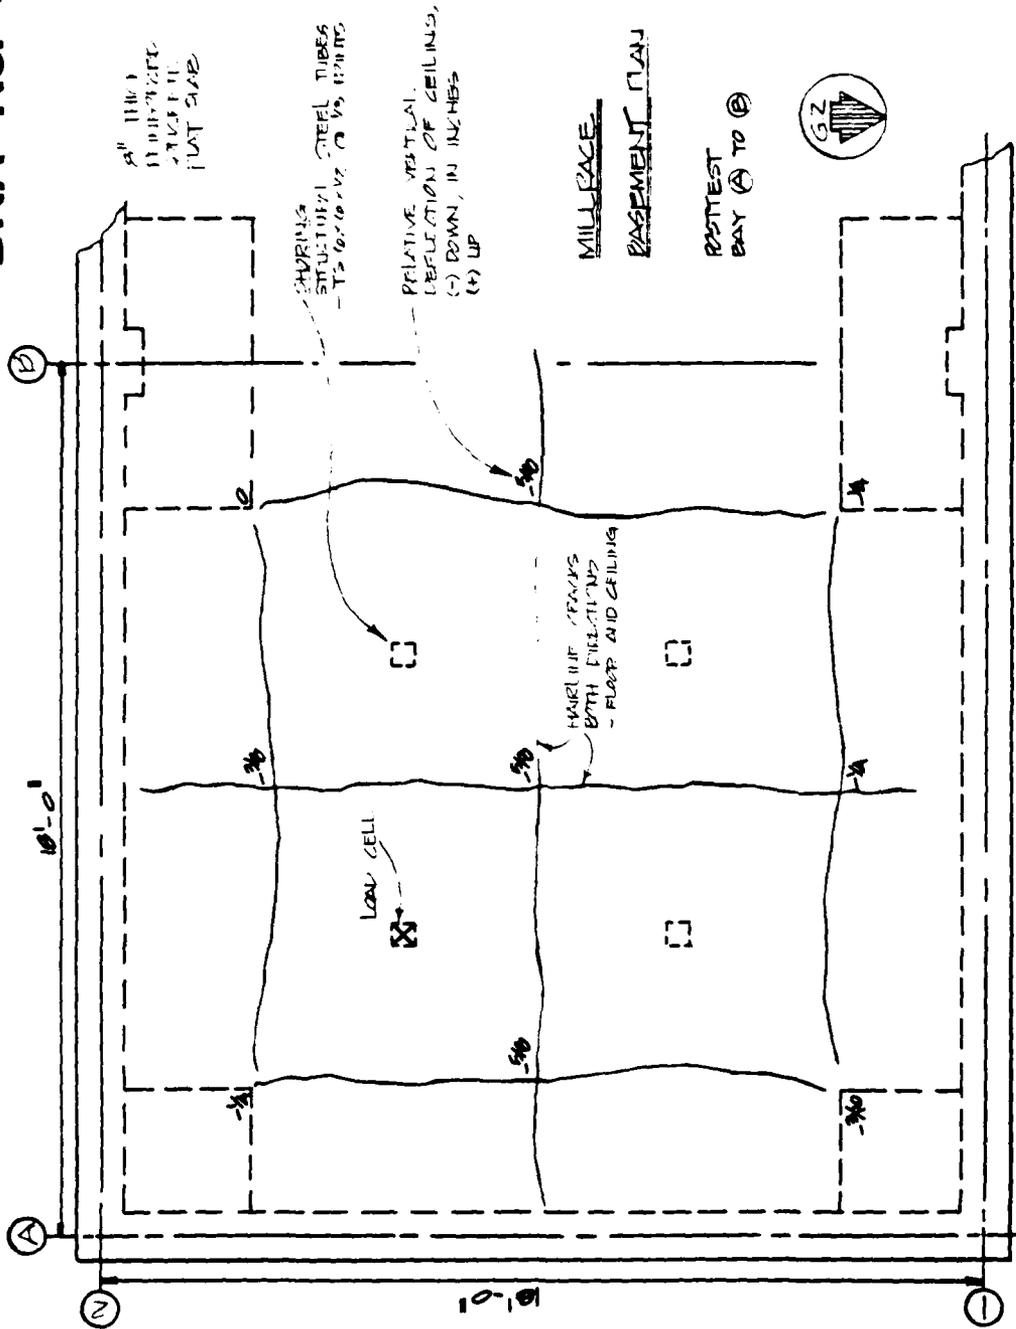
Fig. 5-28. Location of Shoring, Instrumentation, and Damage to Floor and Ceiling Slabs in Bay A to B, Area No. 1.

Both the floor and ceiling slabs in all three bays exhibited cracking in both directions midway between the shoring. The maximum vertical deflection of the ceiling in these bays was $5/8$ in. in a downward direction. Figures 5-28, 5-29, and 5-30 show the location of the cracks and the recorded ceiling deflections. Figure 5-31 is an interior view of these three bays looking toward line A from line C, and shows the timber pole shores in the foreground, and one of the steel tube shores in the background. Figure 5-32 is a closeup of the steel tube shores, and shows a load cell in location on top of the shore.

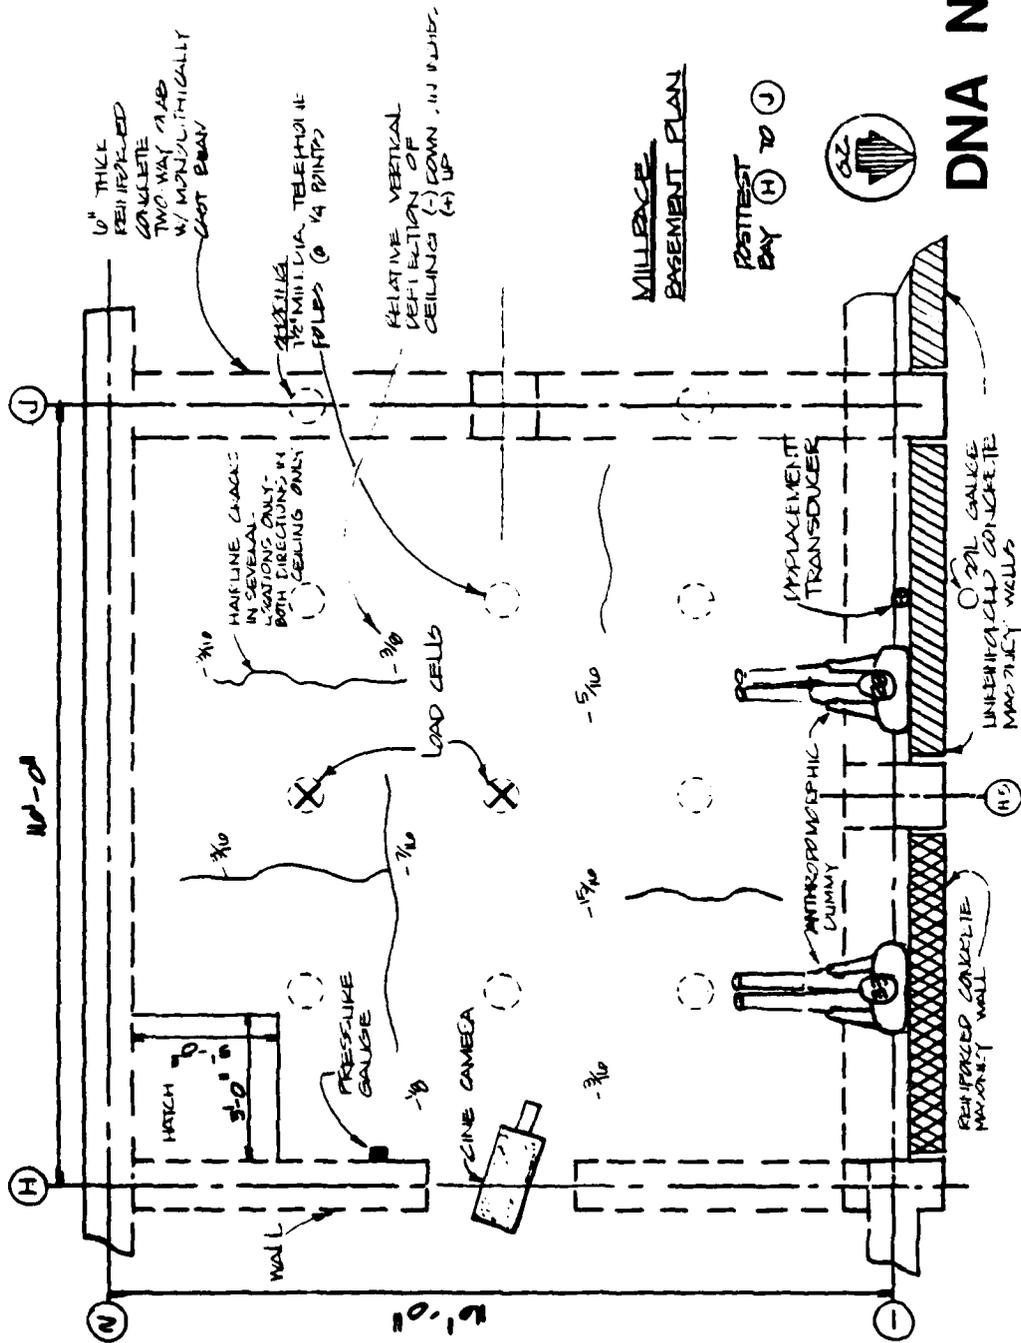
Fig. 5-48. Location of Shoring, Instrumentation, and Damage to Two-Way Slab, Bay H to J, Area No. 4.

The pressure gauge located on the wall on line H, adjacent to the door in the bay from lines H to J (see Figure 5-48 for location), recorded a positive pressure of approximately 1.0 psi with a rise time of 125 ms, immediately followed by a rapid decrease to a negative pressure of approximately 2.5 psi in 150 ms.

The load cell located nearest the wall on line 2 (see Figure 5-48 for location) in bay H to J recorded a loading of 180 kips and a loading duration of 50 ms, while the other load cell in the same bay recorded a loading of 205 kips with the same loading duration, 50 ms.
