USAAEFA PROJECT NO. 80-14

# LIMITED ARTIFICIAL AND NATURAL ICING TESTS PRODUCTION UH-60A HELICOPTER (RE-EVALUATION)

FINAL REPORT

AUGUST 1981

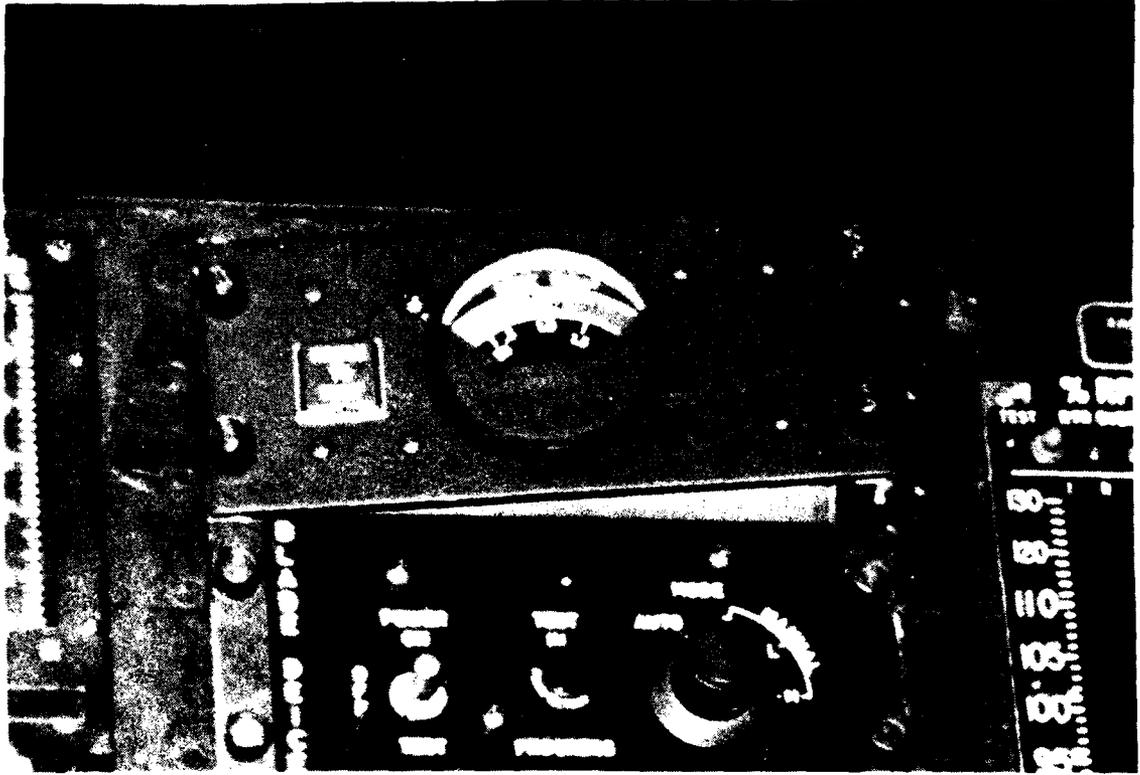
Photo 17. Canted Icing Rate Meter
