REPORT OF FLOOD
14-16 MARCH 1978
CHAGRIN AND GRAND RIVERS
OHIO

U.S. ARMY ENGINEER DISTRICT, BUFFALO

JUNE 1978

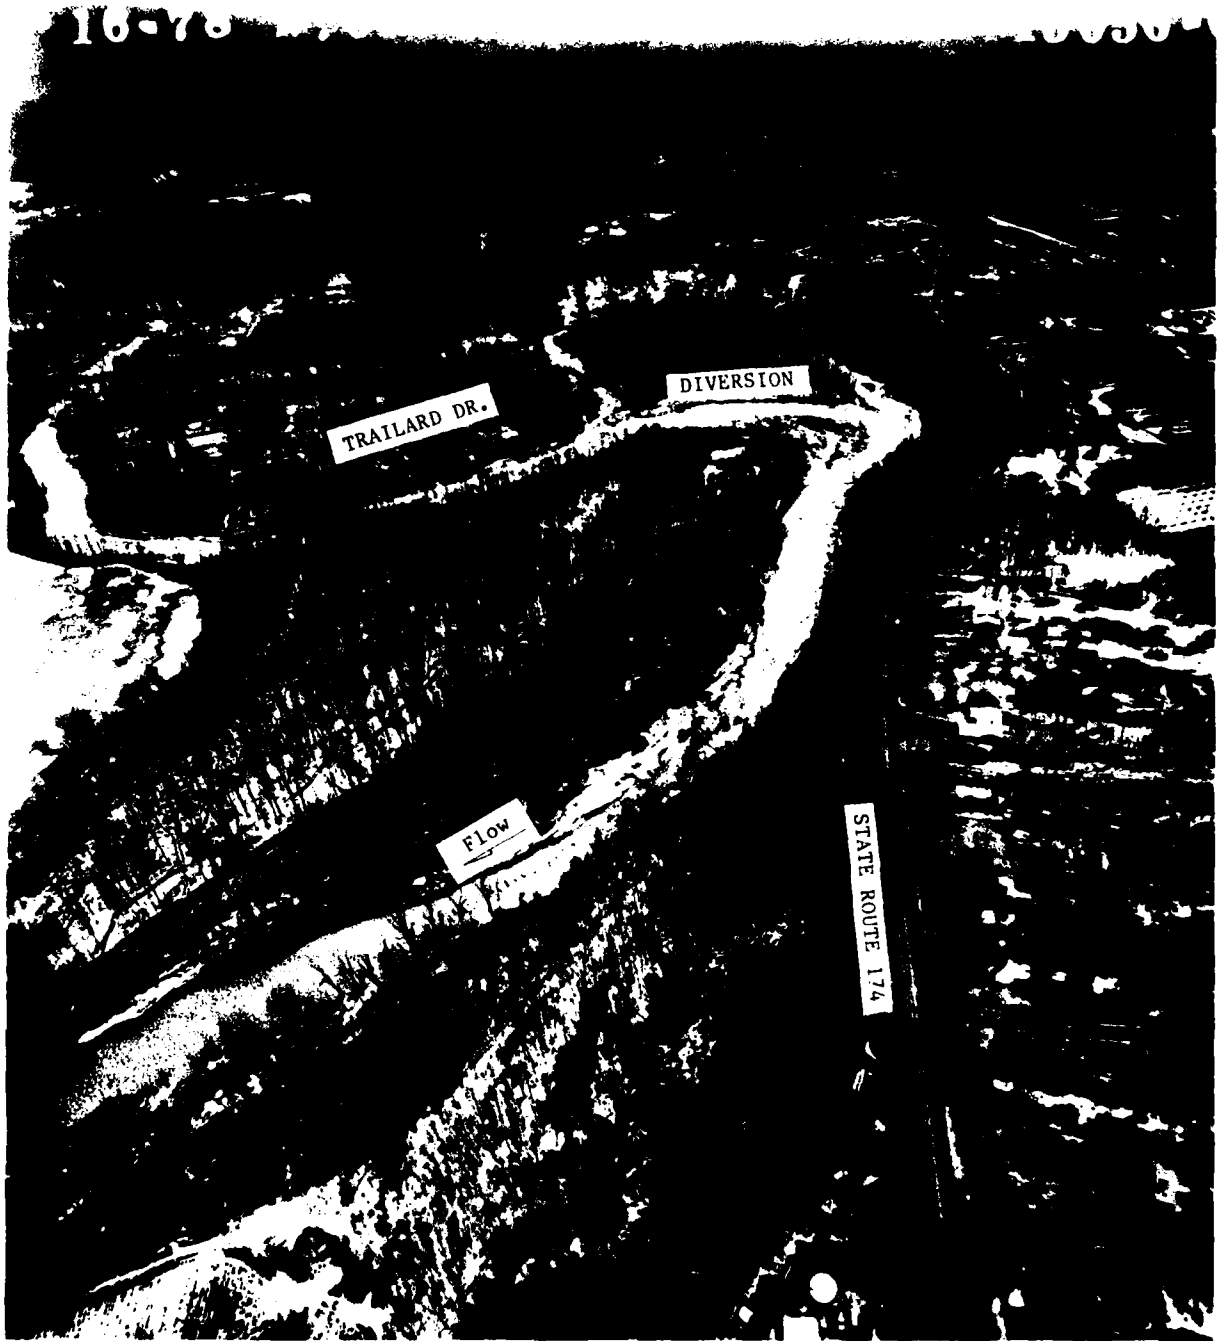
A local flood control channel at the Horseshoe Glen area in Willoughby Hills (Photo 1) was completed in October 1960 at a cost of \$15,000 to residents of the Trailard Drive area in an attempt to reduce flood damage and hazard such as occurred in the January 1959 flood, which claimed the lives of five local residents. The channel dimensions are approximately 900 feet long, 200 feet wide, and 6 feet deep. The channel was completed using private funds and donated land.

Photo 1 - Aerial view of the Chagrin River, Trailard Drive area showing local channel diversion project. Photo taken by Kucera & Associates, Mentor, Ohio, 16 March 1978

Residents of the Trailard Drive area (Horseshoe Glen) were not as severely affected as the other Willoughby Hills developments located upstream. The local river diversion project in the Horseshoe Glen area was probably instrumental in reducing damage there.

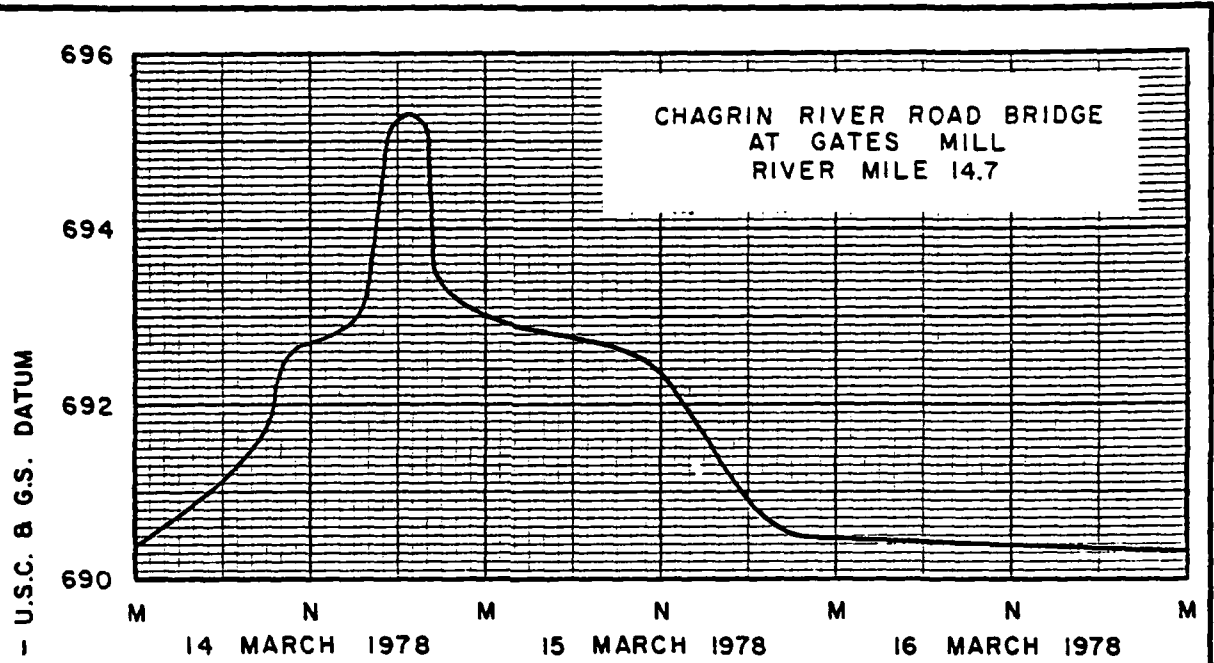
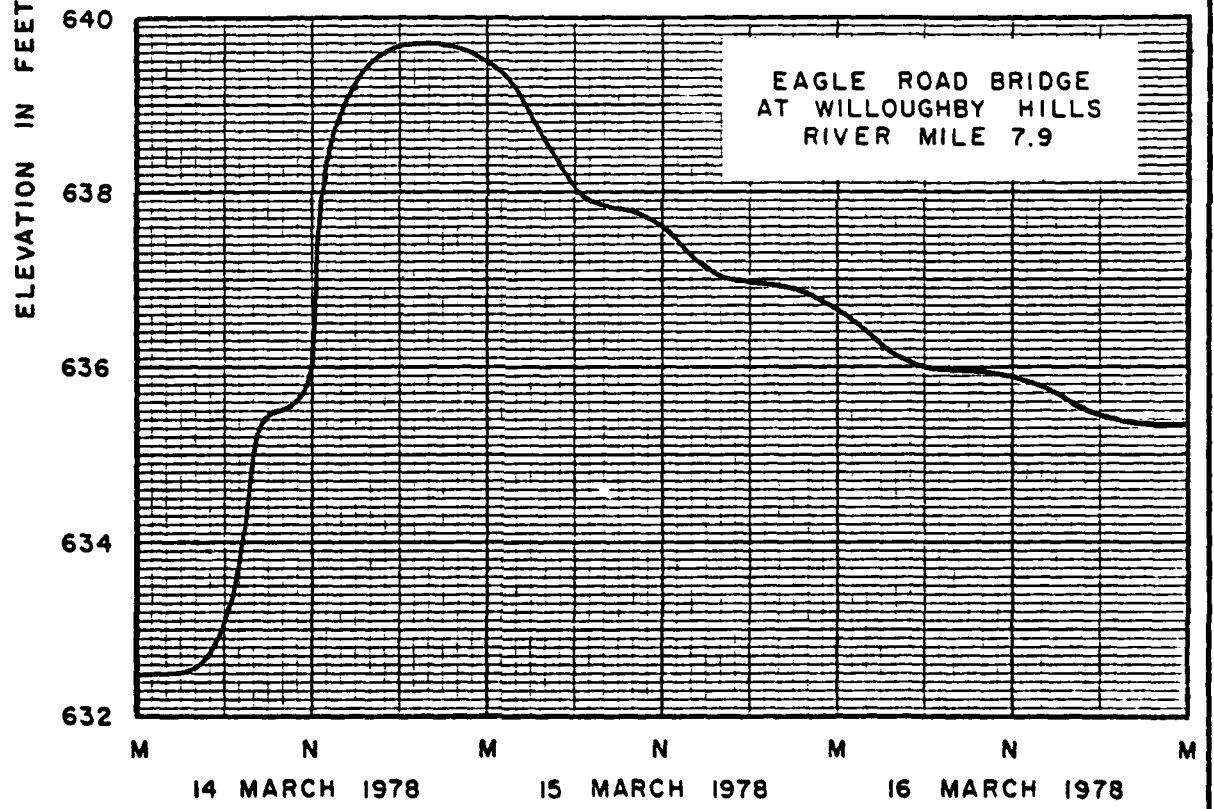
REPORT OF FLOOD 14-16 MARCH 1978
CHAGRIN RIVER BASIN
STAGE HYDROGRAPHS

In addition, two staff gages, one on the Eagle Road bridge located in the city of Willoughby Hills and the other in the village of Gates Mills, are monitored during flood flows by members of the Willoughby Hill Fire Department. Stage hydrographs for these three gages can be found on Plates 3 and 4.

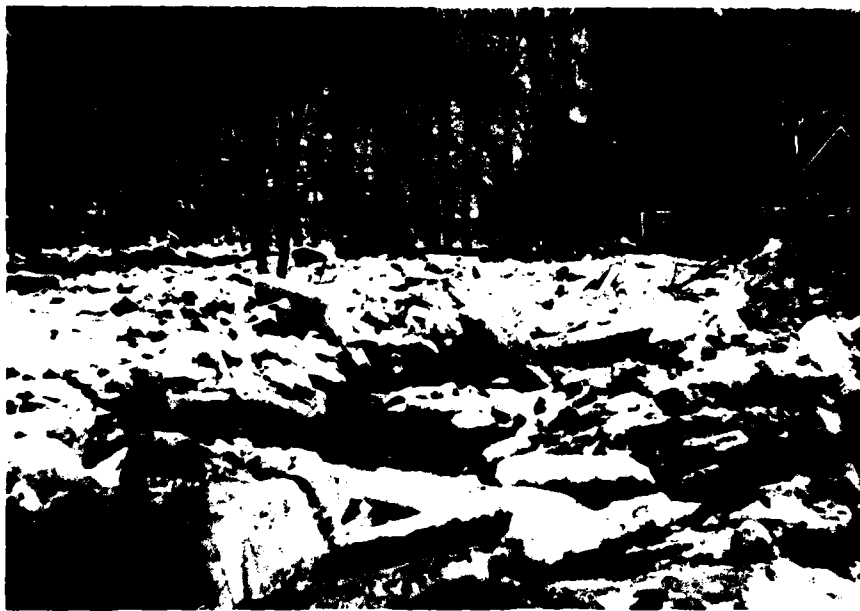
Photo 2 - Ice forced from river onto lawns and yards of Milann Drive residents at mile 10.3.

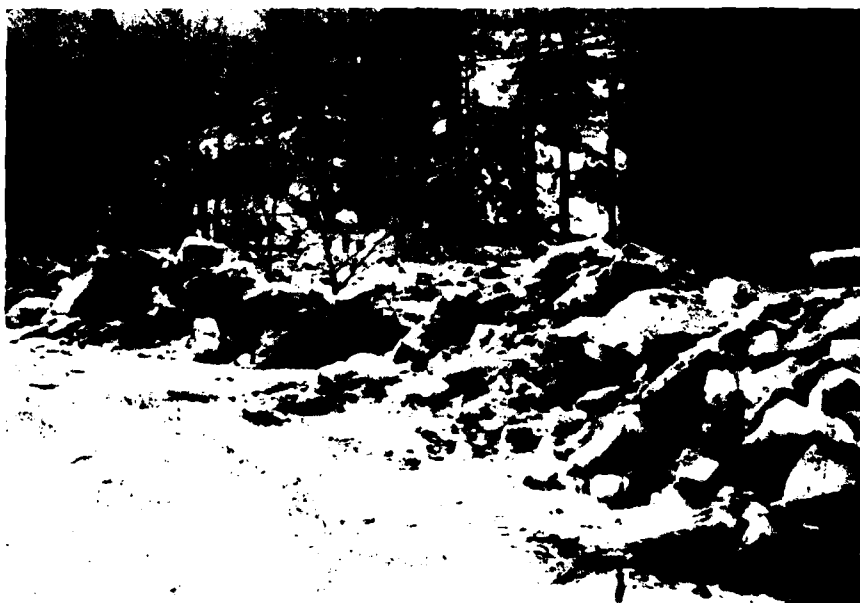
Photo 3 - Ice had to be plowed from Milann Drive to permit access for emergency vehicles.

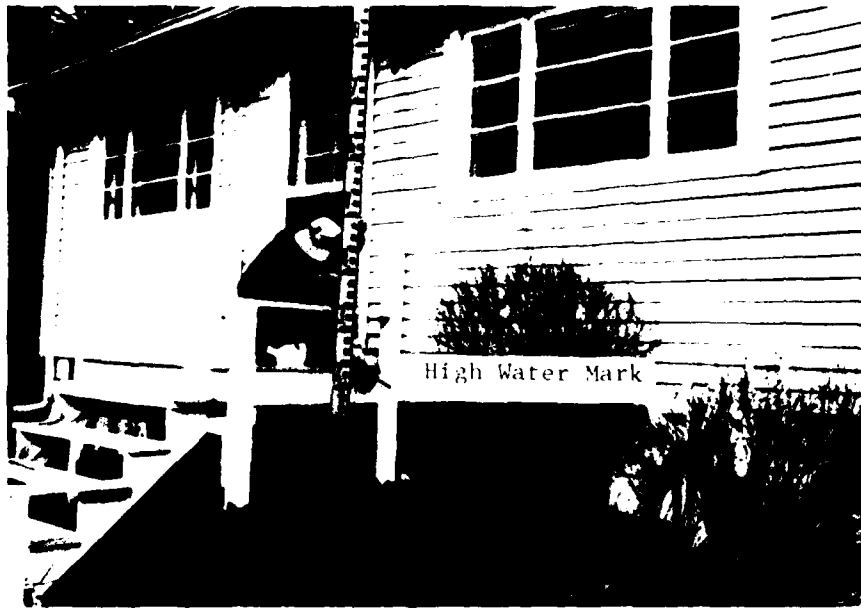
Photo 4 - Residence on Milann Drive mile 10.2 barely escaped first floor inundation.

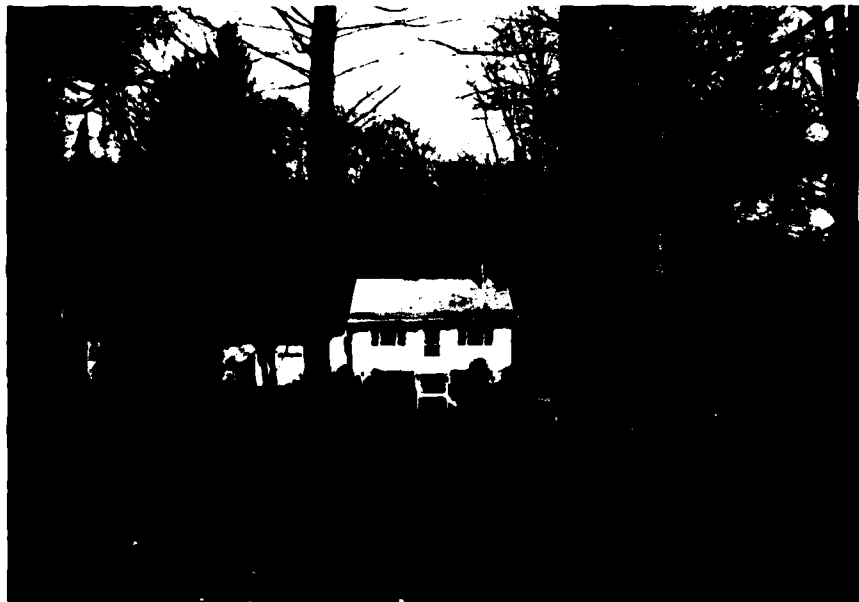
Photo 5 - Same residence as above. Pressure of water and ice caused the collapse of the basement wall.

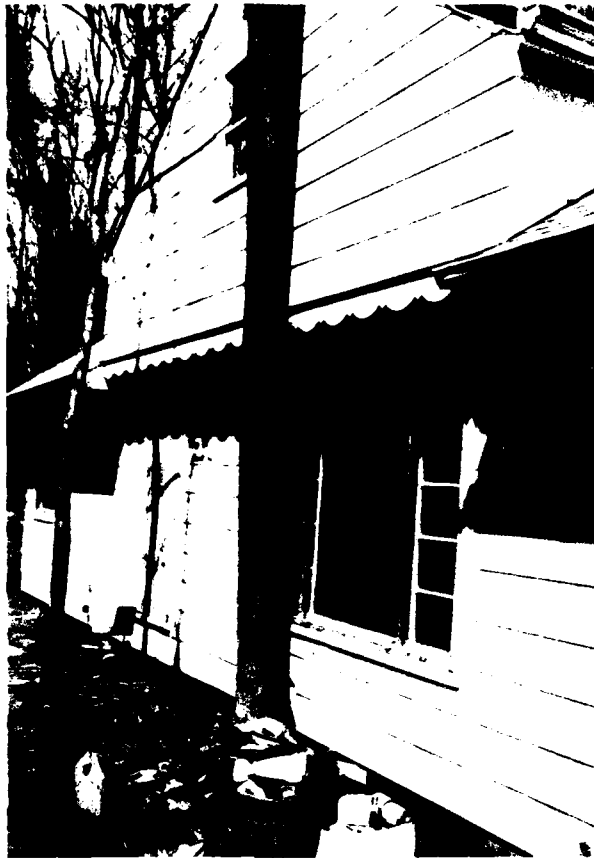
About 11:30 a.m., the jam broke sending a wall of water and tons of ice downstream toward the Dodd Road and Trailard Drive communities. The first house in the path of the wave on Dodd Road was lifted from its foundation and displaced several feet (Photo 7). A few hundred feet down Dodd Road other houses were flooded nearly to the first floor ceilings. The water rose so fast that automobiles were floated away and deposited elsewhere downriver.

Photo 7 - Home on Dodd Road river mile 3.4 floated from foundation and lodged against tree.

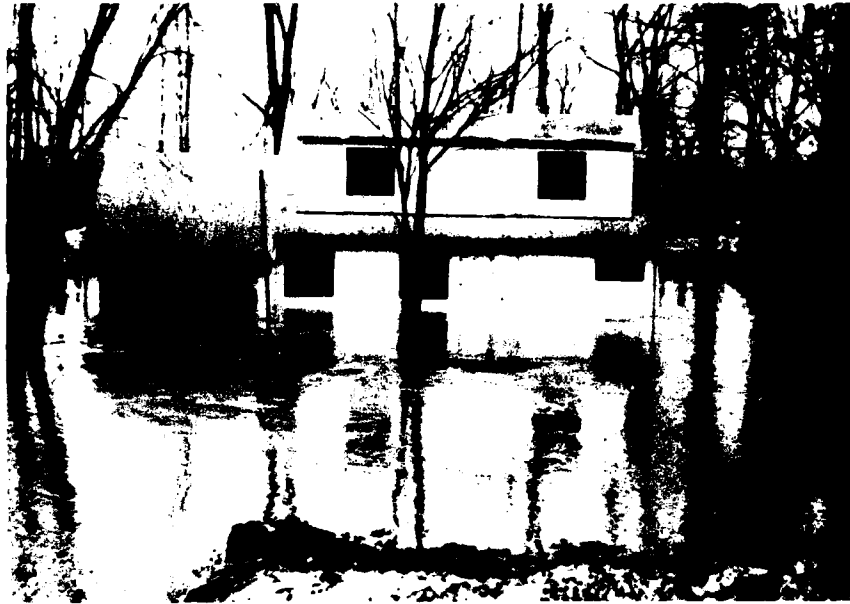
Photo 9 - Dodd Road residence, mile 8.3, taken shortly after peak flow, 15 March 1978

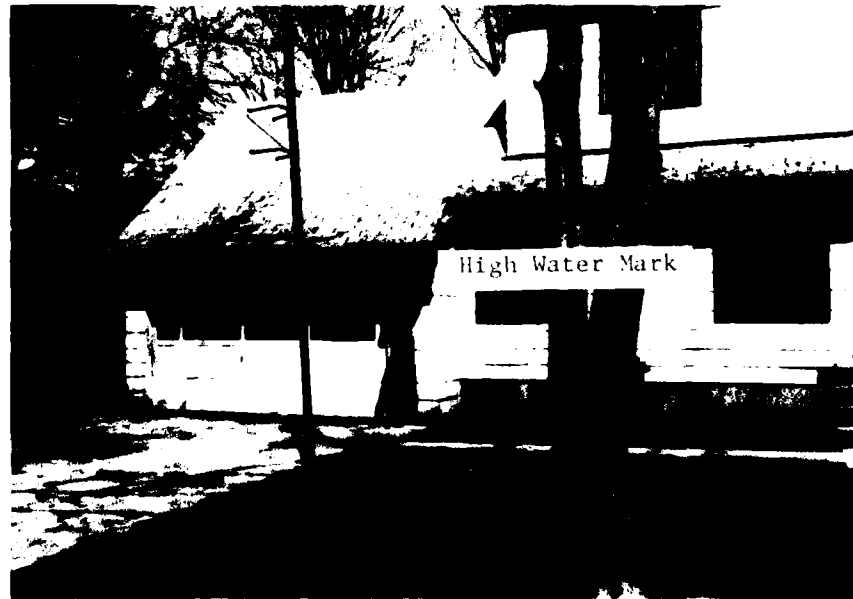
Photo 10 - Same residence as above showing high water mark.
Photo taken 6 April 1978

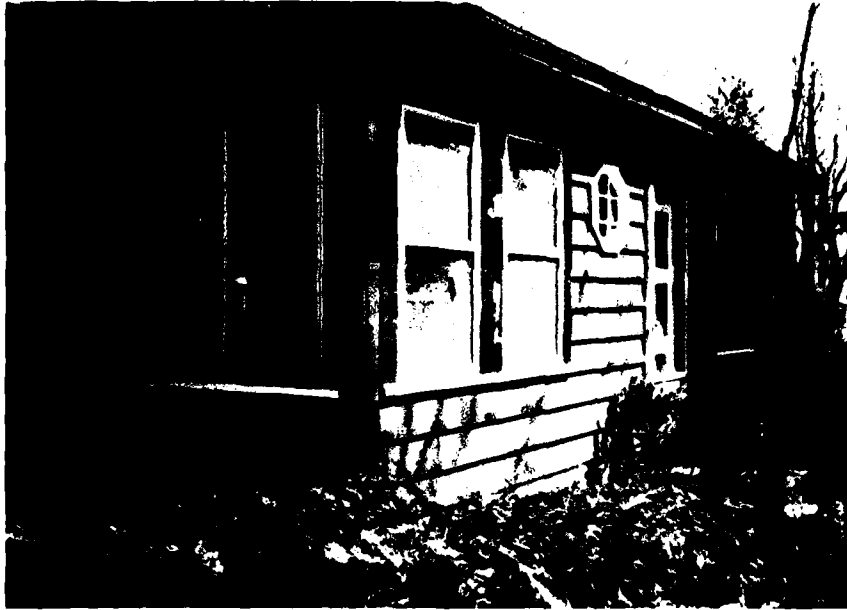
Photo 11 - River front residence on Dodd Road, mile 8.3.
Note high water mark visible on front windows.
Photo taken 6 April 1978

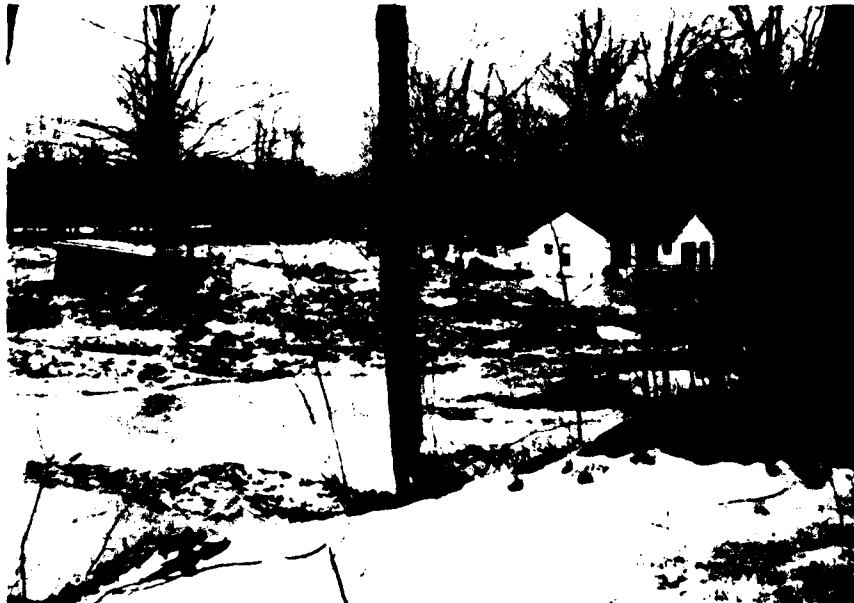
Photo 12 - Ice and debris float from the river, which
inundates houses along Dodd Road at mile 8.3. Note large
block of ice to the left of the house.
Photo taken 15 March 1978

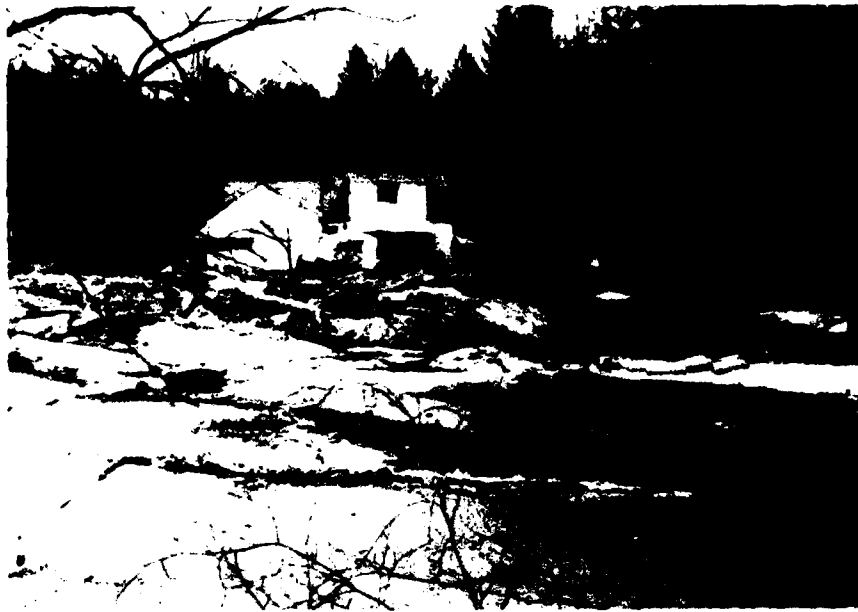
Photo 13 - Houses on Chagrin Drive taken from Dodd Road, mile 8.1. Note sheets of ice lying in river on the left side of photo.

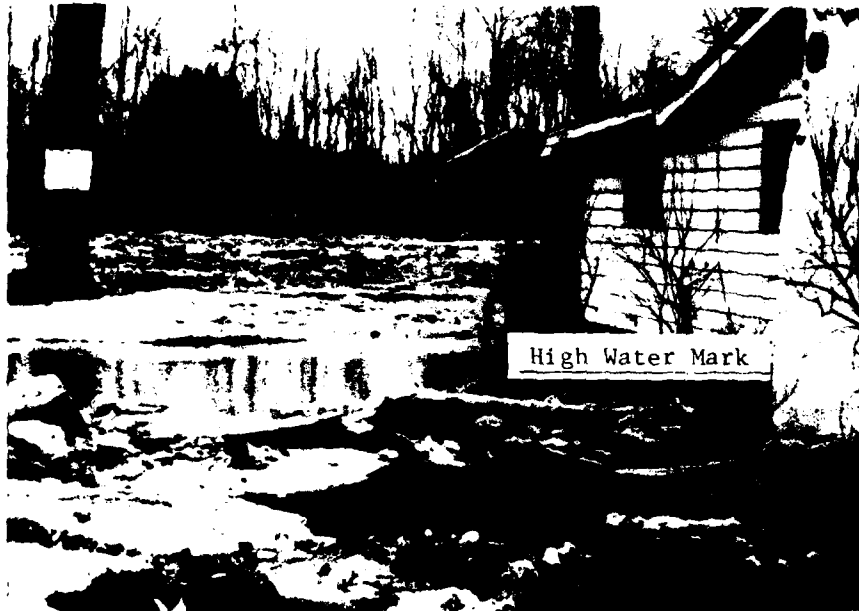
Photo 15 - Residence on Trailard Drive, mile 7.9. Photo taken after peak flow had passed 16 March 1978.

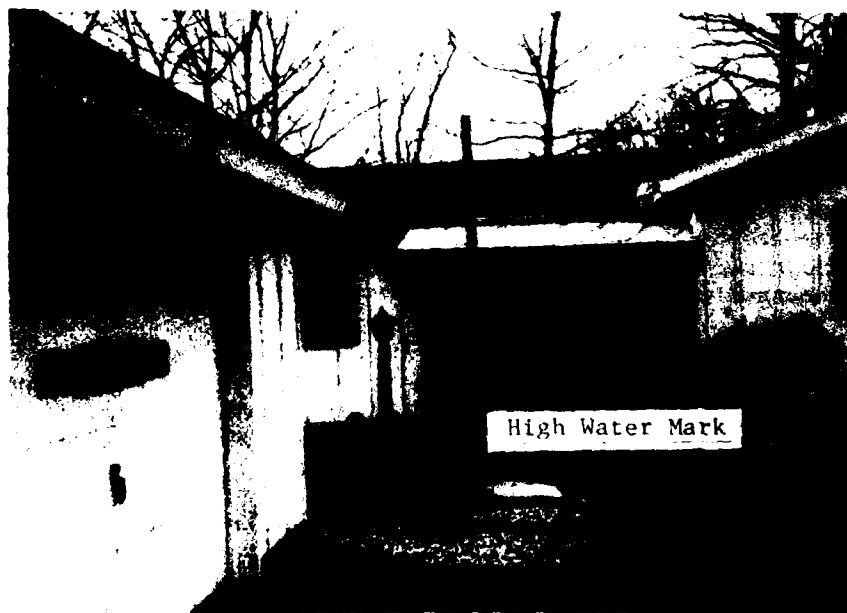
Photo 16 - Residence on Trailard Drive, mile 7.4, showing high water mark.

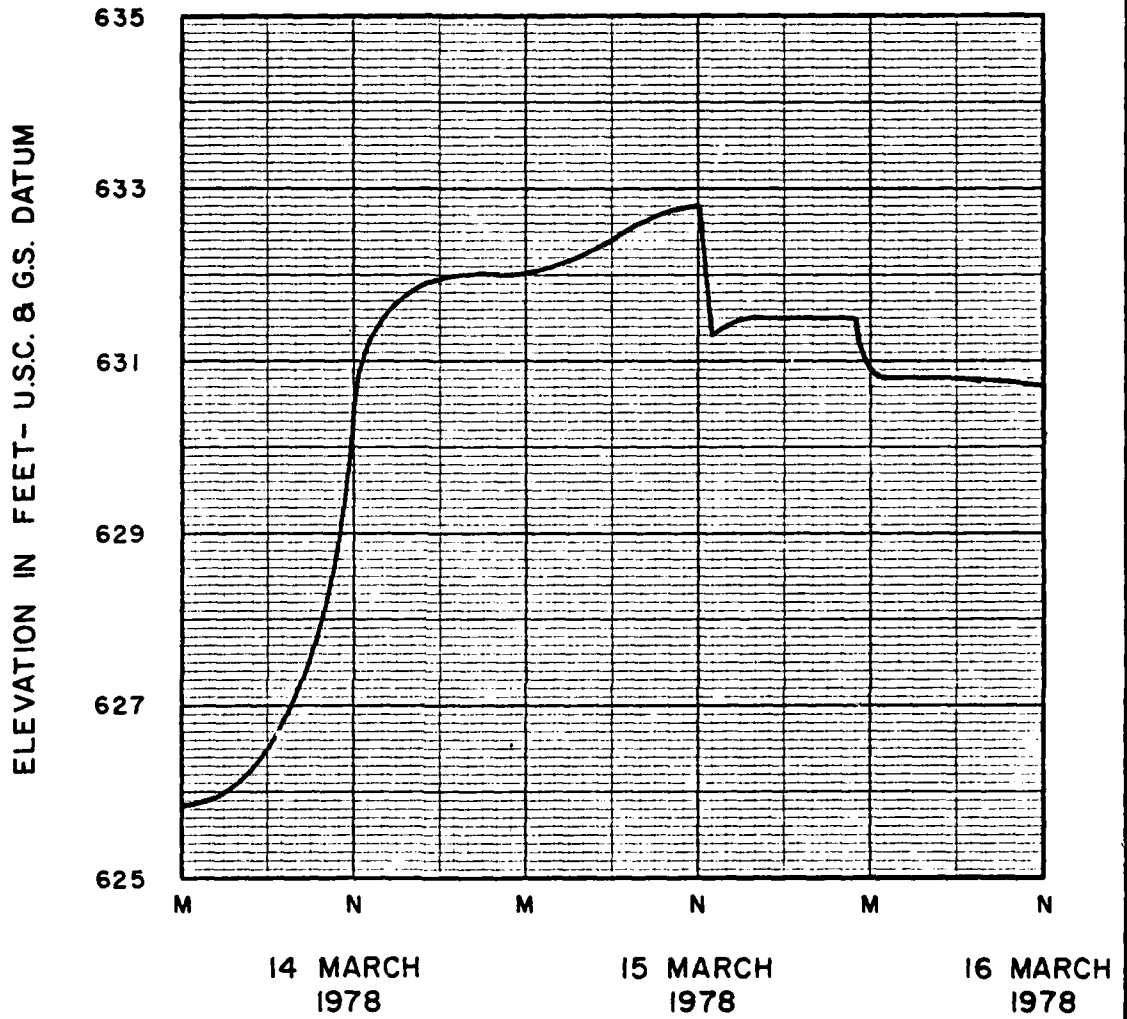
REPORT OF FLOOD 14-16 MARCH 1978
 GRAND RIVER BASIN
 STAGE HYDROGRAPH
 U.S.G.S. GAGE AT PAINESVILLE

Discharge records have also been available on the Grand River at Painesville, where the USGS has maintained a gaging station since 1974. The stage hydrograph for the March 1978 flood is shown on Plate 5. The peak discharge for this event under free flow conditions is estimated to be 11,000 cfs and has a recurrence interval of three years.

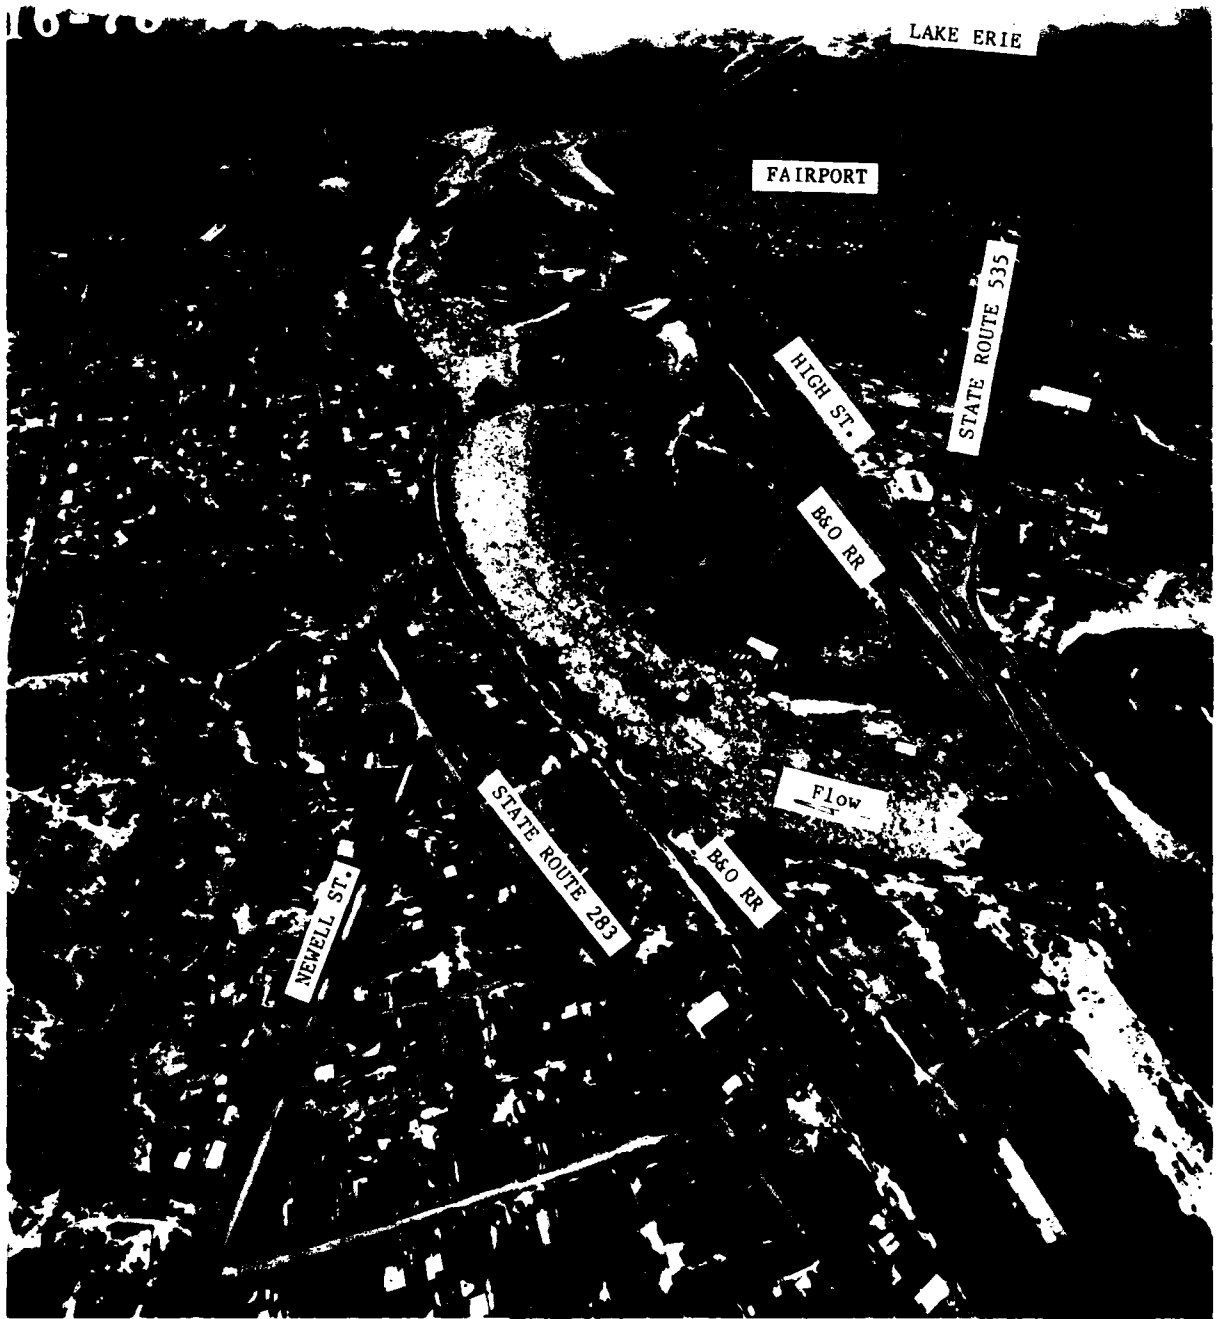
Photo 17 - The Grand River looking north from Painesville toward Fairport and Lake Erie. Photo taken by Kucera & Associates, Mentor, Ohio, 16 March 1978.

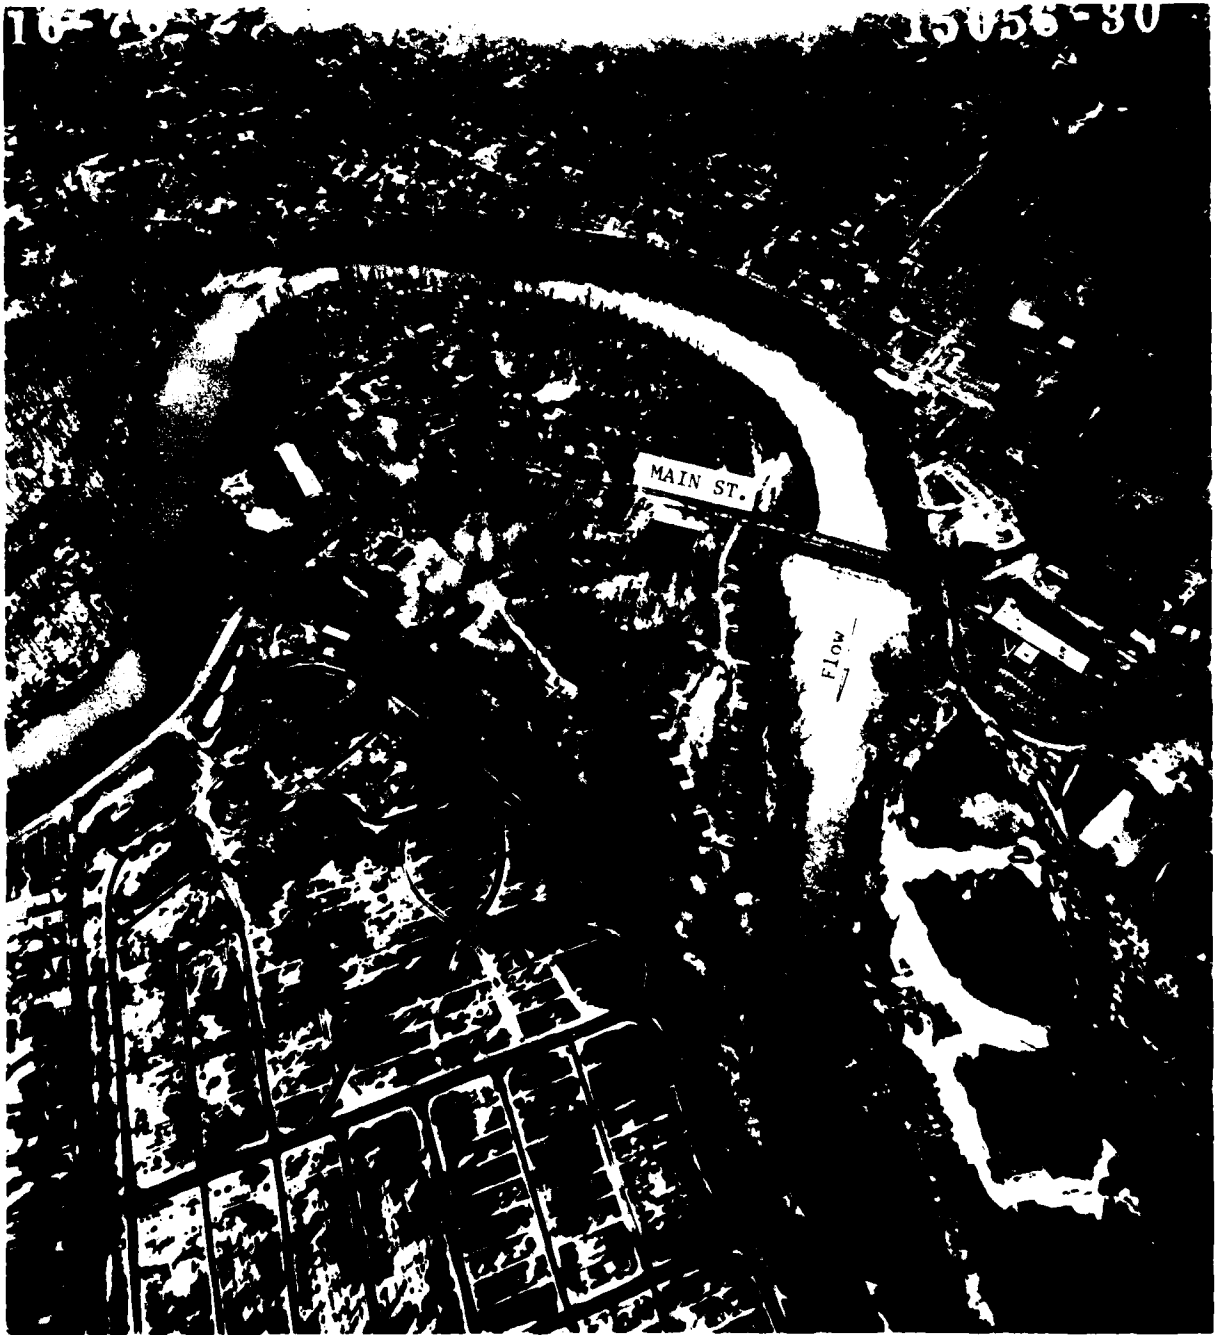
Photo 18 - The Grand River at Painesville showing low-lying apartments (center of photo). Taken by Kucera & Associates Inc., Mentor, Ohio, 16 March 1978.
