MISCELLANEOUS PAPER SL-82-14

# EVALUATION OF CONCRETE CORES FROM WATERBURY DAM, WATERBURY, VT.

Final Report

Prepared for U. S. Army Engineer District, New York  
New York, N. Y. 10278

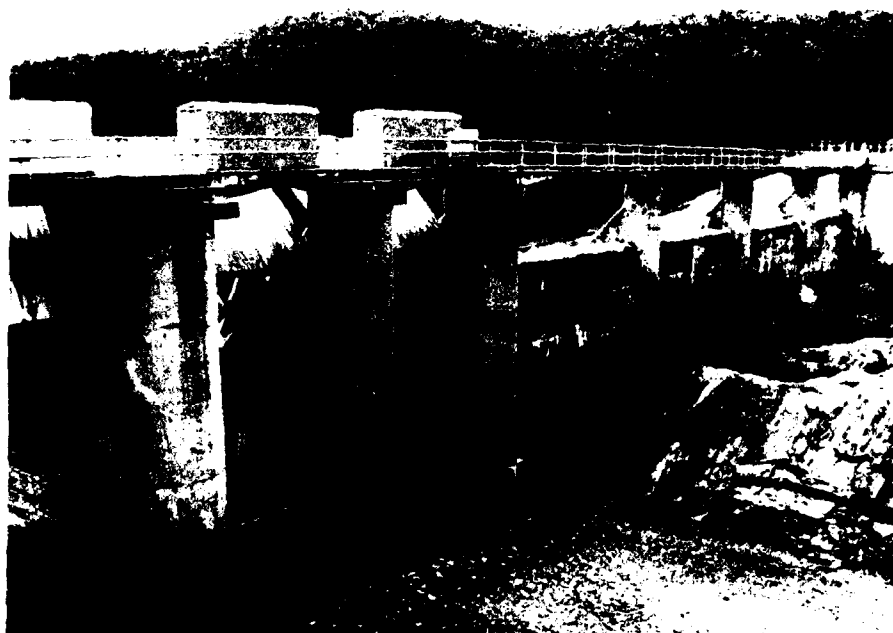
24. The upstream vertical faces of the four spillway sections have pattern cracking every 3 to 4 ft on centers. Some of the cracks are open and white exudation products are present. Views of these surfaces are presented in Figures 36 and 37.

Figure 36. From right to left, spillway sections A-4, A-3, A-2, and A-1 and a partial view of the tainter gate sections

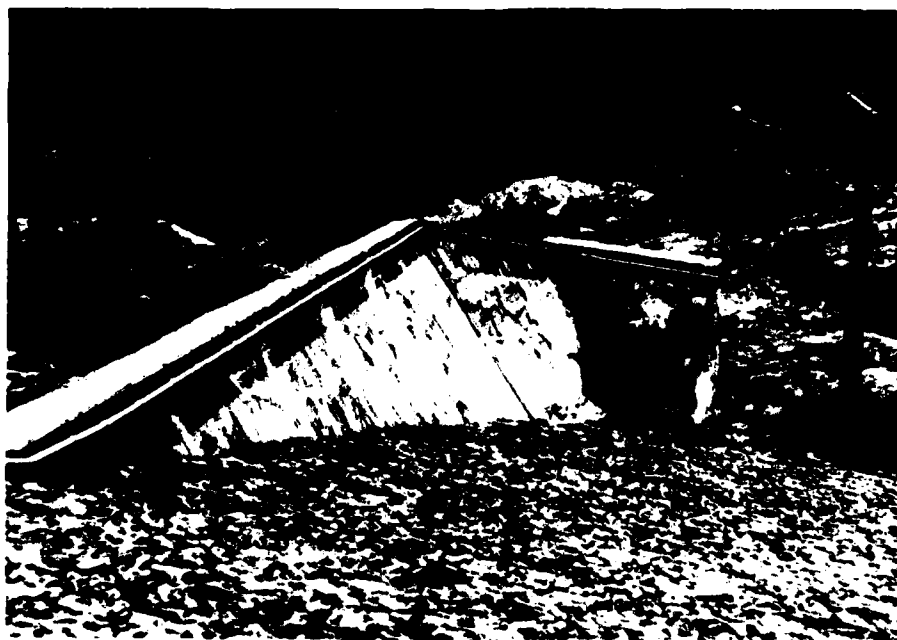
27. The concrete in the right retaining wall on the upstream side is in good condition. Several local areas of deterioration are present; white exudation is also present. Looking downstream on the right retaining wall there are a number of areas of deteriorated concrete; these areas show scaling for approximately 5 or 6 cm. Exudation is also present. The downstream retaining wall has severe surface concrete deterioration as can be seen in Figure 41.

Figure 41. Downstream concrete surface of  
right retaining wall

33. It is suggested that the dam be repaired by removing the deteriorated concrete and replacing it with a frost-resistant concrete overlay. The overlay should be doweled into the existing concrete and reinforced. Adequately frost-resistant concrete to withstand the most severe natural weathering can be produced if three criteria are met: (a) adequate air-void system, (b) sound aggregate, and (c) adequate maturity prior to being allowed to freeze and thaw in a critically saturated condition. The latter is met if concrete develops a compressive strength of 3500 psi prior to freezing. Some thin layers of overlay concrete may have a low modulus of elasticity to have more strain capacity to resist cracking. The use of organic additives ("latexes") including products such as so-called "acrylic polymers" has been advertised for this objective and may merit consideration when the overlay is less than 2 in. thick.
