INFRARED INSPECTION OF NEW ROOFS(U) COLD REGIONS  
RESEARCH AND ENGINEERING LAB HANOVER NH C J KORHONEN  
DEC 82 CRREL-SR-82-33

# Special Report 82-33

## *Infrared inspection of new roofs*

Charles J. Korhonen

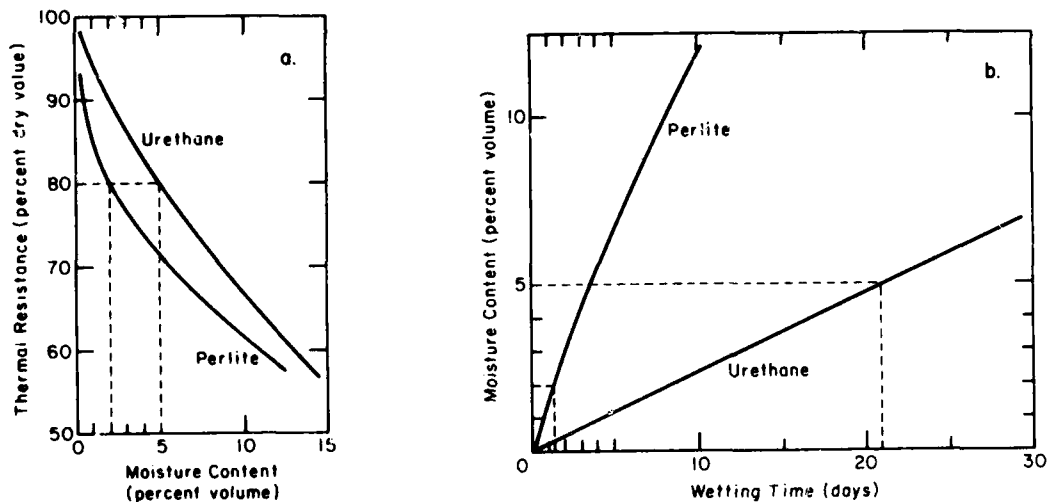
In Figure 1a we see that a moisture content of 2% by volume reduces the thermal resistance of perlite to 80% of its original dry value. In contrast, the same percent reduction in urethane's insulating ability does not occur until it has a moisture content of 5%. The relative time required to achieve these water contents under combined temperature and moisture gradients is shown in Figure 1b. It is seen that a day and a half was required to induce a moisture content of 2% into the perlite, whereas

Figure 1. Relationship between the thermal insulating value and the rate of moisture gain for perlite and urethane insulation.<sup>8</sup>

it took 21 days for the urethane to become 5% wet. Thus urethane not only gains moisture slower but requires more water to produce the same percent change in thermal effect on a roof.

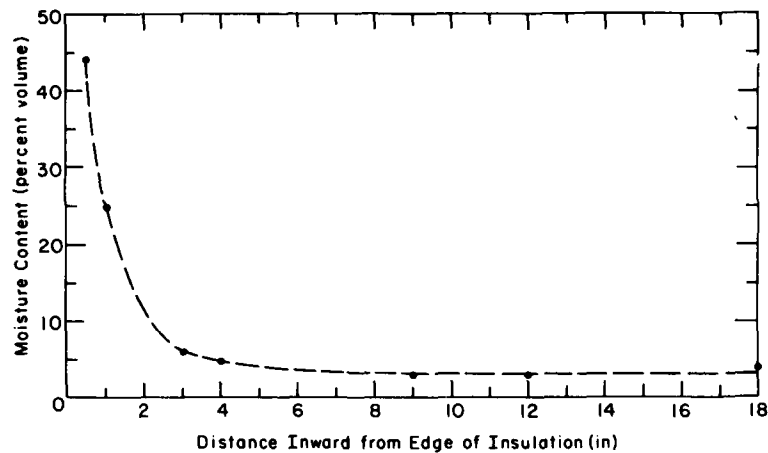
Figure 5. Relationship between moisture content and the distance away from the edge of a board of urethane insulation shown in Figure 3.<sup>9</sup>

that the volumetric water content dropped from over 40% near the edge of the board to 10% about 2 inches into the board (that moisture would have been distributed more uniformly in a fibrous insulation).

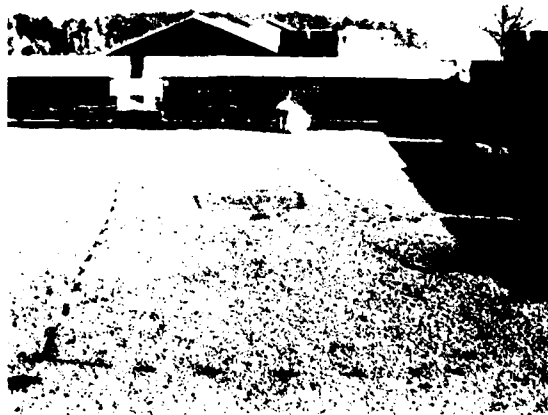
Figure 6 shows two thermograms of a roof area taken 5 months apart. Their differences suggest that the amount of moisture there had changed. Core samples and electrical resistance probe readings indicate that essentially no additional water had entered this area between the two surveys.<sup>5</sup> It is evident that thermogram 6a revealed few signs of moisture and that thermogram 6b, taken during the warranty's tenth month, showed clear signs of moisture. The extent of wet insulation detected with an infrared camera during each survey is shown by the spray paint markings in the Figure 6c daytime photograph. The five small areas outlined with a solid line of paint represent the wet insulation detected in May. The much larger area outlined by a dotted paint line indicates the wet insulation "seen" five months later.<sup>5</sup> (Had it not been for the core samples taken, most of the insulation in Figure 6a would have been thought to be dry in May. This demonstrated the importance of taking core samples.)

c. October 1979 photograph. The solid spray-painted lines depict the extent of wet insulation detected in May while the dotted lines depict the October boundaries.

Figure 6. Two thermograms and a daytime photograph of a roof containing wet urethane insulation. Note how much more moisture is detected by the October 1979 survey.
