USAAEFA PROJECT NO. 81-18

UH-60A LIGHT ICING ENVELOPE EVALUATION WITH THE BLADE DEICING KIT INSTALLED BUT INOPERATIVE

FINAL REPORT

JUNE 1982

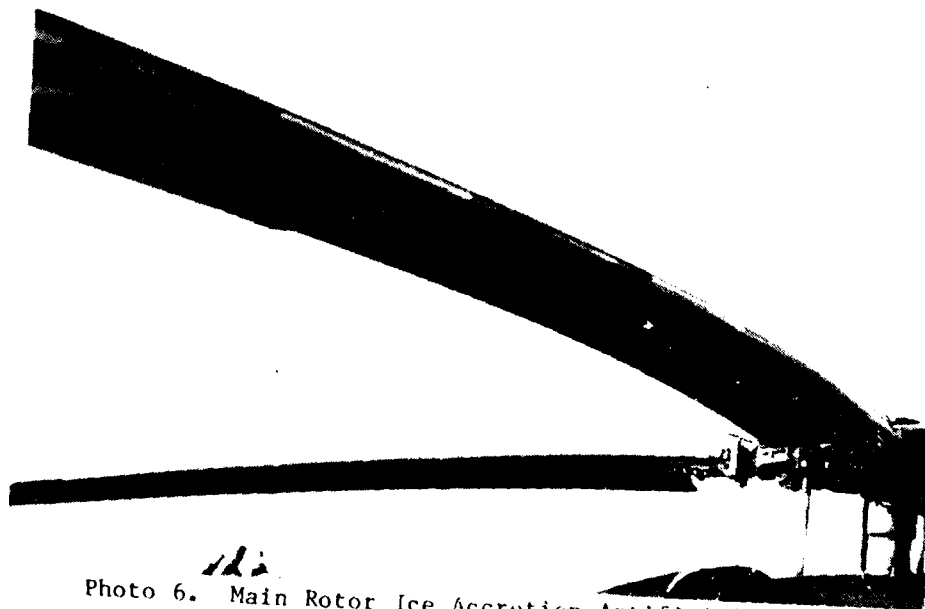
Photo 6. Main Rotor Ice Accretion Artificial Icing:
0.21 gm/m³ LWC, -17.0° C, 45 Minutes

Photo 7. Main Rotor Ice Accretion Artificial Icing:
0.21 gm/m³ LWC, -17.0°C, 45 Minutes

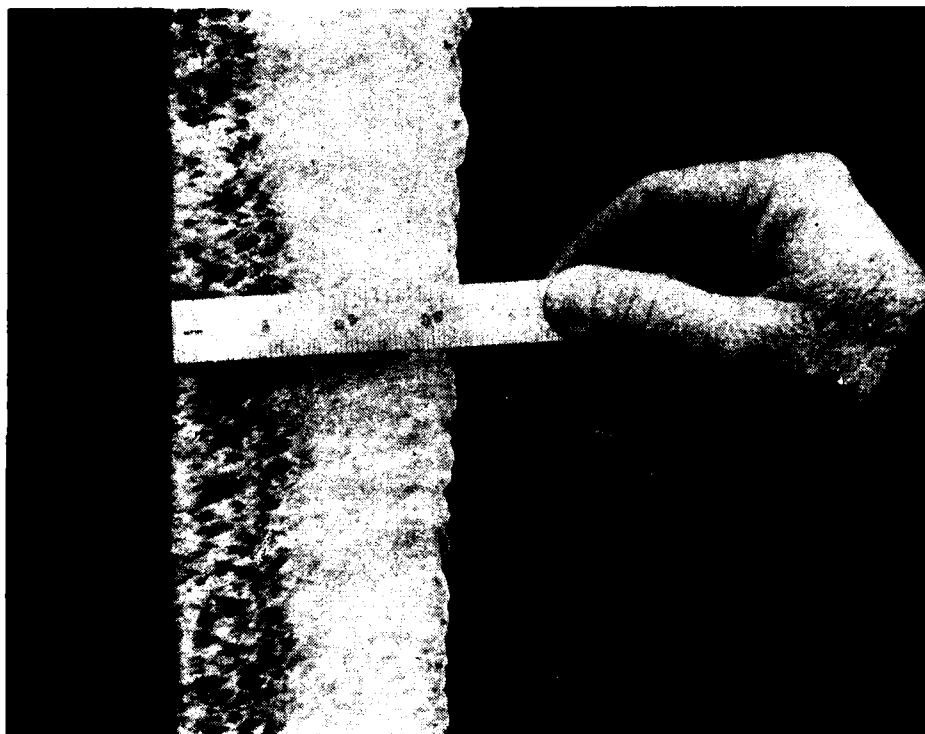
Photo 11. Ice Accretion on FM Antenna Natural Icing:
0.42 gm/m³, -7.0° C, 95 Minutes

Photo 12. Ice Accretion on FM Antenna Natural Icing:
0.42 gm/m³ LWC, -7.0° C, 95 Minutes

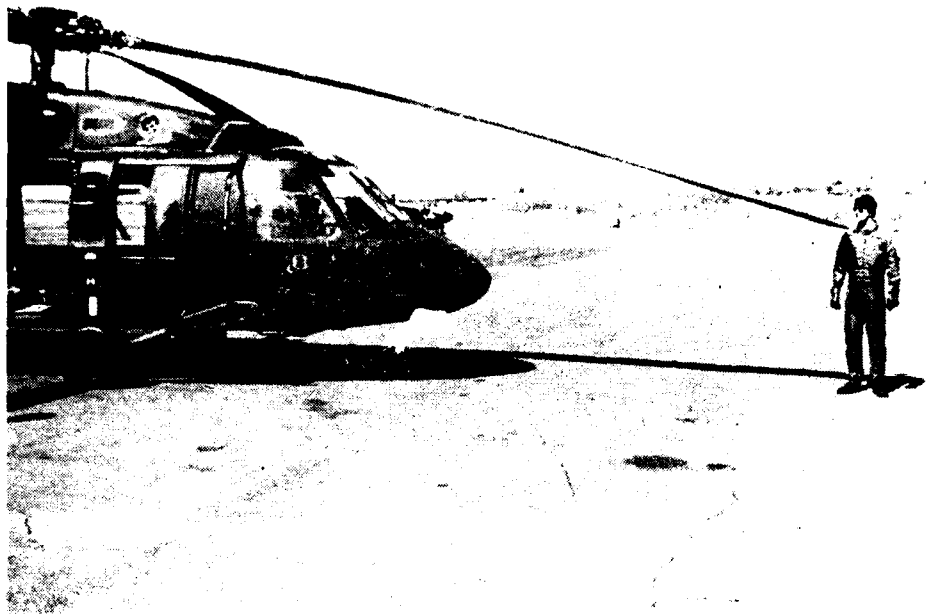
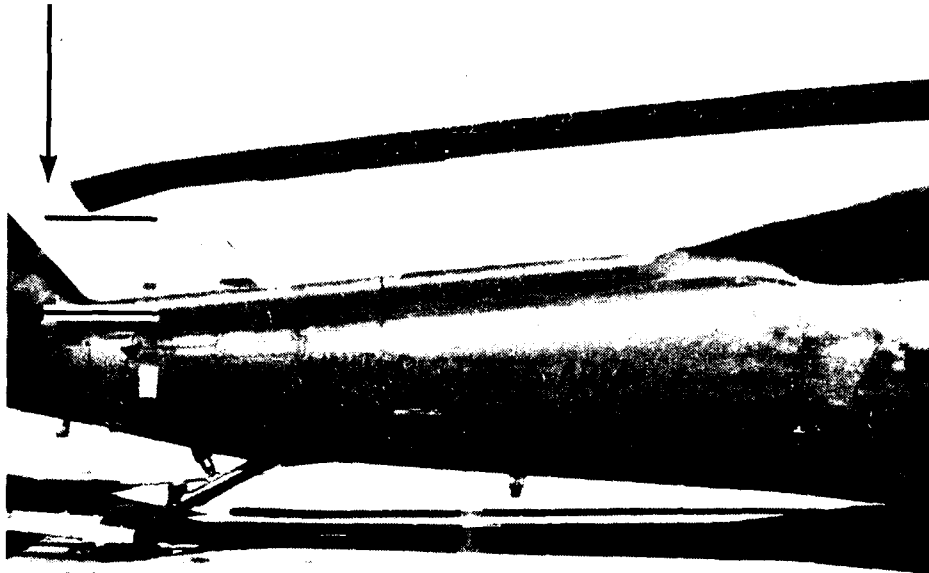
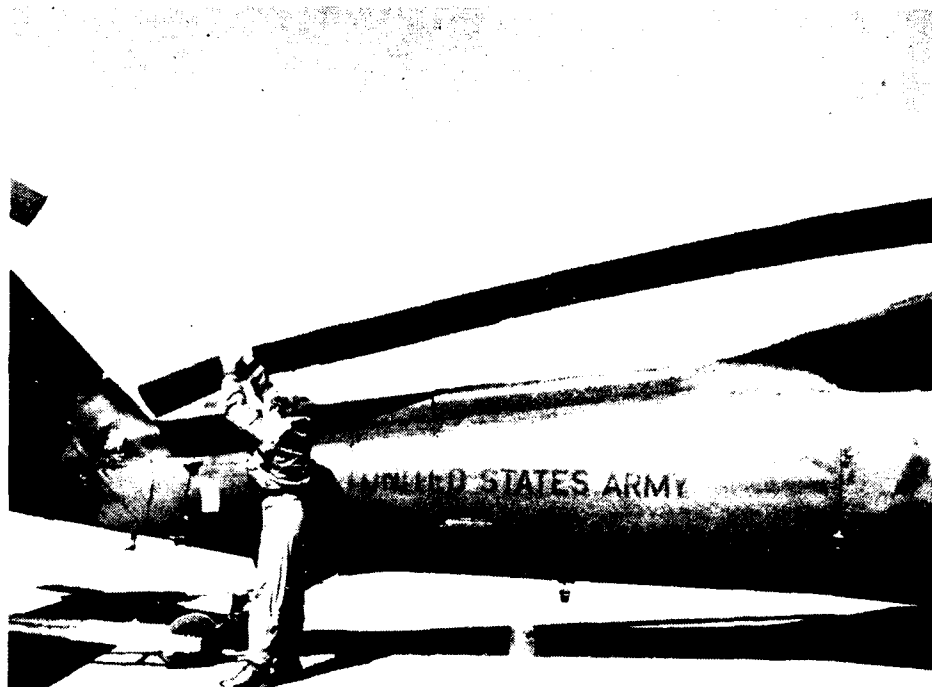
or gusty wind conditions the main rotor blades may strike the tail rotor drive shaft in the vicinity of the tail rotor intermediate gear box. Photos 13 through 15, appendix G show the static position of a main rotor blade with the droop stop in the "flight" position. The blade may flex more than this in high or gusty winds and cause fuselage or main rotor system damage if the flap restrainers are frozen in the "flight" position. Photos 16 and 17, appendix G show a flap restrainer in the "shutdown" position and frozen in the "flight" position, respectively. This situation occurred after an artificial icing encounter of 60 minutes at 0.49 gm/m^3 LWC and $-6.0 \text{ }^\circ\text{C}$. The unheated GCT droop stops functioned properly at all icing conditions tested with 0.3 gm/m^3 LWC or less. At all conditions tested with LWCs greater than 0.3 gm/m^3 the potential exists for improper positioning of the droop stops and flap restrainers during shutdown. The production droop stops (P/N 70105-08151-041) demonstrated poorer ice accretion characteristics than did the GCT droop stops (ref 4, app A); therefore, improper droop stop positions may occur at LWCs less than 0.3 gm/m^3 . Incorrect GCT droop stop position during shutdown could cause main rotor/fuselage contact and is a deficiency.

Photo 13. Droop Stop in the "Fly" (Incorrect) Position

Photo 14. Droop Stop in the "Fly" (Incorrect) Position

Photo 15. Droop Stop in the "Fly" (Incorrect) Position

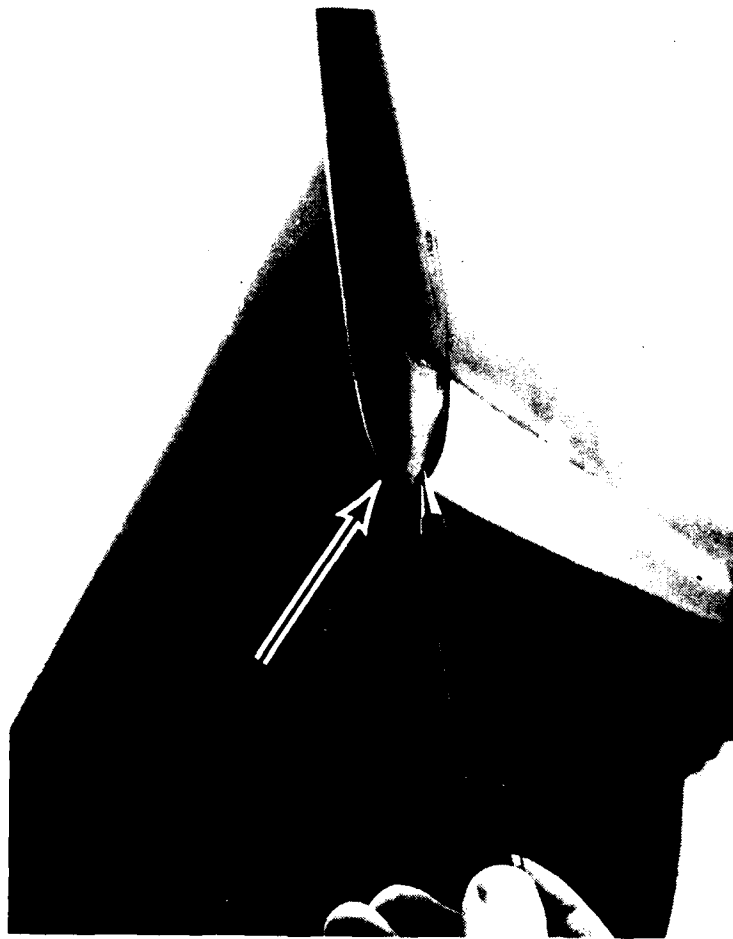
16. The aircraft sustained damage during flights under both artificial and natural icing conditions. During an artificial icing flight at 0.49 gm/m^3 LWC and $-6.0 \text{ }^\circ\text{C}$ a tail rotor blade tip cap was damaged, requiring replacement (photo 18, app G). During another artificial icing flight at 0.5 gm/m^3 LWC and $-12.5 \text{ }^\circ\text{C}$, several components were damaged. The white strobe portion of the upper anti-collision light was broken (photo 19, app G) by ice shed from the main rotor. The shattering glass from the anti-collision light was thrown into the tail rotor blades causing damage to the leading edge of all four blades. Additionally, the tail rotor gear box fiberglass cowling was hit by ice shed from the main rotor causing a dent approximately 9 inches in diameter and 4 inches deep. The cowling was split approximately 6 inches (photos 20 and 21, app G).

Photo 18. Damaged Tail Rotor Tip Cap Artificial Icing:
0.49 gm/m³ LWC, -6.0° C, 60 Minutes

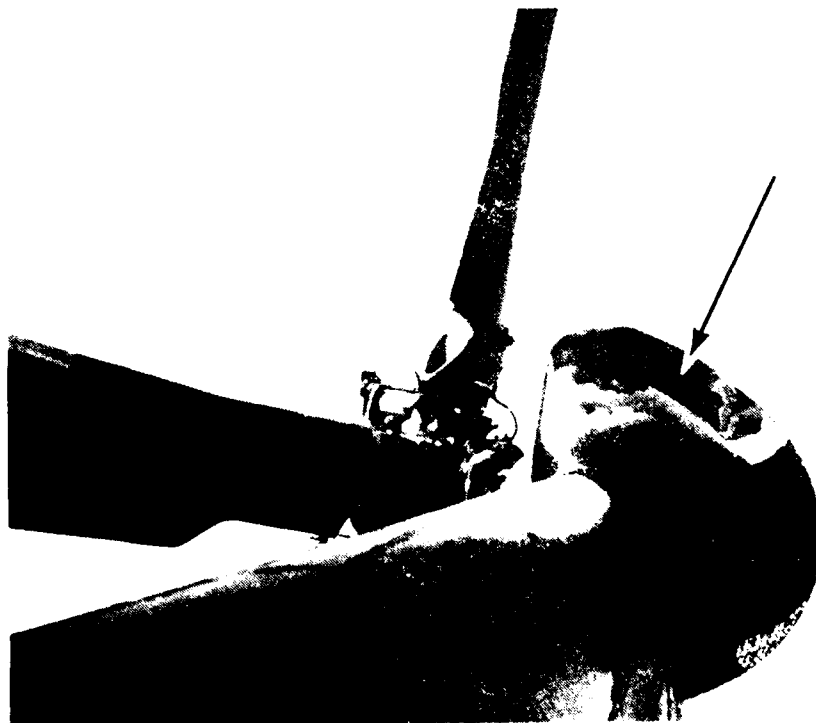
18. The main rotor ice shedding characteristics discussed in the two preceding paragraphs resulted in aircraft damage. No aircraft damage occurred at any conditions tested with 0.3 gm/m³ LWC or less. However, the potential exists for aircraft damage due to ice sheds at LWC's above 0.3 gm/m³. Aircraft damage occurring from rotor system ice sheds at LWCs of approximately 0.5 gm/m³ constitutes a deficiency. The UH-60A should not be cleared for operation in icing conditions more severe than 0.3 gm/m³ LWC without a qualified deice kit installed and operational.

Photo 20. Damaged Tail Rotor Gearbox Cowling Artificial Icing:
0.5 gm/m³ LWC, -12.5° C, 81 Minutes

Photo 21. Damaged Tail Rotor Gearbox Cowling Artificial Icing:
0.5 gm/m³ LWC, -12.5°C, 81 Minutes

30. The UH-60A should not be cleared for operation in icing conditions more severe than 0.3 gm/m^3 liquid water content without a qualified deice kit installed and operational (para 18).

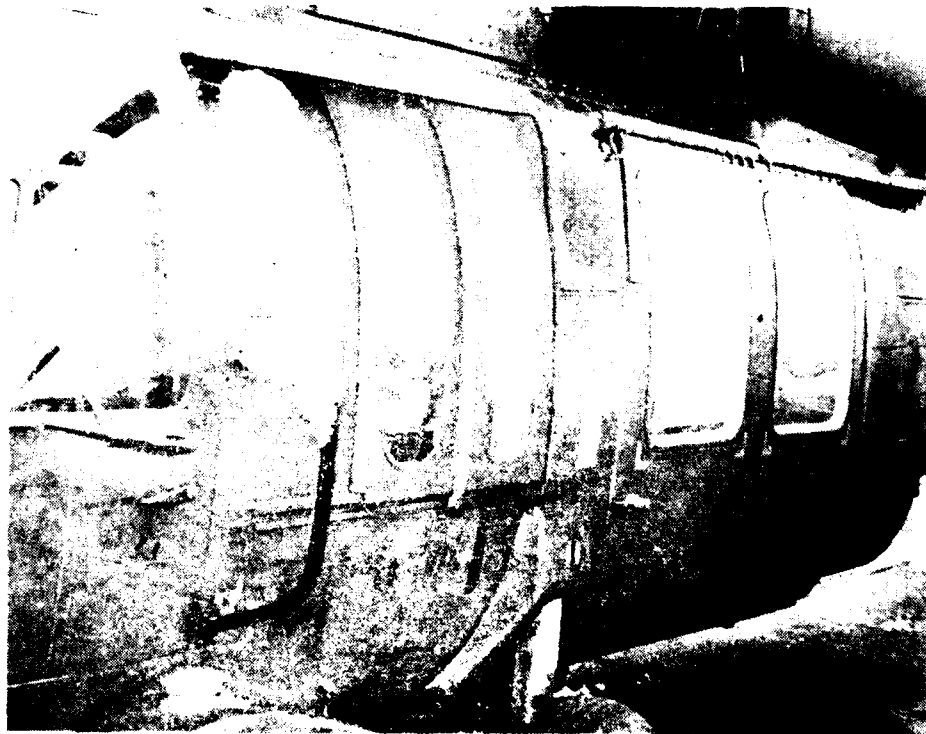
Photo 22. Ice Accretion on FM Antenna Natural Icing:
0.5 gm/m³ LWC, -4.0°C, 43 Minutes

23. Ice Accretion on FM Antenna Natural Icing:
0.5 gm/m³ LWC, -4.0°C, 43 Minutes
