MODIFICATION AND LABORATORY EVALUATION OF A SHIPBOARD
MULTIFUNCTIONAL MAS... (U) NAVAL SURFACE WEAPONS CENTER
DAHLGREN VA J A BYRNE ET AL. MAY 82 NSWC/TR-82-71

4. TITLE (and Subtitle) MODIFICATION AND LABORATORY EVALUATION OF A SHIPBOARD MULTIFUNCTIONAL WASTE INCINERATOR (MFI), PHASE II	5. TYPE OF REPORT & PERIOD COVERED Final

6. PERFORMING ORG. REPORT NUMBER	
7. AUTHOR(s) J. A. Byrne W. W. Jones	8. CONTRACT OR GRANT NUMBER(s)	
9. PERFORMING ORGANIZATION NAME AND ADDRESS Naval Surface Weapons Center (G51) Dahlgren, VA 22448	10. PROGRAM ELEMENT, PROJECT, TASK AREA & WORK UNIT NUMBERS 63721N 21484

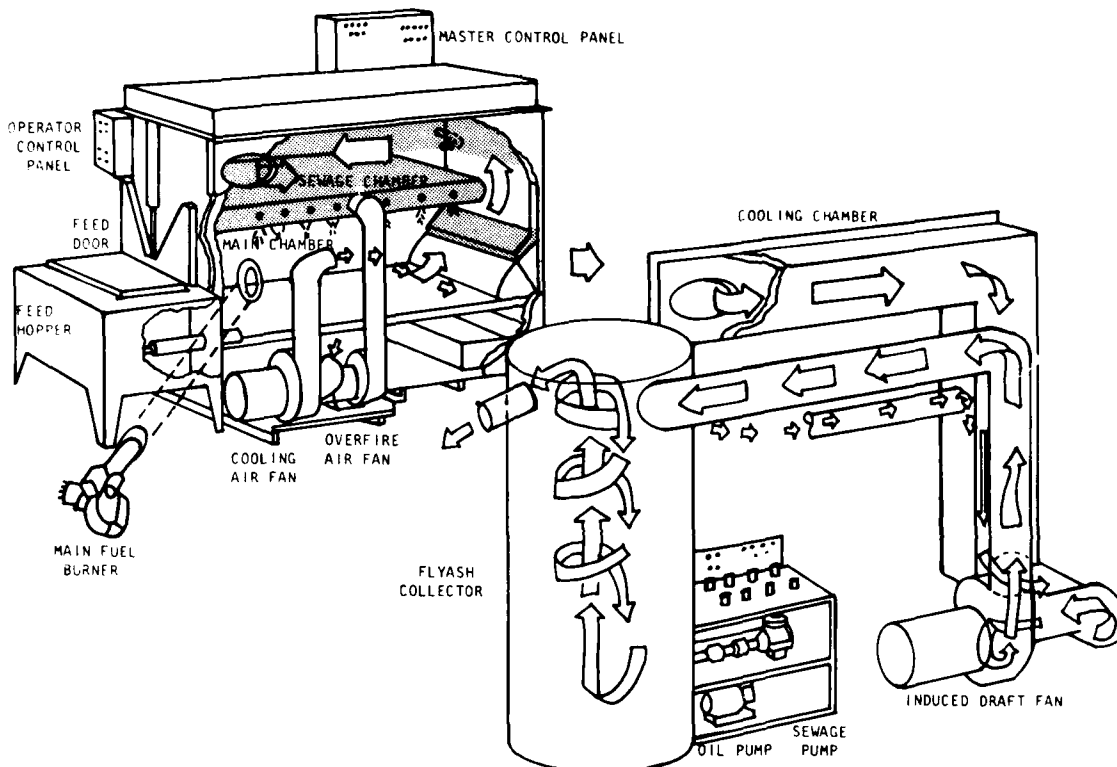
1. Deteriorated refractory material in the sewage and main chambers, as shown in Figure 2
2. Lack of refractory material in the base of the cooling chamber
3. Deterioration of cooling jacket insulation
4. Poor location of the sewage chamber cleanout/viewing port for adequate cleaning of the ashes
5. Poor air flow in the cooling jacket

Figure 2. Deteriorated Refractory Sections (Shaded Sections) of MFI Phase II

These deficiencies were dealt with by partially refurbishing the MFI from August through September 1979. This refurbishment began with the careful disassembly and evaluation of the incinerator to determine the condition of all components, especially those accessible only through disassembly.

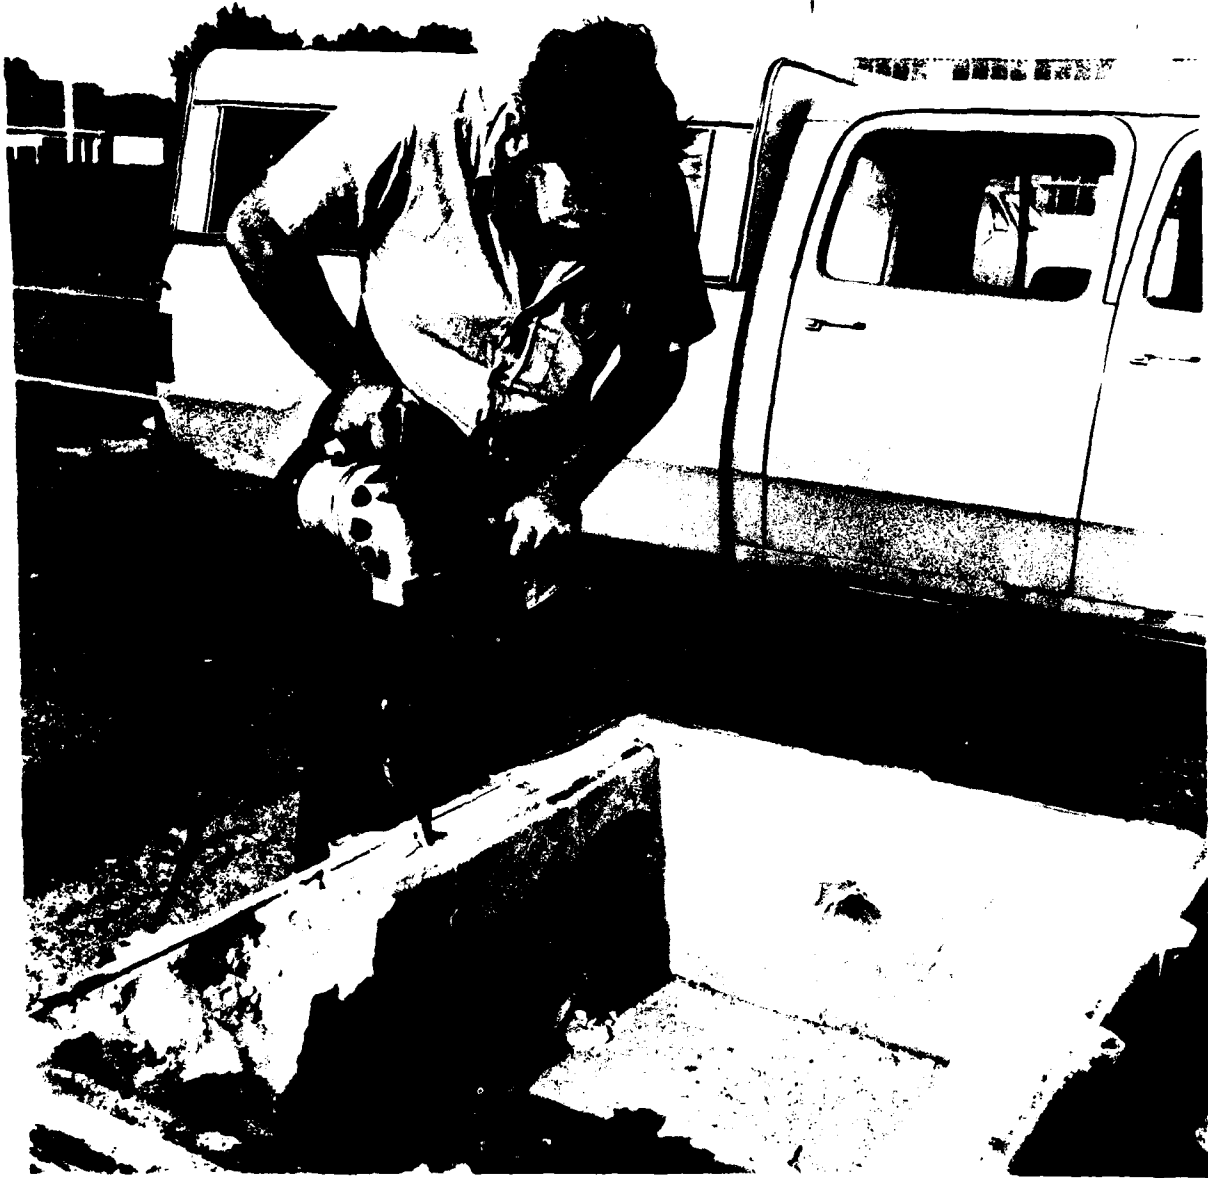
Figure 11. Refractory Removal from the Sewage Chamber

The refractory material of the sewage chamber, partition, and ash door overhead was removed as shown in Figures 10 and 11. The condition of the metal structures is shown in Figures 12, 13, and 14. Figure 12 shows the sewage roof metal structure. Figure 13 is a front view of the sewage chamber wall metal structure. The partition's metal structure, shown in Figure 14, was repaired by replacing the destroyed air manifold pipe. The location of that pipe was also changed, so that an increased thickness of refractory material protected the pipe. All metal structures were then sandblasted and

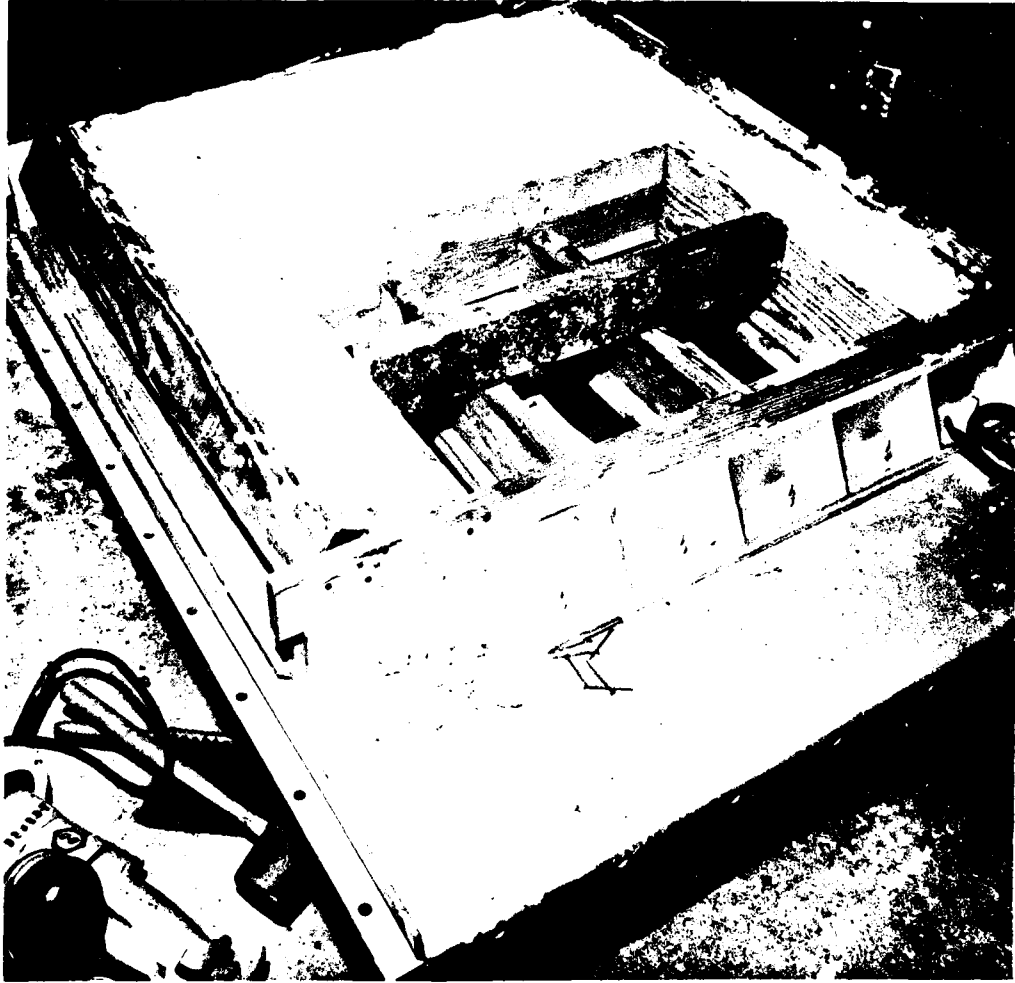
Figure 19. The Front Wall After Casting with the Form in Place

The front wall of the incinerator was refurbished with a castable insulating refractory, KAST-O-LITE 30[®], because there were extensive cracks in the wall. The finished wall is shown in Figure 19. Note the V-shaped expansion etches, which were supposed to relieve expansion/contraction stresses. Such stresses can cause large cracks in the refractory.

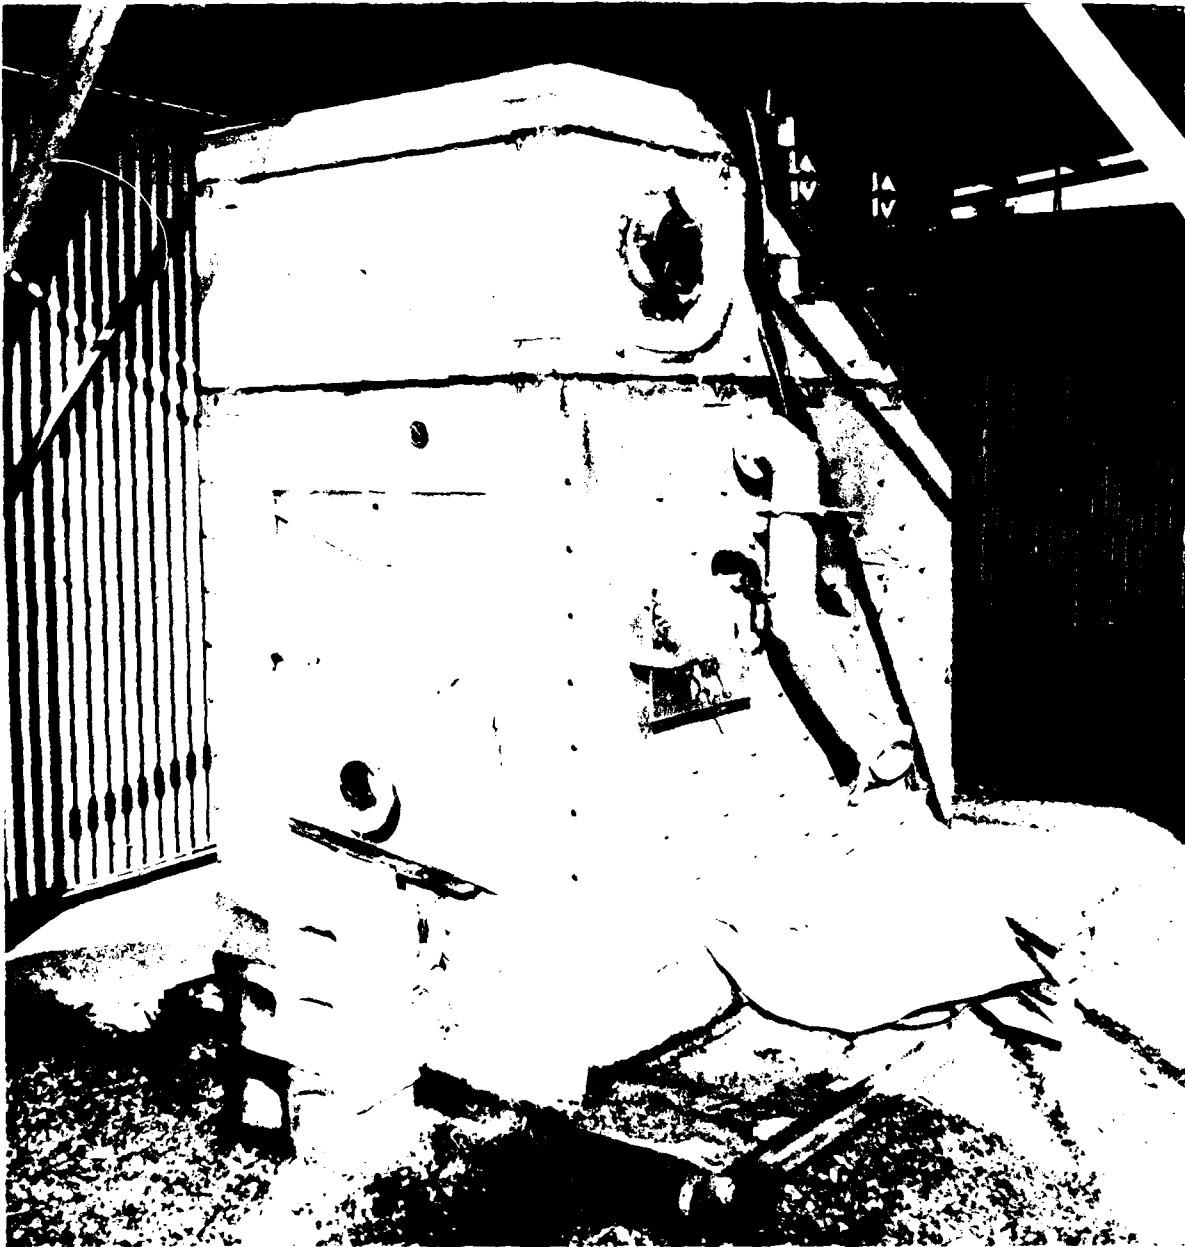
Figure 22 shows the structure after curing. The lower left circular opening was used as the burner port, and the upper right opening was attached to the exhaust flue. Figure 23 is a view of the main chamber after curing. The ash door overhead and the bottom of the partition are shown. The repaired portion of the side wall in the upper left appears as a bright white area surrounding the thermocouple shield.

Figure 22. The Main and Sewage Chambers Assembled for Curing

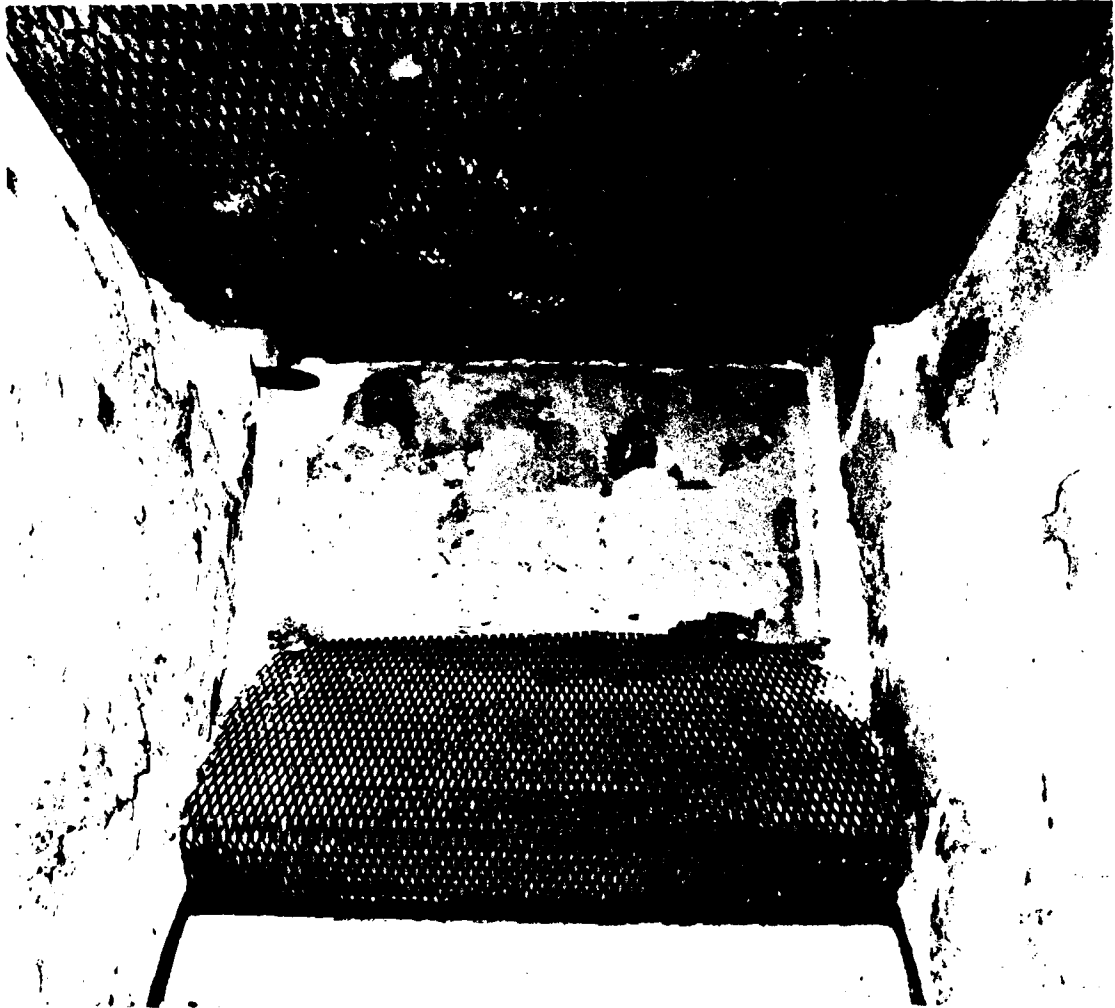
Figure 23. The Side and Back Walls in the Main Chamber

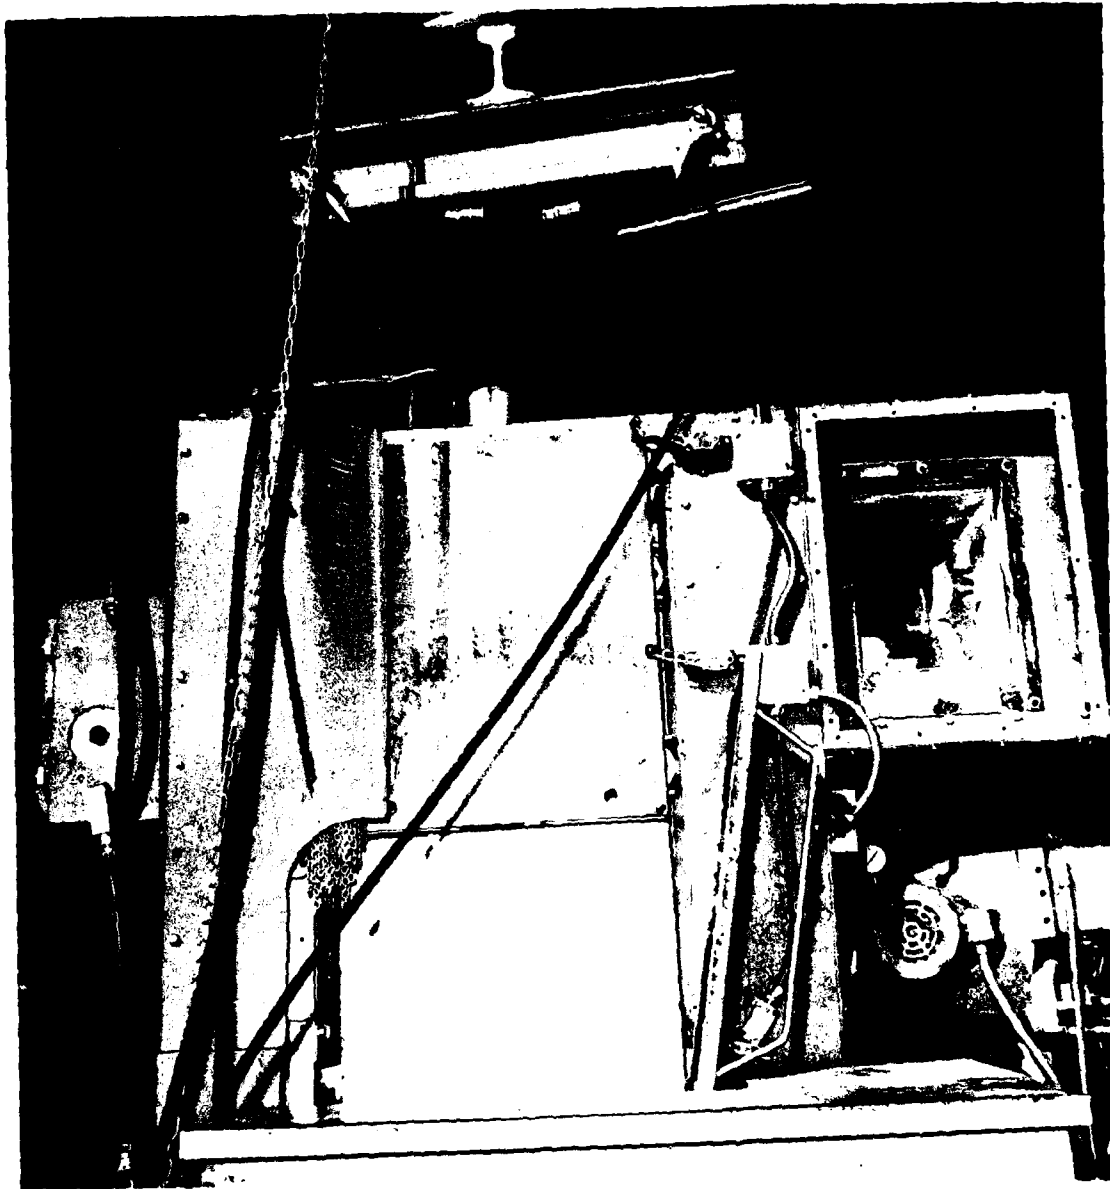
Figure 47. The Cooling Chamber and Chain Curtain Guard Damage

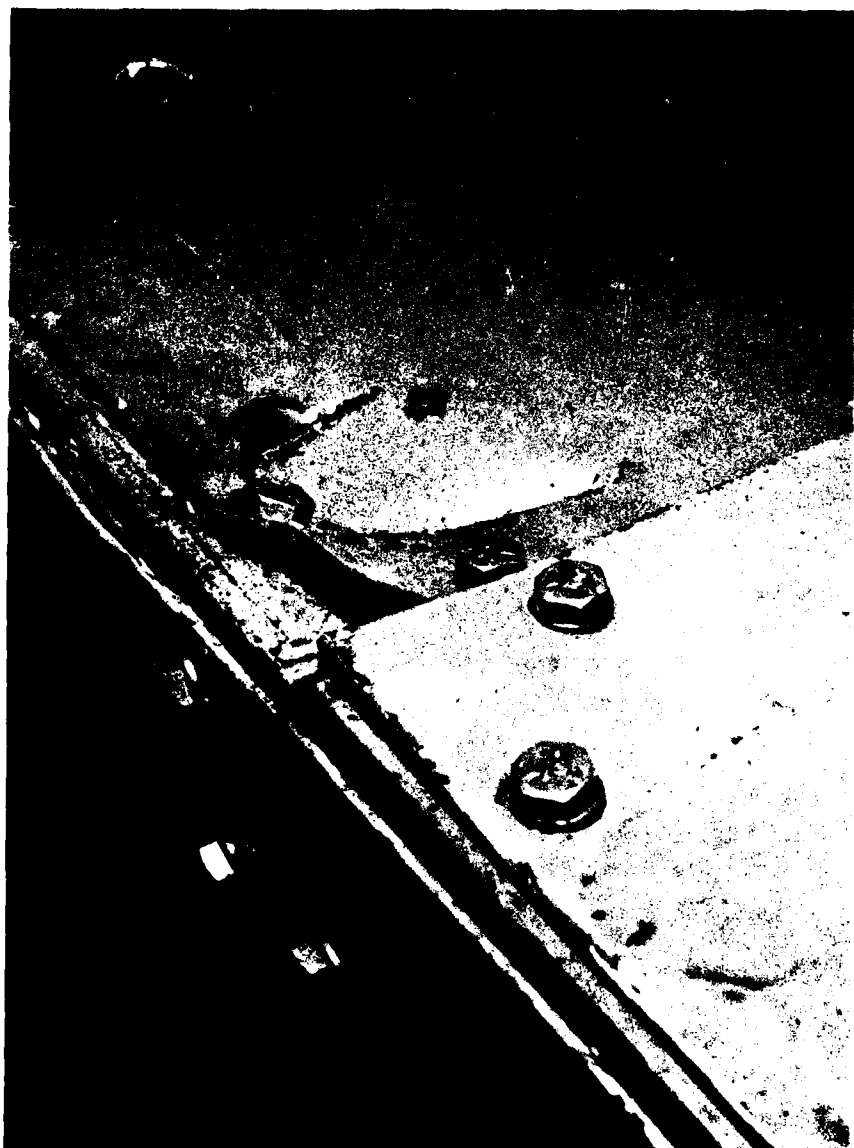
Figure 51. Damaged Cooling Jacket Roof Panel
