Materials and Electronic Equipment Corrosion Tests in Some U.S. Navy Geothermal Environments

by
C. Rodgers
Public Works Department
S. Finnegan
and
K. Graham
Research Department

MARCH 1983

**NAVAL WEAPONS CENTER
CHINA LAKE, CALIFORNIA 93555**

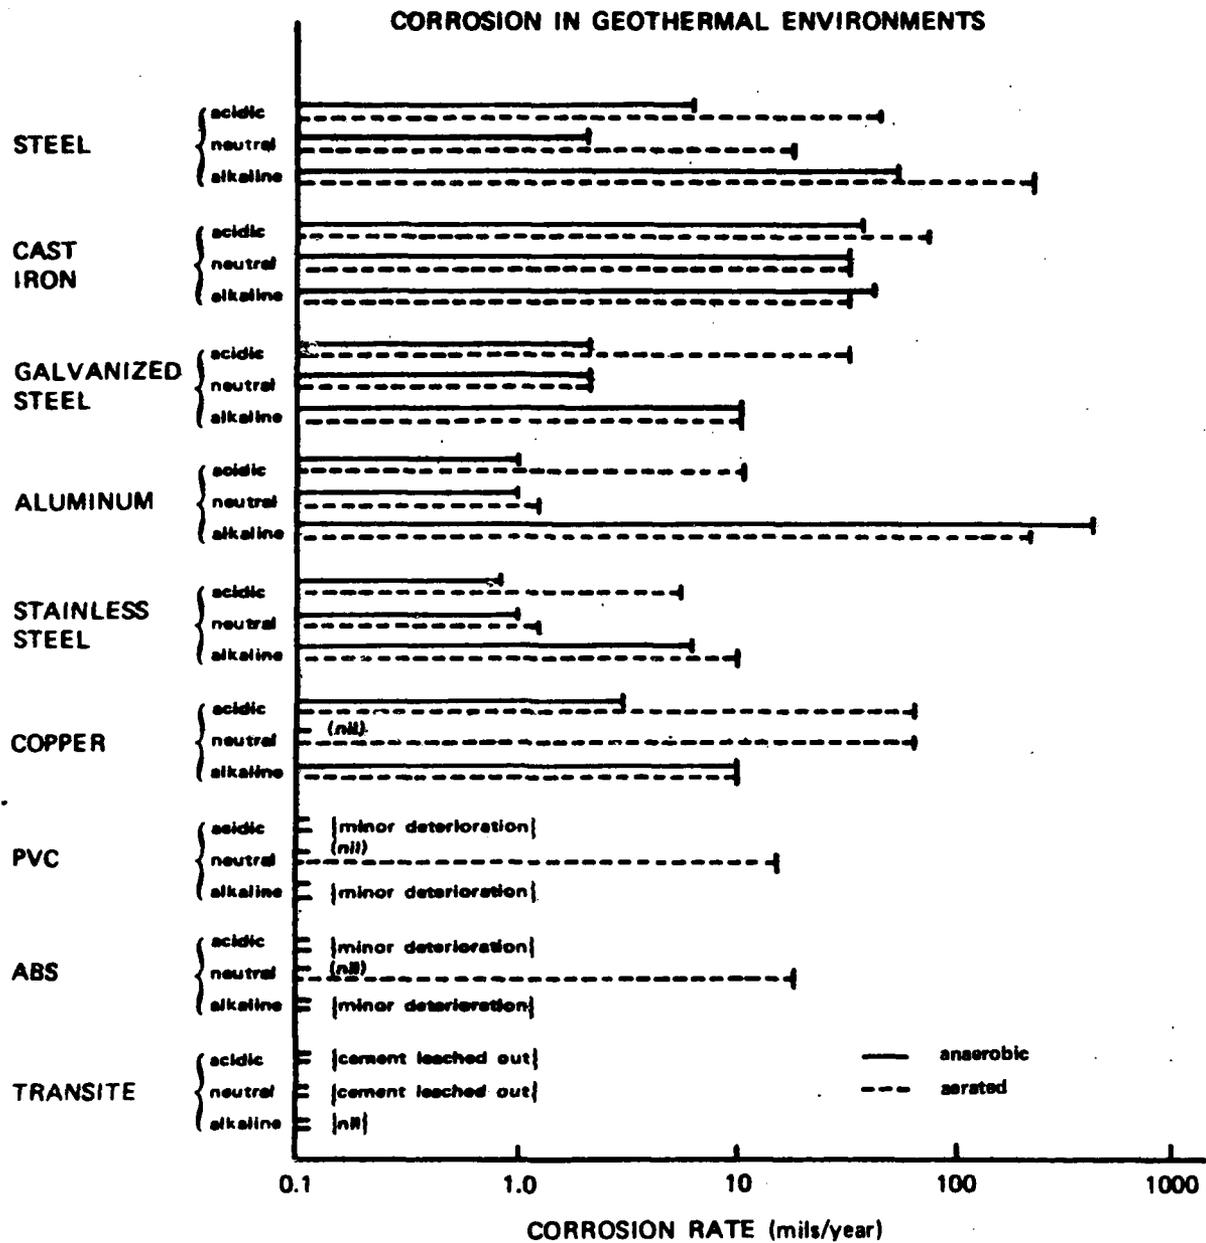
Corrosion studies of common construction-grade piping materials in natural geothermal environments have been previously conducted at the Naval Weapons Center (NWC) (Ref. 1). Ten-foot-long sections of nine different materials were exposed to three different moderate-temperature (less than 220°F) geothermal fluids under both anaerobic and aerated conditions for periods up to about 1 year. Test fluids included two different water-saturated steam environments and a mildly alkaline, saline water. The steam environments included an acid-sulfate site at the Devils Kitchen area and a neutral (pH) groundwater-diluted site at the Coso area. Test materials included mild steel, galvanized steel, 304 stainless steel, gray cast iron, 6063-T6 aluminum, cold-drawn copper, ABS and PVC plastics, and transite. Results from this study are reproduced in Figure 1.

FIGURE 1. A Comparison of Corrosion Rates for Various Materials in Three Geothermal Fluids Found at the Coso Geothermal Area (Ref. 1).

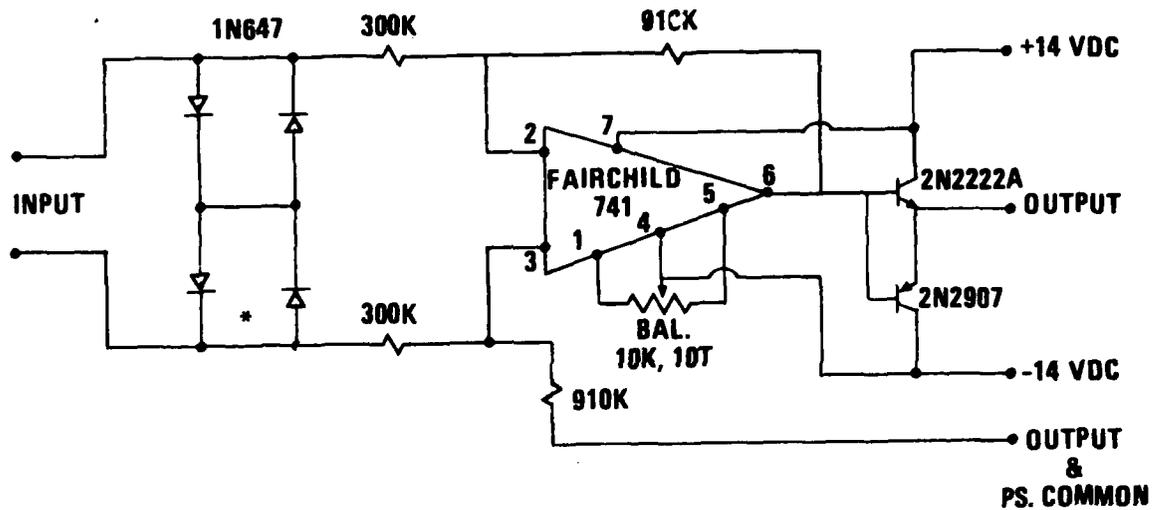
*Circuit #4 - The diode limiters on the input circuit have been removed.

FIGURE 2. Breadboard with Four Integrated Circuit Amplifier Circuit.

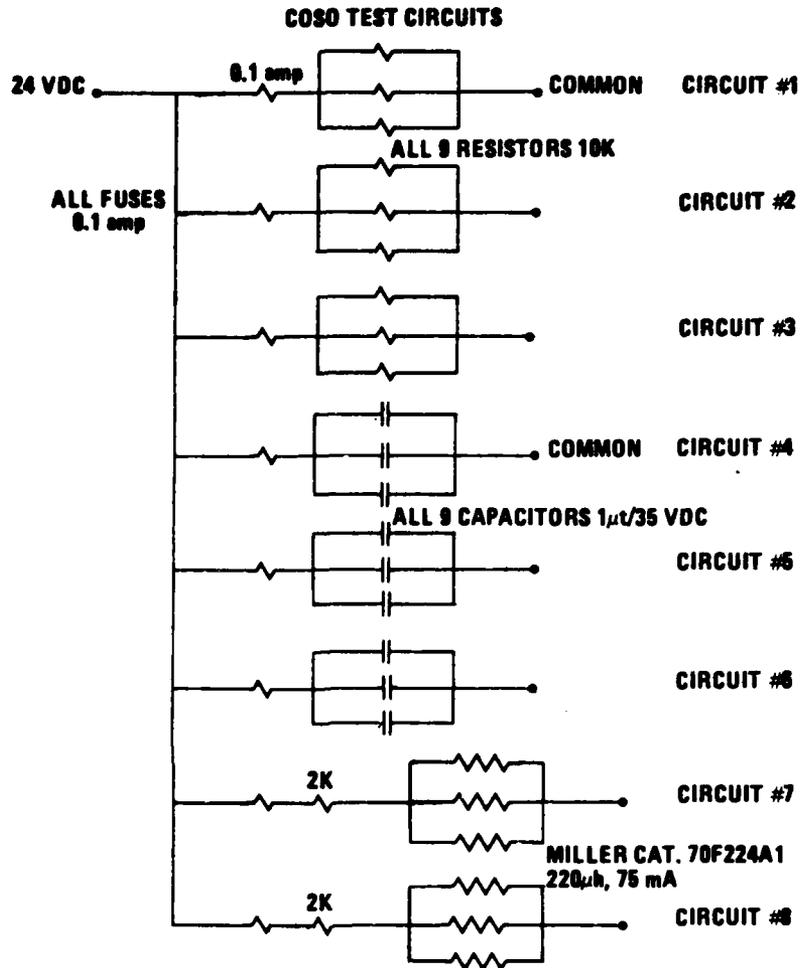
Circuits 1, 2, 4, 5, 7 and 8—flux removed.
Circuits 3, 6 and 9 were not cleaned.

FIGURE 3. 24-VDC Circuit with Resistors, Capacitors, and Coils in Parallel Circuits.

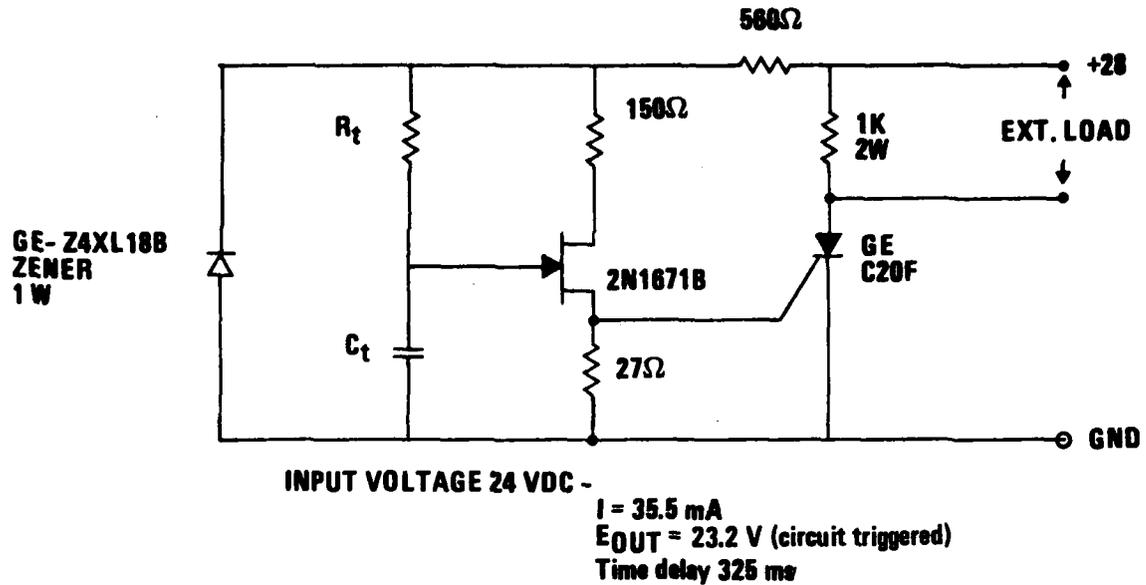
FIGURE 4. Solid-State Timing Circuit.
