NASA Technical Memorandum 84637

FLIGHT SERVICE EVALUATION OF COMPOSITE COMPONENTS
ON BELL 206L AND SIKORSKY S-76 HELICOPTERS

DONALD J. BAKER

MARCH 1983

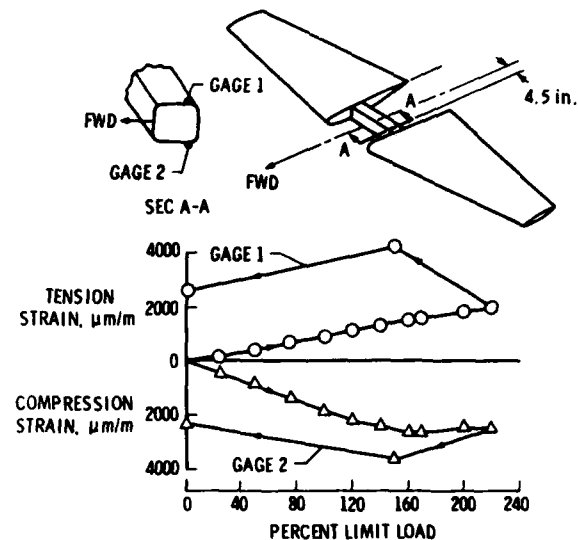
The first horizontal stabilizer removed from service had accumulated 1600 flight hours over a 17 month period in the Lake Charles, LA area. No defects were found during inspection of the stabilizer. Deflection from the proof load was the same as in the initial acceptance test. Plots of strain as a function of limit load are shown in figure 17. The tension strain response was linear up to 160 percent of design limit load (DLL) and then increased at a reduced slope until the maximum applied load of 220 percent of DLL was reached. The compression strain response was linear to 120 percent of DLL and then increased at a reduced slope until 170 percent of DLL was reached. There was no increase in compression strain after 170 percent of DLL. At 220 percent of DLL a loud "snap" was heard and the load dropped to 150 percent of DLL. Attempts to increase the load beyond the 150 percent DLL resulted in deflection until the test fixture limit was reached. Visual inspection of the stabilizer indicated a buckle in the splice plate on the left hand leading edge of the spar. Teardown of the component indicated a loss of shear transfer capabilities between the composite material and the metal honeycomb (figure 18). At 220 percent of DLL, the shear load had been transferred to the Kevlar/epoxy torque box and eventually buckled the splice plate. The structure still supported 150 percent of DLL but with reduced rigidity. The stabilizer tested for certification did not fail but reached the maximum deflection allowed by the fixture at 268 percent of DLL. Additional tests will be necessary to determine if the change in failure mode is the result of environmental degradation of the composite

Figure 17. Strain as a Function of Percent Limit Load on S-76 Horizontal Stabilizer Spar, .1 m (4.5 in.) from Centerline.

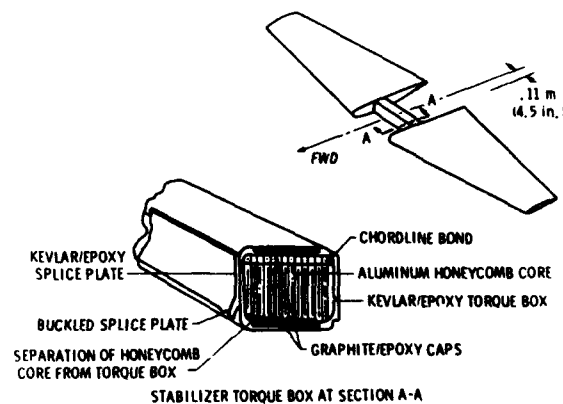
Figure 18. Schematic of S-76 Composite Stabilizer Static Fracture Modes.

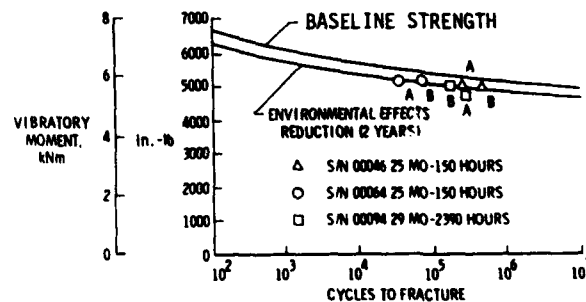
The first tail rotor spar (Serial Number 00094) removed from service had accumulated 2390 flight hours over a 29 month period in the Lake Charles, LA area. No defects were found during the inspection of the spar. The spar was fatigue tested and the results are given in figure 19 along with data from spars labeled serial numbers 00046 and 00064 (reference 3). These spars were removed from a Sikorsky flight test aircraft that was at West Palm Beach, FL. The points designated "A" represent the first fracture on one side of the spar. Testing was continued on the other side until fracture occurred and the results are designated "B". The data indicate a 94 percent retention in fatigue strength for the spars exposed 2 to 2 1/2 years compared to the strength of dry spars tested at room temperature for FAA certification. Four coupons were machined from the failed spar (No. 00094) and dried. The average moisture content was 0.26 percent. The two spars (S/N 00046 and 00064) removed from a flight test helicopter had 150 hours of service each and contained .29 percent (S/N 00046) and .32 percent (S/N 00064) of moisture, respectively. The 94 percent strength retention for the spars with 2 to 2 1/2 years service compares well with the 95 percent strength retention projected from laboratory conditioned specimens (reference 3).

Figure 19. S-76 Tail Rotor Spar, Moment-Cycle Fatigue Curve.
