EVALUATION OF BURIED-CABLE DETERIORATION AT GUAM
MARIANA ISLANDS(U) NAVAL RESEARCH LAB WASHINGTON DC
W M MCDAVIT 13 JUN 83 NRL-8717

(2)
NRL Report 8717

Evaluation of Buried-Cable Deterioration at Guam, Mariana Islands

June 13, 1983

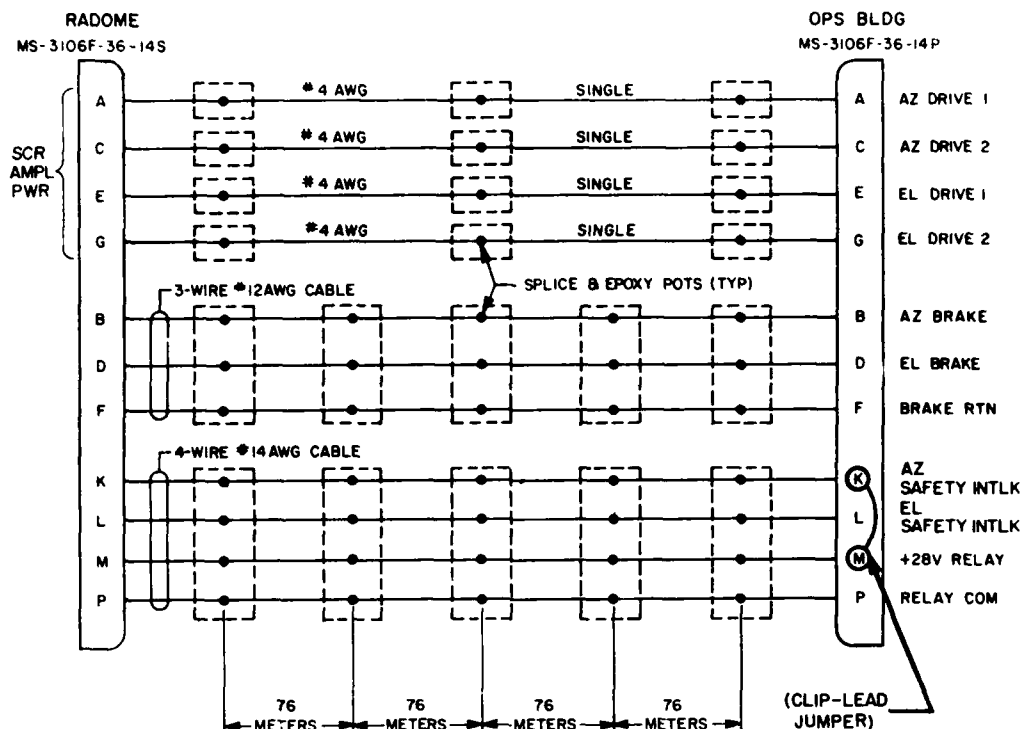
Fig. 2 — Cables in Fig. 1, including the four-wire cable of concern in this report

In April 1980 NAVCAMS issued a "Problem Reporting and Enhancement Recommendation" (PRAER) message, relating to a break in one of the buried SCR conductors (Fig. 3). This unusual situation opened a safety-interlock circuit and negated the use of one operational antenna. By electronic means, site maintenance personnel located the break, which was in the red-insulated wire. The trench was excavated at that point, and the safety-interlock conductor with the red insulation was repaired by splicing. During this endeavor, site personnel noted evidence of termite activity and postulated that the damage was caused by termites. One month later the author was on-site at NAVCAMS and conducted a spot inspection in the other two antenna cable trenches. In all cases evidence of termites having been present was substantiated. No evidence of external damage to the insulations of the cables/wires could be observed. Within the next 3 months breaks occurred in the other two trenches in the red wires, adversely affecting the other two operational antennas. Thereupon station maintenance personnel installed a clip-lead jumper bypassing the safety interlock, to return the antennas to a workable status (Fig. 2).

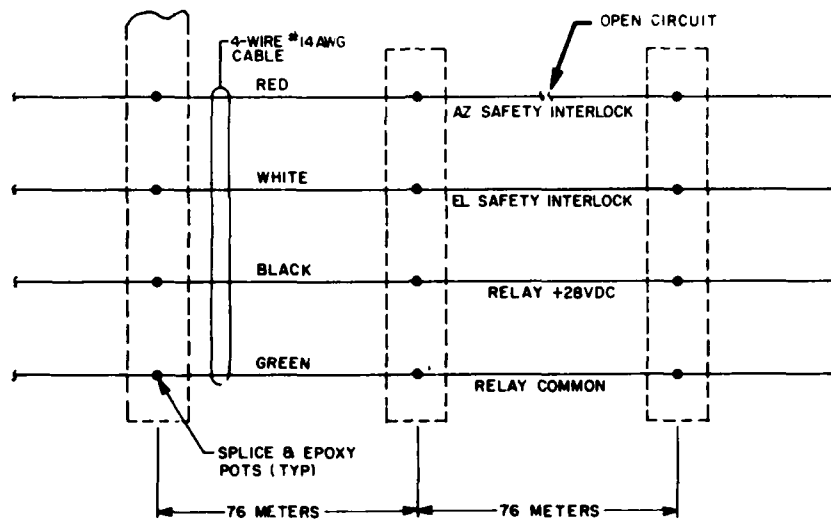
Fig. 3 — Break that occurred in the four-wire cable. A break occurred in the wire with red insulation in each of the three trenches, with one break being fixed by excavation and splicing and the other two being made workable by a jumper as shown in Fig. 2.

Next approximately 15 m of the defective cable type was carefully stripped of the outer insulation to inspect the four insulated wires inside more effectively and to determine if moisture was present. It was during this phase of the investigation that green spots were noticed on the red-insulation wire. The spots varied in size and color intensity and were not spaced evenly or continuously. There was, however, an apparent correlation between the diameter of the spots and the color intensity; that is, the darker green spots were greater in diameter, and vice versa. By touch, the spotted areas appeared to be some sort of deterioration in the insulation, since scabs could be flaked or picked off. Also noted was a tendency for the spots to be grouped in areas 2 to 4 m long. Investigations into some of the other 76-m sections showed inconsistencies in the spotting effect: some sections had similar spotting, some had none at all, and others had spots of lesser frequency. Continuity checks of various sections proved to be inconclusive overall, although the following findings were validated:

To try to determine the cause of these deteriorations, some of the spotted areas in the impaired insulations were carefully cut away. In so doing, it was discovered that the copper stranded wire under these spots was corroding and disintegrating. Now it had to be determined whether the corroding wire was causing the spots in the insulation or the spots were causing the copper corrosion.

Seawater salts were found in the stranded copper conductor and were the major contributors to the ultimate destruction of the wire. How the wire was initially exposed to saltwater is not known. If the cable, of which the affected conductor was a part, had been stored or shipped in a saltwater-contaminated environment, then the highest level of contamination would have been concentrated at the ends of the cable, where the conductors were exposed, that is, at the only two points where the direct-burial-qualified outer insulation is nonexistent. On-site visual inspections did not reveal that situation. No evidence of deterioration existed at the ends of any of the 12 sections of buried cables. Similarly, it cannot be logically presumed that the bare copper wire had been stored by the manufacturer in a saltwater environment. Had this happened, corrosion would have been found throughout greater areas of the affected conductors.

Naval Research Laboratory SSD personnel were then tasked to (A) supervise the excavation of all of the Guam cable trenches, (B) install and verify operation of new SCR cables, and (C) determine the cause of the cable failure. In April 1980, a two-man SSD team proceeded to Guam to undertake these assignments. These tasks were completed, and this report will be directed at task C, the evaluation of observations and the determination of the cause(s) for the cable breaks.
