# Analysis of FY 79 Army Aircraft Accidents

USASC TECHNICAL REPORT  
TR 80-2  
APRIL 1980

Prepared by  
G. Dwight Lindsey

Directorate for  
Investigation, Analysis, and Research

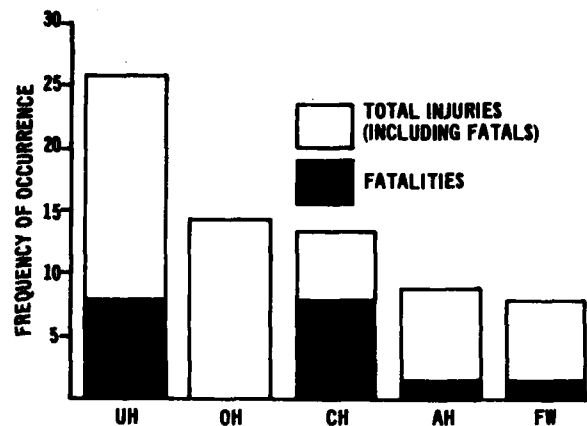
FIGURE 4. — FY 79 Injuries and Fatalities in Army Aircraft Accidents

The number of fatalities and injuries by aircraft type are shown in figure 4. Aircraft types are presented in order of injury frequency.

Utility, observation, and cargo helicopters accounted for the majority of fatalities and personnel injuries. While observation aircraft accidents were responsible for the second largest number of injuries, there were no fatalities in these crashes. Utility and cargo aircraft accidents accounted for nearly all (78%) of the FY 79 fatalities.

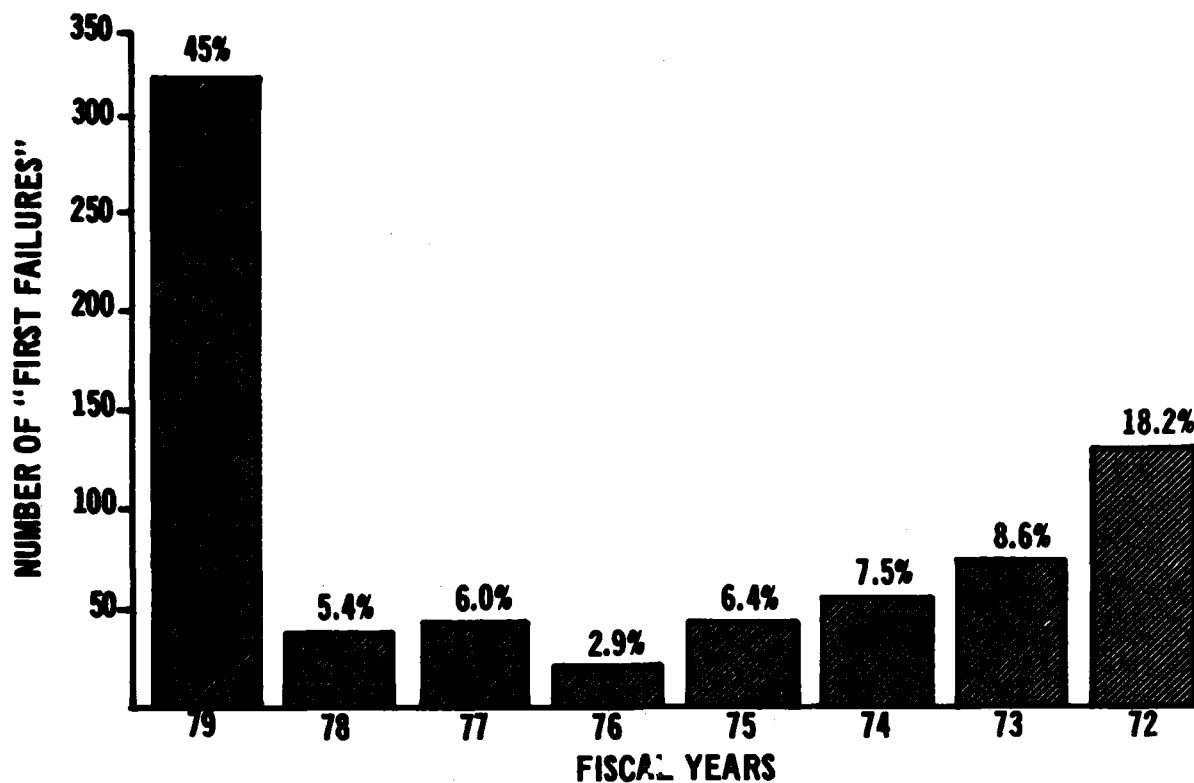
FIGURE H-1. — Year the 729 Parts That Failed During FY 79 Were First Reported in a Mishap

A review of available data did not disclose a plausible explanation for the high percentage of first failures in FY 79. The forced and precautionary landing survey mentioned earlier revealed a U-shaped pattern similar to that shown in figure H-1, i.e., a higher percentage of first failures in the first and last years surveyed.

This distribution of first failures, together with the findings of the survey, may indicate the onset of a failure history for the 324 parts first reported in FY 79. To prevent this, commodity managers and reliability, maintainability,

and product assurance personnel are urged to review the failure causes of these parts. By aircraft type, the UH-1 accounted for 35.8 percent; AH-1, 16.0 percent; OH-58, 13.3 percent; CH-47, 13.0 percent; OV-1, 7.4 percent; and U-21, 6.5 percent of the FY 79 first failures. The remaining 8 percent were distributed over lower density aircraft.
