# Special Report 83-21

## *Examination of a blistered built-up roof: O'Neill Building, Hanscom Air Force Base*

C. Korhonen and A. Greaiores

EXAMINATION OF A BLISTERED BUILT-UP ROOF: O'NEILL BUILDING,  
HANSCOM AIR FORCE BASE

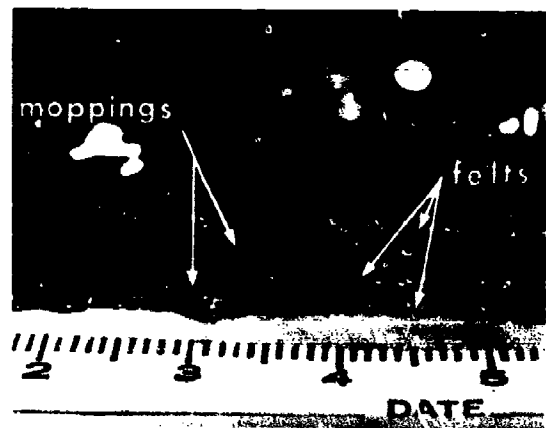
The first blister (Fig. 16) was actually a number of small blisters that had coalesced into a larger one. This group of blisters formed within the asphalt mopping between the insulation and the built-up membrane. We believe that they were built into the roof, as the mop string and the uneven interply moppings (Fig. 16) certainly indicate application problems. If asphalt is allowed to cool too much, it will not flow uniformly when applied. Thick, uneven moppings can result in poor adhesion and blisters. The excessive and nonuniform thickness of bitumen shown in Figures 16 and 17 and recorded in Table 1 strongly suggests that the asphalt was too cold at application. Cold application can cause poor adherence; three of ten insulation samples on this roof were not well adhered to the roof deck (Table 1). Poor adherence between roof components could make the membrane susceptible to thermal splitting and blowoff.

Figure 17. Cross section of built-up membrane. Note the tremendous difference between interply moppings.
