RELIABILITY OF PORTABLE DRY CHEMICAL
FIRE EXTINGUISHERS IN USE
ON MOTORBOATS

W.C. HELGESON

U.S. Coast Guard Research and Development Center
Avery Point Groton, Connecticut 06340

FINAL REPORT

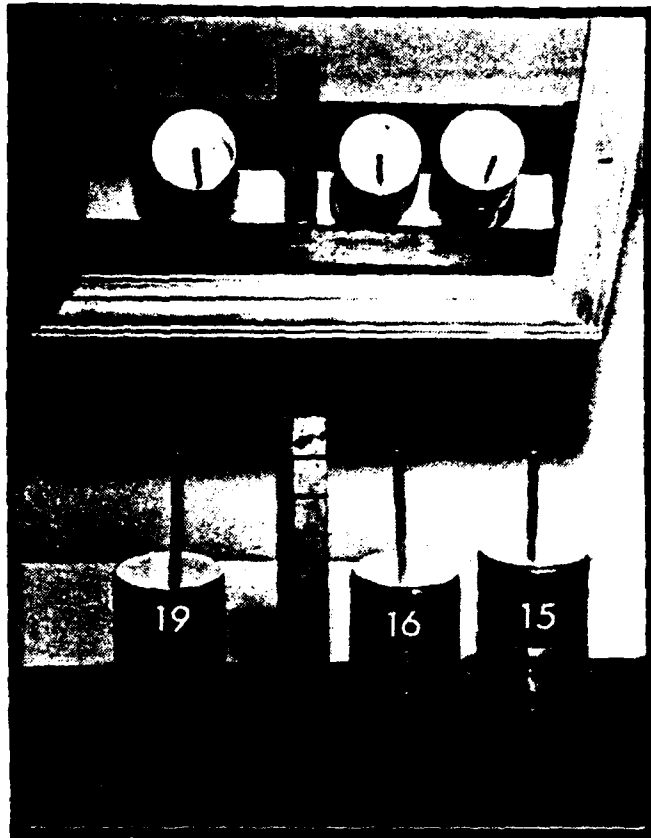
(a) This shows how much agent remained in three of R.C. Industries' non-refillable bottles

9. (15)	2 lb. Non- refillable	1969	R.C. Industries	Z 181039	25.00	4.9
	The agent was well <u>packed</u> .					
10. (16)	2 lb. Non- refillable	1969	R.C. Industries	Z 187747	26.69	5.0
	The agent was well <u>packed</u> .

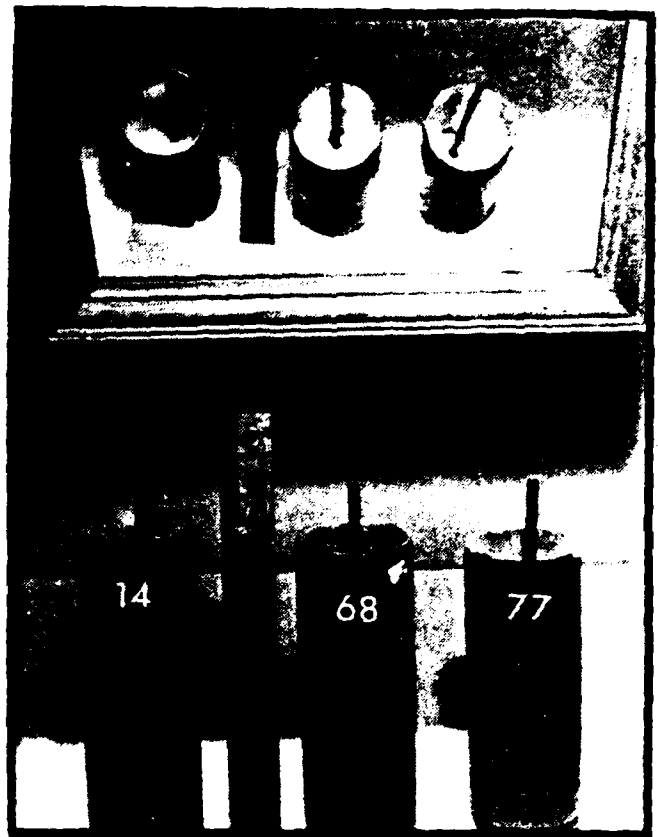
(b) This shows packed agent in R.C. Industries' refillable bottles
Note that the powder did not flow in around the marking stake.

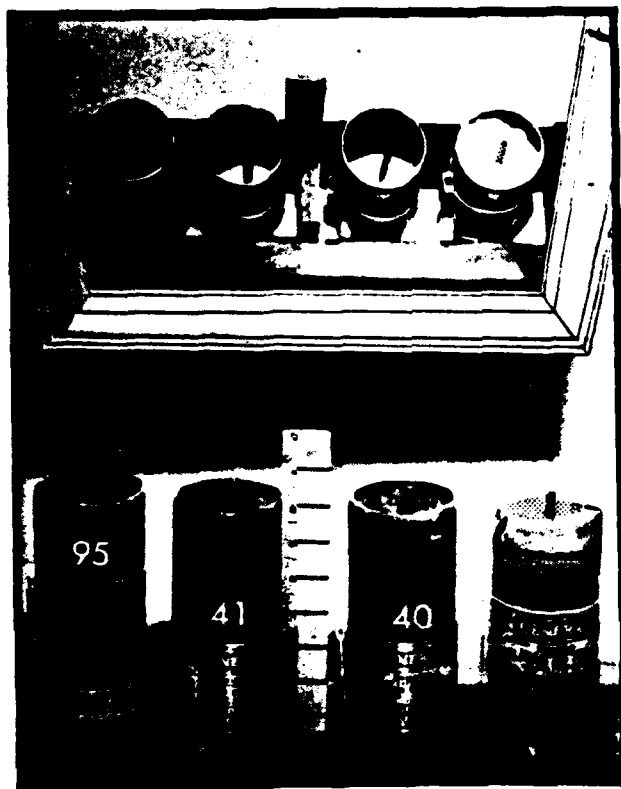
(c) This shows the oldest extinguishers. Note the caking in all three of 41, 40 and 97. A picture of the caked powder from 97 is on the next page.

3. (40)	2 1/2 lb.	1960	General Fire Ext. Corp.	D 92270	39.06	6.2
<p>The agent inside was light blue in color, and <u>caked</u>.</p>						
4. (97)	2 1/2 lb.	1960	General Fire Ext. Corp.	C-58438	16.56	3.2
<p>The siphon <u>tube was packed and caked</u> at the tip. Severe tapping only loosened some of the agent. Contents: <u>caked</u>.</p>

5. (41)	2 1/2 lb.	1960	General Fire Ext. Corp.	D 101829	63.44	8.5
<p>The agent was well <u>packed and caked</u>. The color was light blue.</p>						
6 (86)	2 3/4 lb.	1966	Walter Kidde Company, Inc.	P 452253	95.45	44.0
<p>When fired the powder spilled out only about 1 1/2 - 2 feet. Powder also sprayed out a hole at the neck of the valve. The powder that remained appeared fine.</p>

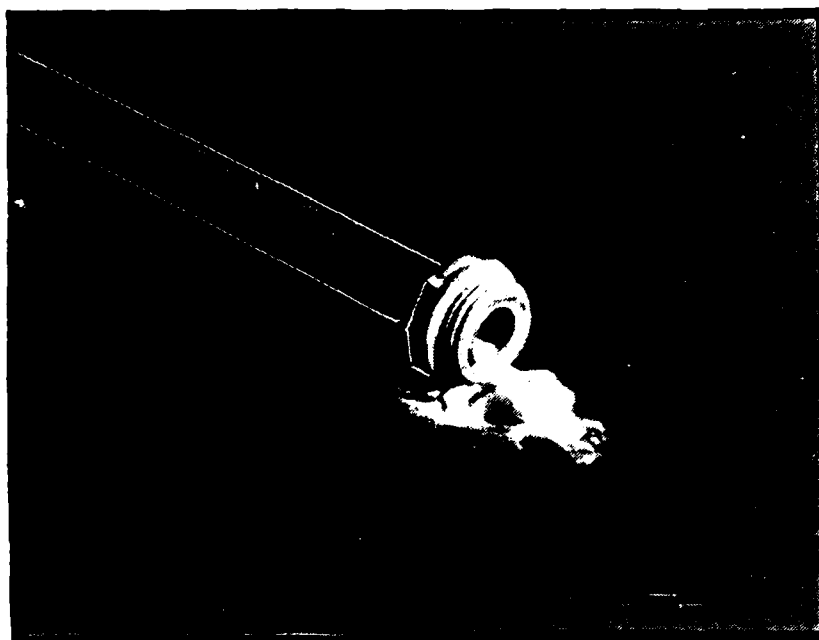
(e) This shows the caked plug from "Fyr-Fyter" survey number 69.

No.	Type	Date Mfd.	Manufacturer	Serial No.	Percent Rated Amount Discharge %	Duration of Discharge Seconds
8. (69)	2 3/4 lb.	1967	FYR-FYTER	N-660086	79.83	9.2
	The siphon tube was packed and the agent was caked. There was a <u>caked</u> plug at the valve end of the tube.

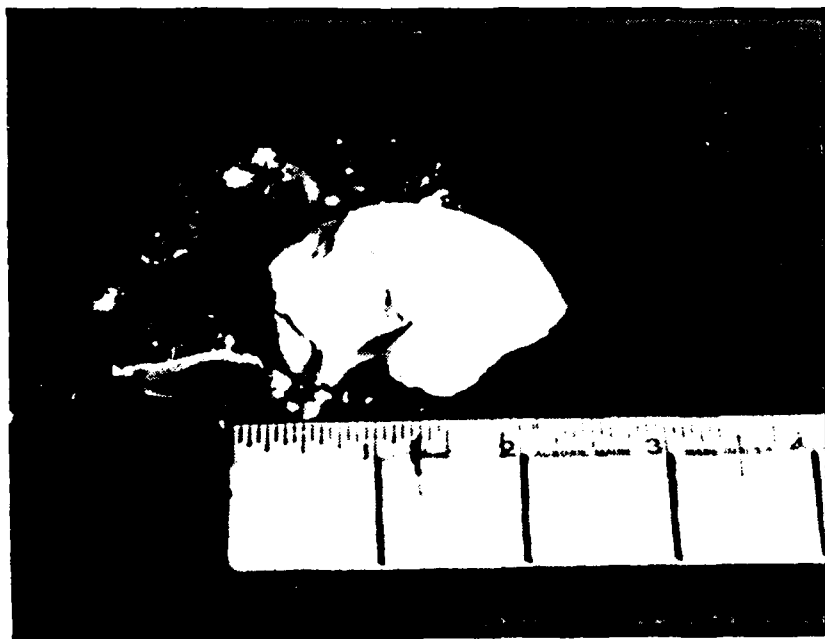
(f) This shows a caked lump of agent from "General" survey number 97.

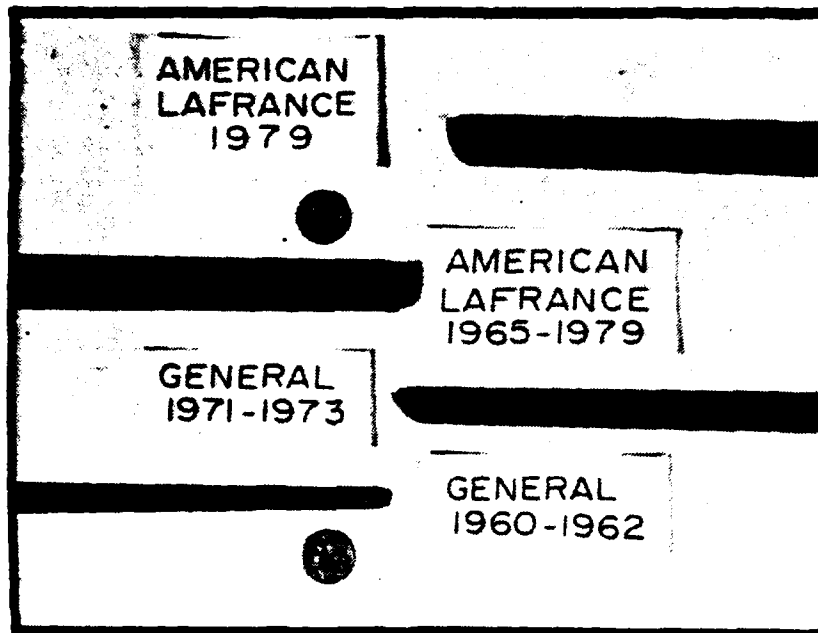
Although there was some packing and caking of the chemical agent, these conditions did not occur enough times to merit another survey or corrective measures. There also has been a design change which should lessen the effects of any packing. The siphon tube size has been increased from 5-7mm on 1960-1969 models to 8-14mm on the 1970-1982 models. Since 1975 some of the tubes have circular cut-outs or are cut at an angle to increase the surface area of the end of the tube. Figure 3 shows the different tubes photographed next to a dime to indicate the size.

Comparison of typical 1960's small siphon tube to the newer, larger tubes. The small tube is copper. The rest are rigid plastic.

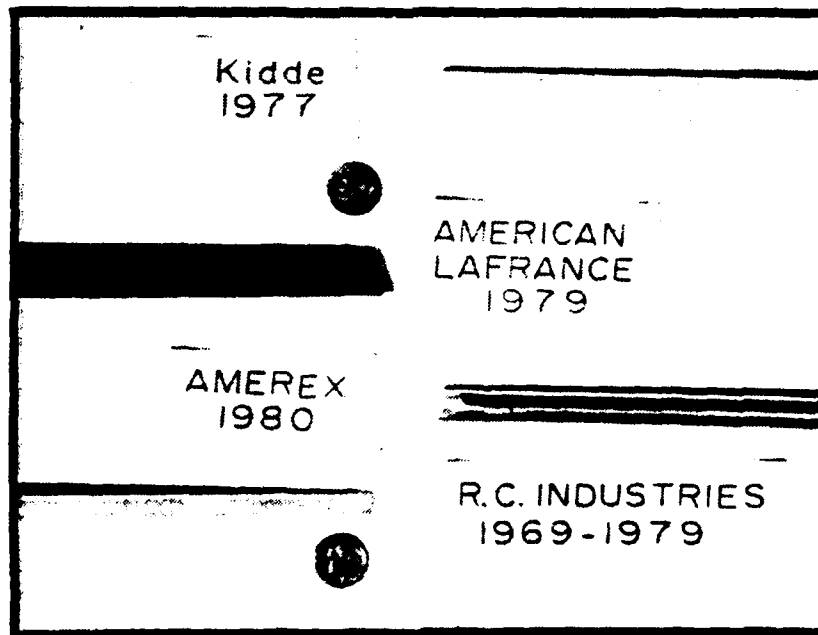
Comparison of 1970's siphon tubes. Kidde and American LaFrance have rigid plastic tubes. Amerex has an aluminum tube. R.C. Industries has a semi-flexible, plastic tube.
