MISCELLANEOUS PAPER SL-83-17

EVALUATION OF CONCRETE CORES CARUTHERSVILLE FLOODWALL

G. Sam Wong

September 1983
Final Report

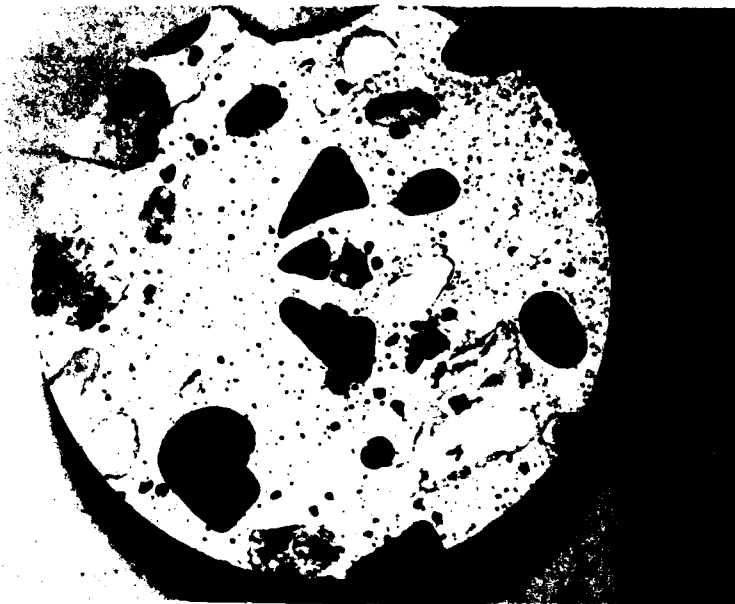
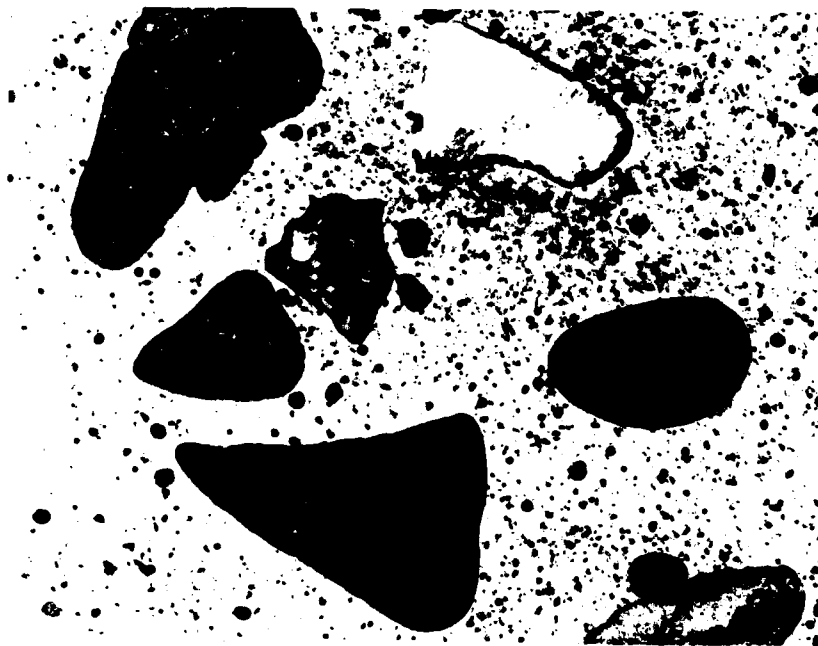
Photograph 1. Core MEM-5 CON-1 is concrete typical of the 1932 construction. No entrained air voids, oversanded and both gravel and sand appear gap graded

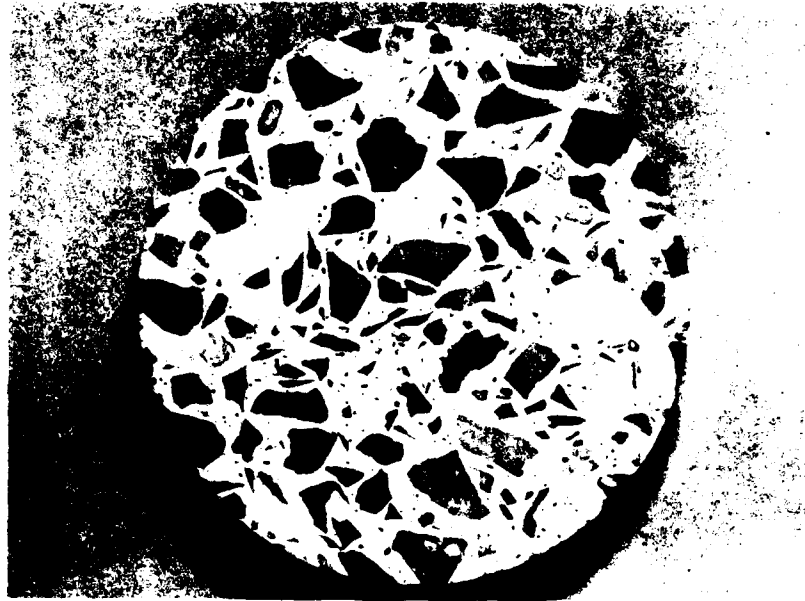
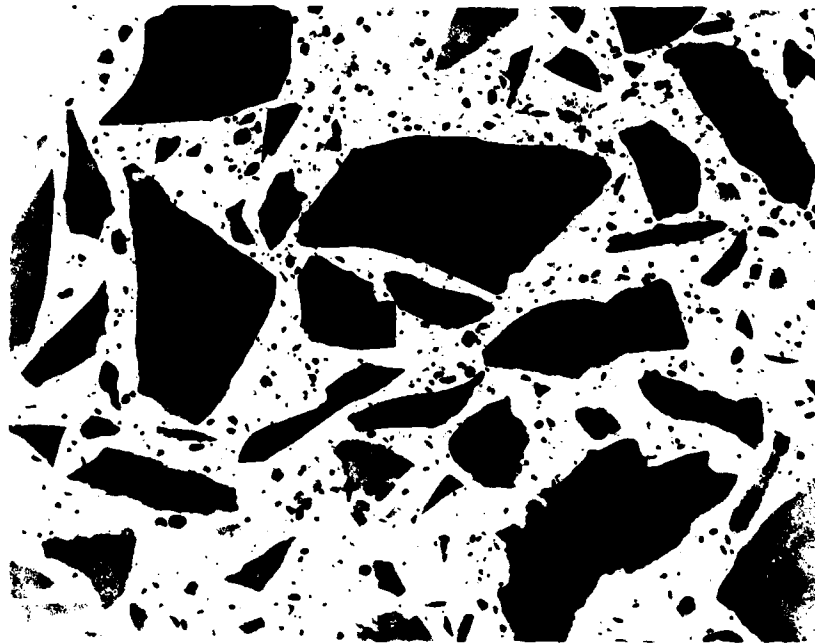
20. The old concrete tended to be more variable. Its composition ranged from 3/4-in. maximum size crushed limestone coarse aggregate to a totally siliceous aggregate concrete, as illustrated in Photographs 2a, 2b, 3a, 3b, 4a, and 4b. The physical condition of the old concrete also changed within a boring as well as between borings. Some of this concrete was severely honeycombed, contained cold joints and incipient fractures.

Photograph 2. Core MEM-5 CON-2 is typical of concrete in Type A section.
Nonair-entrained concrete with crushed carbonate coarse aggregate and
natural siliceous fine aggregate

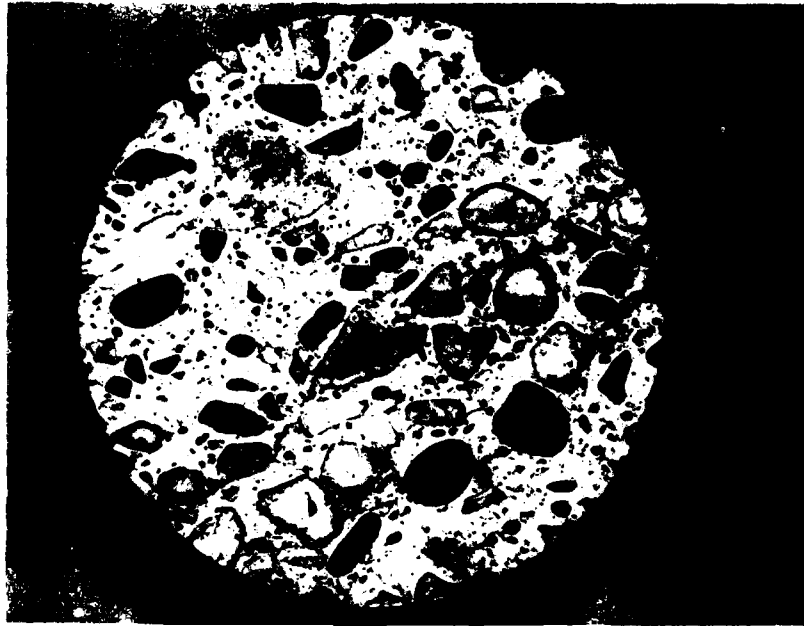
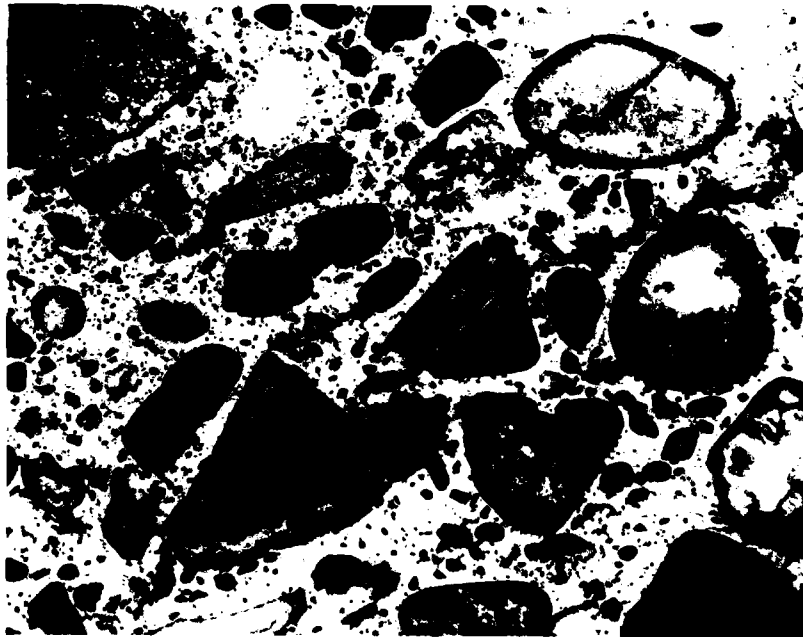
Photograph 3. Core MEM-5 CON-7 is one of two types of concrete in Type B section. Nonair-entrained concrete with natural siliceous coarse and fine aggregate

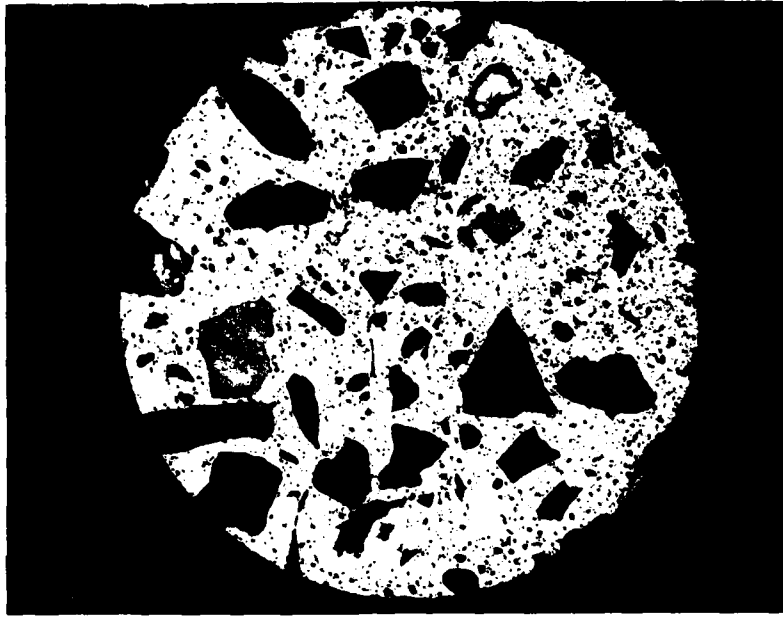
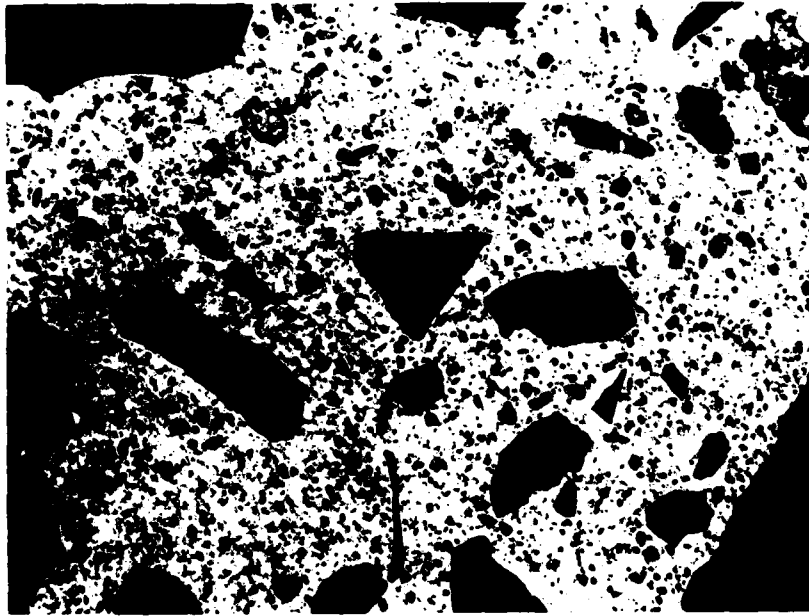
39. The maximum depth of deterioration was 3.0 ft in the old concrete core MEM-5 CON-8. This cracking of the concrete was not believed to be caused by alkali-silica reaction or frost action as was the case in other parts of the structure. Cores MEM-5 CON-4 and 7 of old concrete were showing signs of advanced weathering due to frost action and alkali-silica reaction which will result in eventual loss of surface concrete integrity.

Photograph 4. Core MEM-5 CON-8 is one of two types of concrete in Type B section. Nonair-entrained concrete with crushed limestone coarse aggregate with occasional quartz gravel particle and a natural siliceous fine aggregate

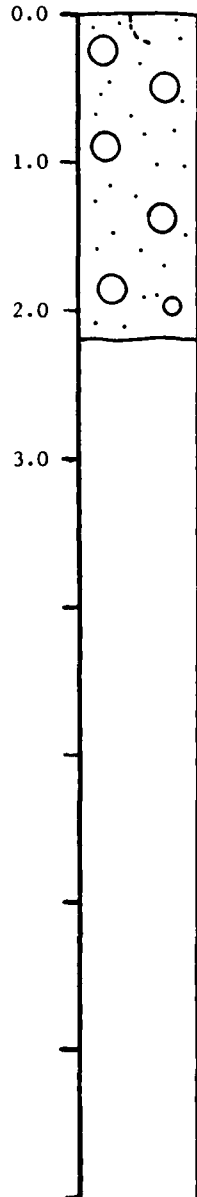
MEM-5 CON-11 (New concrete, horizontal boring)
Caruthersville Floodwall, Caruthersville, Missouri
6-in.-diameter core

Incipient fracture to 0.2 ft. Stained, crack around aggregate leaving ball and socket effect; no apparent reaction product.
