MISSISSIPPI RIVER
STUDY OF ALTERNATIVES FOR REHABILITATION
OF LOCK AND DAM NO. 1
MINNEAPOLIS, MINNESOTA

VOLUME III
APPENDICES B-F

DEPARTMENT OF THE ARMY
ST. PAUL DISTRICT, CORPS OF ENGINEERS
ST. PAUL, MINNESOTA

APRIL 1976

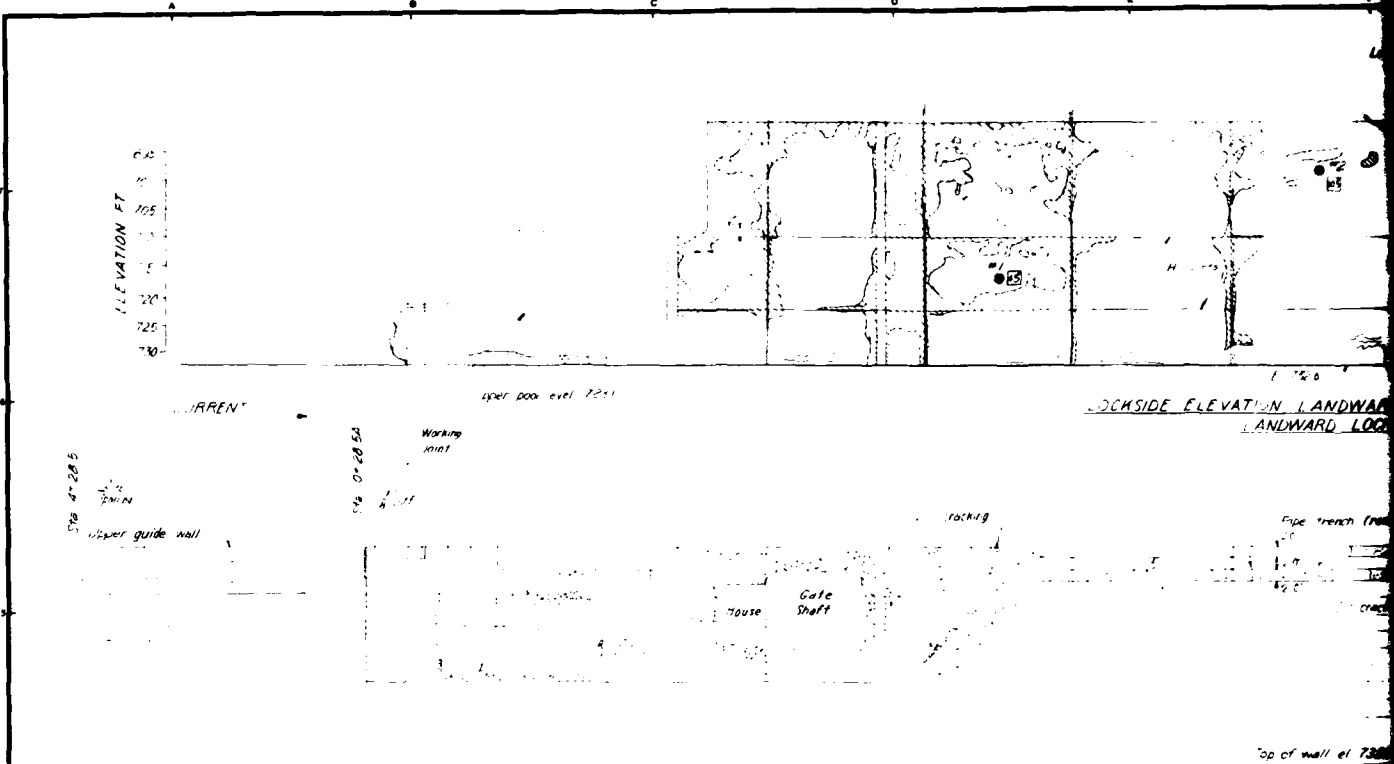
CONCRETE CONDITION	UPPER GUIDE WALL		MONOLITH NO.					
	1	2	3	4	5	6		
CRACKING	Minor transverse and horizontal	None	None	Longitudinal hairline cracks on the top face of the wall.	Diagonal and vertical surface along edge longitudinal crack along top edge of wall.	Minor transverse and horizontal cracks on top surface.	Minor transverse and horizontal cracks on top surface.	
SCALING AND SPALLING	Very light to medium horizontal surfaces.	Light scaling.	Severe scaling and spalling along downstream vertical joint edge. 60% of top surface has been repaired.	Severe scaling along the vertical joints and edges with repair scaling at top horizontal construction joint. 60% of top surface repaired.	Severe scaling along the vertical joints and edges with repair scaling at top horizontal construction joint. 60% of the top surface repaired.	Severe scaling along the vertical joints and edges with repair scaling at top horizontal construction joint. 60% of the top surface repaired.	Moderate scaling on the vertical joints and edges with repair scaling at top horizontal construction joint. 60% of the top surface repaired.	Severe scaling along vertical joints and edges with repair scaling at top horizontal construction joint. 60% of the top surface repaired.

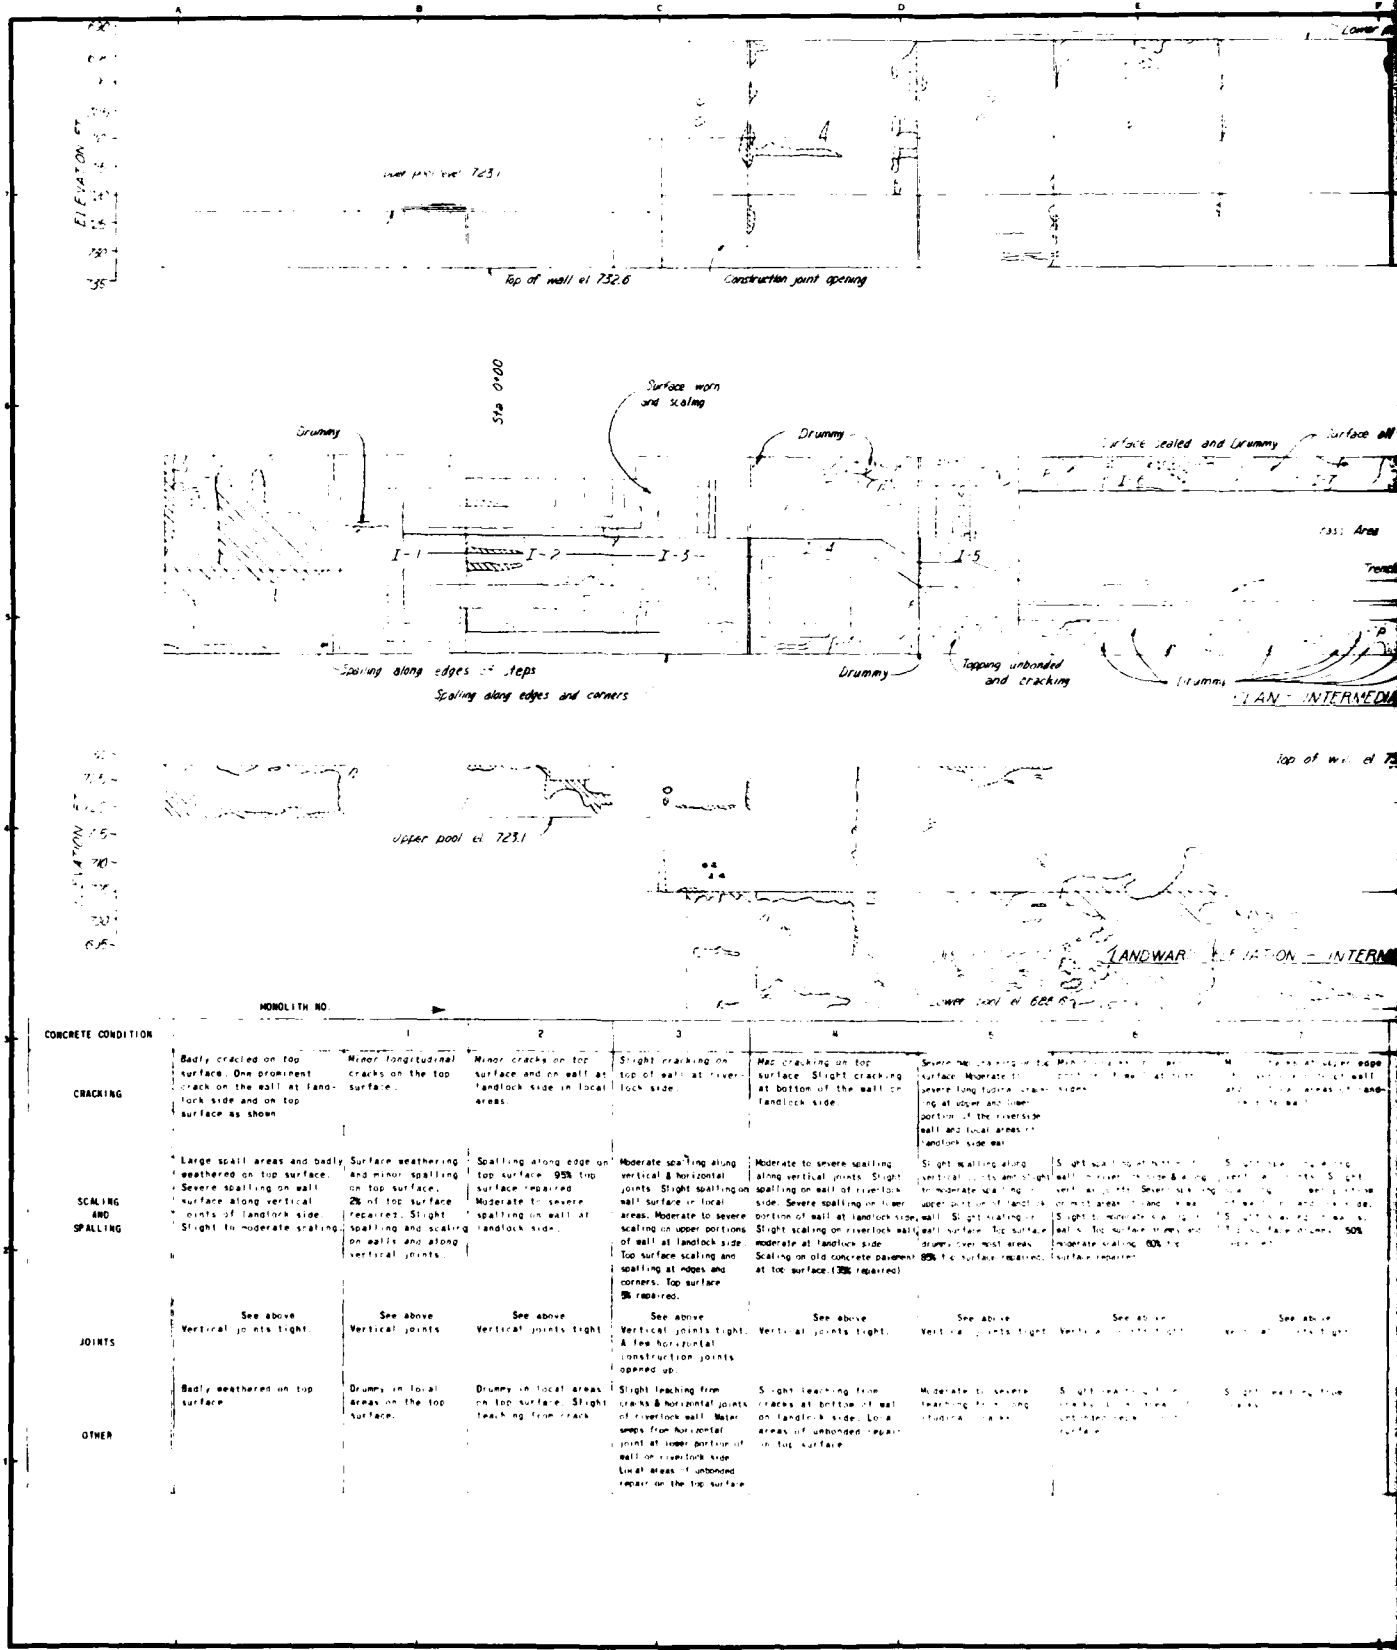
MONOLITH NO.							
	1	2	3	4	5	6	7	
CRACKING	Badly cracked on top surface. One prominent crack on the wall at landlock side and on top surface as shown.	Minor longitudinal cracks on the top surface.	Minor cracks on top surface and on wall at landlock side in local areas.	Slight cracking on top of wall at riverlock side.	Mad cracking on top surface. Slight cracking at bottom of the wall on landlock side.	Severe hair cracking in the surface. Moderate to severe longitudinal cracking along at upper and lower portion of the riverlock wall and local areas at landlock side wall.	Minor cracking on wall at upper edge and moderate areas of scaling on the wall.	
SCALING AND SPALLING	Large spall areas and badly weathered on top surface. Severe spalling on wall surface along vertical joints of landlock side. Slight to moderate scaling.	Surface weathering and minor spalling on top surface. 2% of top surface requires. Slight spalling and scaling on walls and along vertical joints.	Spalling along edge on top surface. 95% top surface repaired. Moderate to severe spalling on wall at landlock side.	Moderate spalling along vertical & horizontal joints. Slight spalling on wall surface in local areas. Moderate to severe scaling on upper portions of wall at landlock side. Top surface scaling and spalling at edges and corners. Top surface 2% repaired.	Moderate to severe spalling along vertical joints. Slight spalling on wall of riverlock side. Severe spalling on lower portion of wall at riverlock side. Slight scaling on riverlock wall surface. Top surface moderate at landlock side. Scaling on old concrete pavement at top surface (30% repaired).	Slight weathering along vertical joints and slight to moderate scaling on upper portion of landlock wall surface. Top surface 8% of surface requires.	Slight weathering on wall in upper portion & along vertical joints. Severe scaling on wall surface in upper portion of landlock wall surface. Top surface moderate to severe scaling. 50% of surface requires.	Slight weathering on wall at upper edge and moderate areas of scaling on the wall. Severe scaling on wall surface in upper portion of landlock wall surface. Top surface moderate to severe scaling. 50% of surface requires.

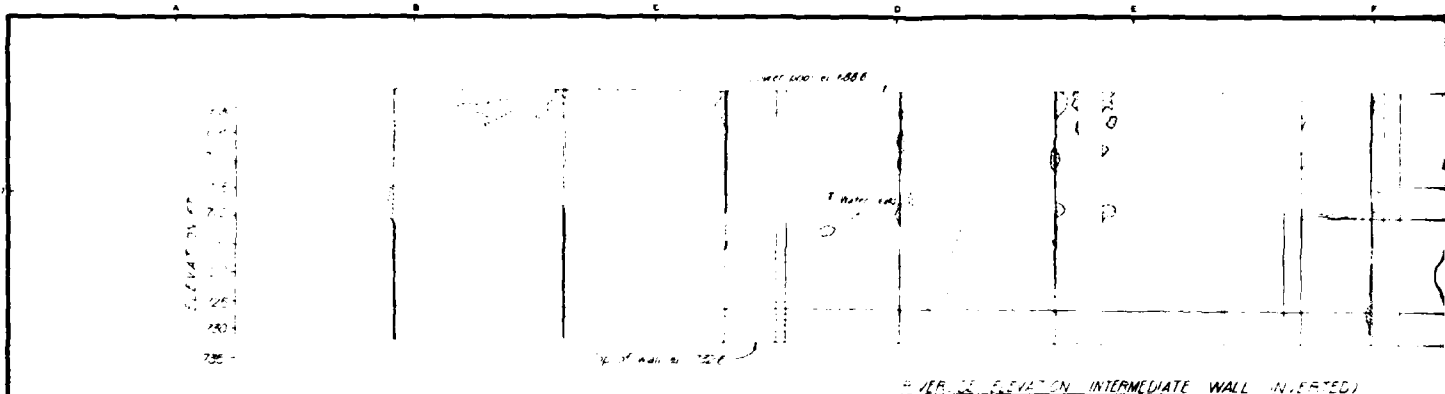
CONCRETE CONDITION	MONOLITH NO.							
	13	14	15	16	17	18		
CRACKING	Major cracking & transverse barrel cracks on top surface. Minor cracks at upper portion of wall near top edge. Minor longitudinal cracks on inner joint of wall on both sides.	Minor hair cracks and stains around repair on top surface. Minor cracks at lower portion of wall on exterior side.	Major cracking in repair concrete on top surface.	Minor cracking in top surface. Slight spalling along vertical joints and on both walls. Slight moderate spalling in both walls. Top surface 30% repaired.	Minor cracking in top surface. Slight spalling along vertical joints. Slight moderate spalling on both walls. Severe along on wall on outside side. 25% top surface repaired.	Minor cracking in upper portion of wall on inside side. Moderate spalling.	Slight moderate spalling along vertical joints. Slight moderate spalling on both walls. Slight cracking in wall on inside side. 10% top surface repaired.	Some large vertical cracks on side.

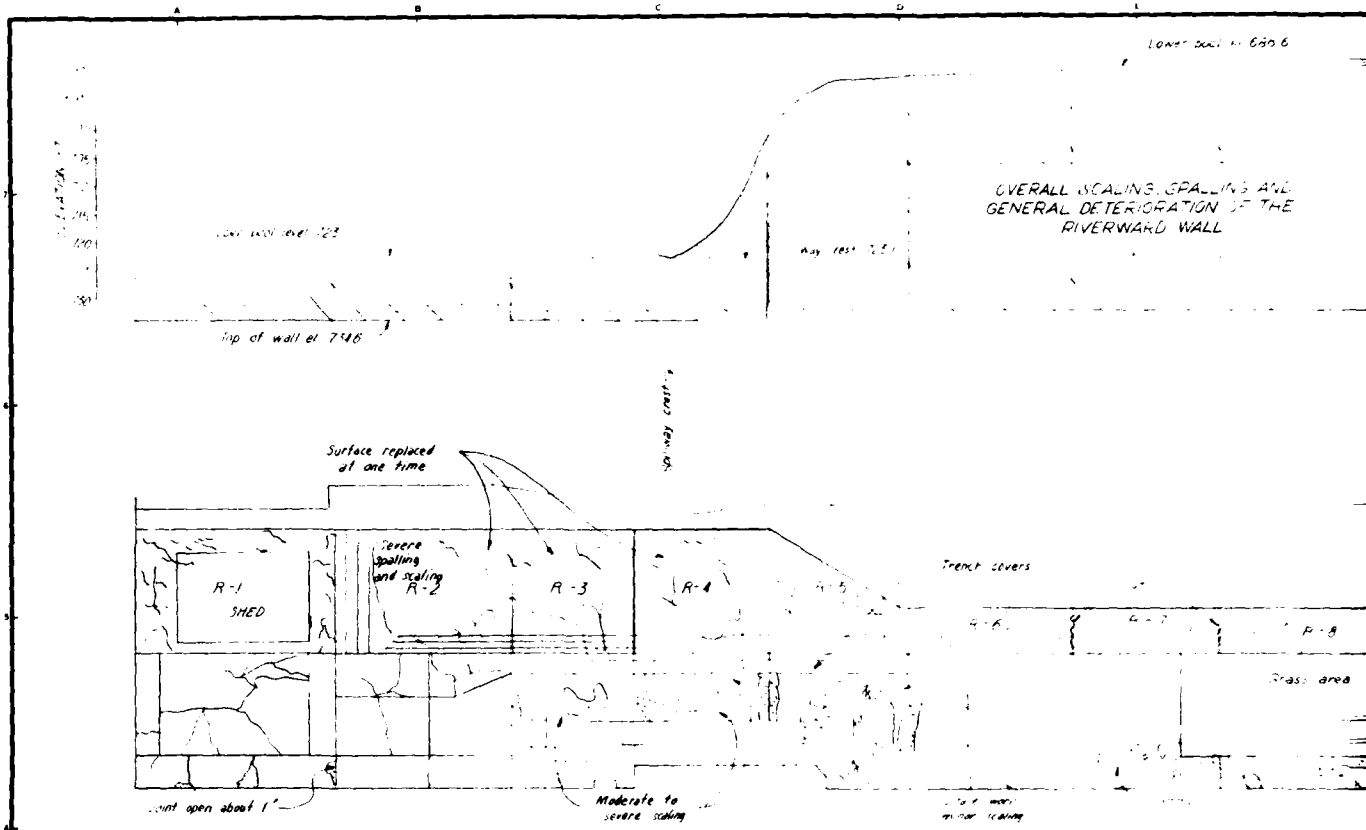
CONCRETE CONDITION	MONOLITH NO.						
	1	2	3	4	5	6	
CRACKING	Severe random cracking and pattern cracking of the top surface.	Severe random cracking of the top surface.	Random cracking of top surface, no concrete (riverward).	Random cracking of top surface, old concrete (riverward).	Random cracking of top surface, old concrete (riverward). Horizontal and vertical cracking of riverward wall.	Minor cracking of top surface, old concrete (riverward). Horizontal and vertical cracking of riverward wall.	
SCALING AND SPALLING	Upstream face severely scaled & deteriorated, increase in water level.	Severe scaling of the top surface and old concrete wall (riverward). Spalling along corners & edges.	50% of concrete surface repaired at one time. Moderate to severe scaling of top surface and riverward.	50% of concrete surface repaired at one time. Local areas dry and unbonded. Moderate to severe scaling of top surface and riverward.	75% of concrete top surface repaired at one time. Minor scaling in riverward wall. Severe scaling of riverward.	30% of top surface repaired at one time. Top surface deteriorated with minor scaling. Moderate scaling in riverward wall. Severe scaling in riverward.	Slight scaling of top surface, old concrete (riverward). Moderate scaling in riverward wall. Severe scaling in riverward.
