**FINAL
FOUNDATION
REPORT**

**AMISTAD POWERPLANT
DEL RIO, TEXAS**

OCTOBER 1983

ALAN J. MARR

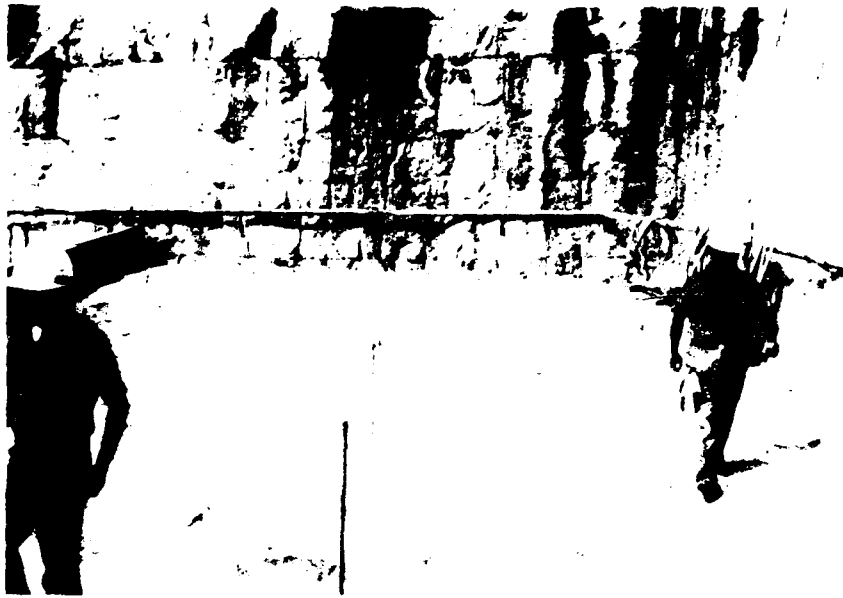
2. Foundation Surface. After final shaping and cleanup, the limestone foundation surface exhibited varying degrees of unevenness. Where final grade occurred along one of the horizontal shaly seams within the formation, the soft shaly material within the seam was removed leaving the finished limestone surface relatively flat. This condition occurred in the generator bay foundation area at elevation 845. In most cases, however, the surface was uneven to a degree of ± 0.5 feet, due to the massive and hard nature of the limestone. In general, the characteristics of the limestone foundation surface are moderately hard to hard, gray to dark gray, very fine grained and massive. Typical limestone surfaces on which concrete was placed are shown on figures 13 through 16.

Figure 13 Typical limestone foundation surface prior to concrete placement (erection bay area at elevation 867)

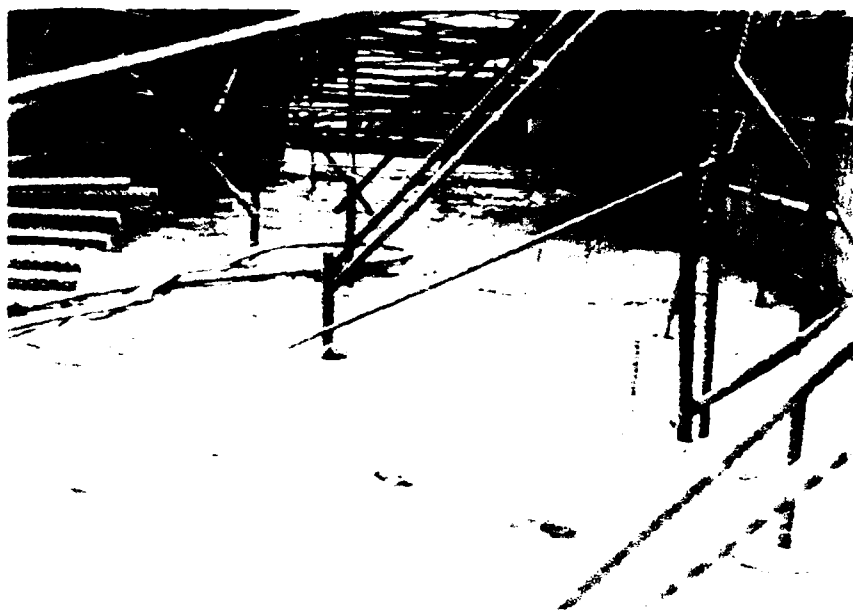
Figure 15 Typical limestone foundation surface prior to concrete placement (generator bay area at elevation 845±)
