INTERIM REPORT M-336
November 1983

**CONSTRUCTION OF ALUMINUM STANDING-SEAM
ROOFING AT AN ARMY FACILITY**

by
Myer J. Rosenfield

CONSTRUCTION OF ALUMINUM STANDING-SEAM ROOFING AT AN ARMY FACILITY

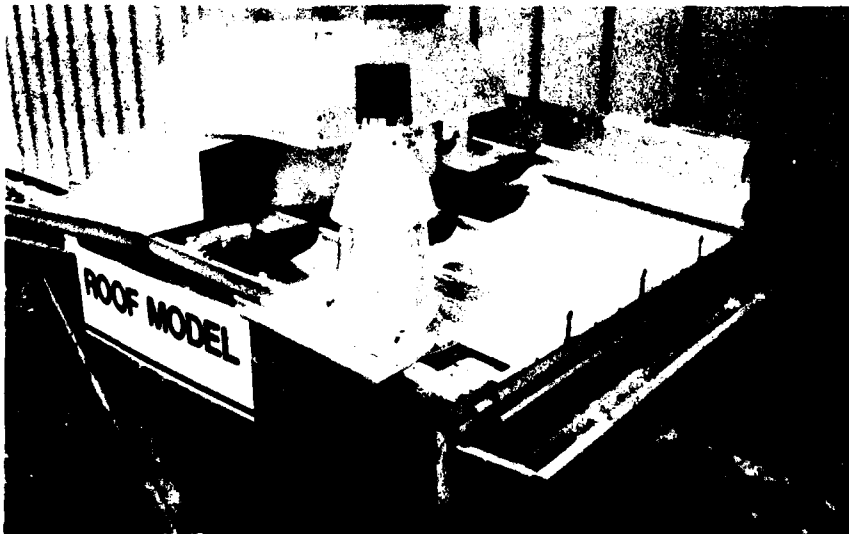
Neither of these details was addressed in the roof model. Figure 2 shows that the ridge cap was not included when the model was prepared. If it had been, these deficiencies would probably have become evident before the roofing components were fabricated.

Figure 2. Roof model.

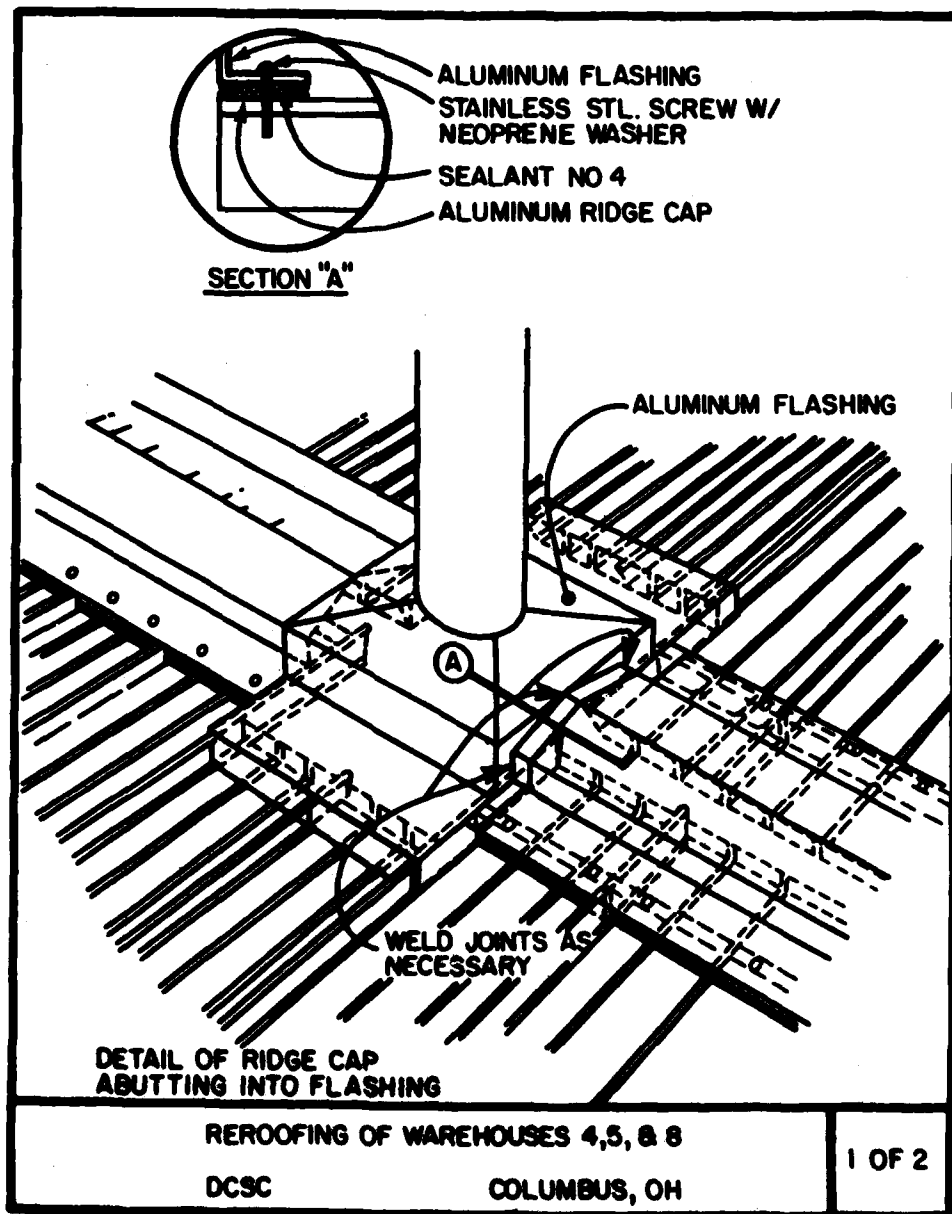
The ventilator flashing intersection was detailed on the drawing shown in Figure 17. This shows a 5-in. (127-mm) vertical wall of the flashing, with the ridge cap low enough for the connection to be completely within this dimension. As shown in Figure 12, the vertical height of the ridge cap should be at least five times the expected roof movement. For 40 ft (12 m) of aluminum over a temperature range of -20°F (-29°C) to 120°F (49°C)—a difference of 140°F (78°C)—the expected change in length is about 7/8 in. (22 mm). Following the recommendation of Figure 12, the vertical height was set at 6 in. (152 mm). To fabricate the intersection as shown in Figure 18, the height of the vent flashing would have to be increased to more than the ridge cap. Instead, it was made equal to the ridge cap wall, and was actually fabricated to the 6-in. (152-mm) dimension. This made the intersection impossible to fabricate as detailed; the result is shown in Figure 19. A large amount of sealant was needed to waterproof these intersections.

Figure 18. Detail of ridge cap at ventilator flashing.
