Structures Technical Memorandum 365

RETRACTION AND LOWERING OF THE MIRAGE UNDERCARRIAGE

S.R. SARRAILHE and B. QUINN

The retraction and lowering process on the aircraft and operation of the jacks in the laboratory were investigated following a failure to lock down.

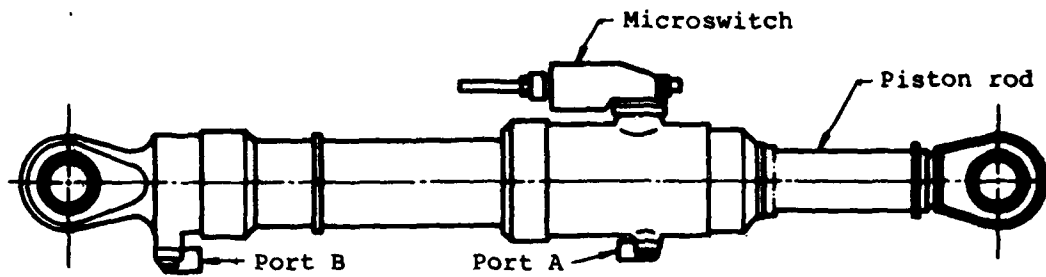
FIG 1(a) RETRACTION ACTUATOR - MAIN UNDERCARRIAGE

The configuration of the lateral jack and operation of the claw lock are shown in Figs. 1a and 1b.

When the undercarriage is lowered the weight of the leg tends to extend the jack and the speed is controlled by a one-way restrictor in the return line, (connected to port A, Fig. 1). Pressure on the return side of the jack piston also acts on the locking piston. This displaces it to the 'unlock' position and compresses the spring, Fig. 1b. (Note that this figure, copied from the handbook, shows the locking piston being displaced by the locking claws but this will not occur during normal operation). When the leg is fully extended the hydraulic flow ceases and the back pressure in the return line falls, the spring then returns the locking piston to the lock position.

- (1) The jack is not fully extended so that the engagement of the locking claws is incomplete.
- (2) The locking piston is not returned to the lock position.

Return of the locking piston could be impeded by excessive back pressure, inadequate spring force or excessive sliding friction. The principal objective of the tests on the aircraft was to check back pressures (return line pressure) while the jack extended and locked.

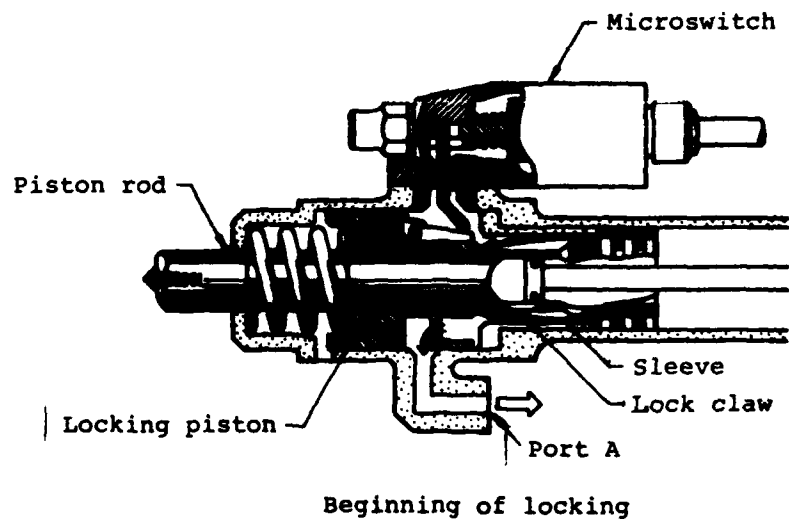
FIG 1(b) PRINCIPLE OF OPERATION OF JACK CLAW-LOCK
MAIN UNDERCARRIAGE

The tests did not show any characteristic in the hydraulic system which could be identified as a possible cause of the malfunction in A3-03 but the traces do highlight the disparity between the forces on the locking piston available from hydraulic pressure in the jack, (e.g. 3000 psi x 4 square inches = 12000 pounds force), and the force from the spring to return the locking piston (about 500 pounds force).

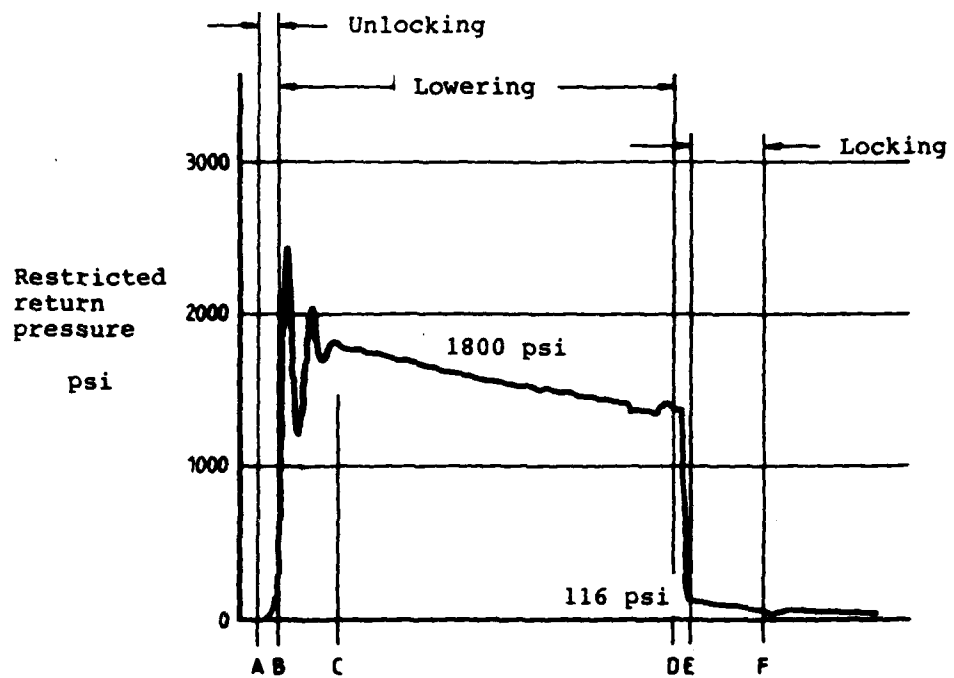
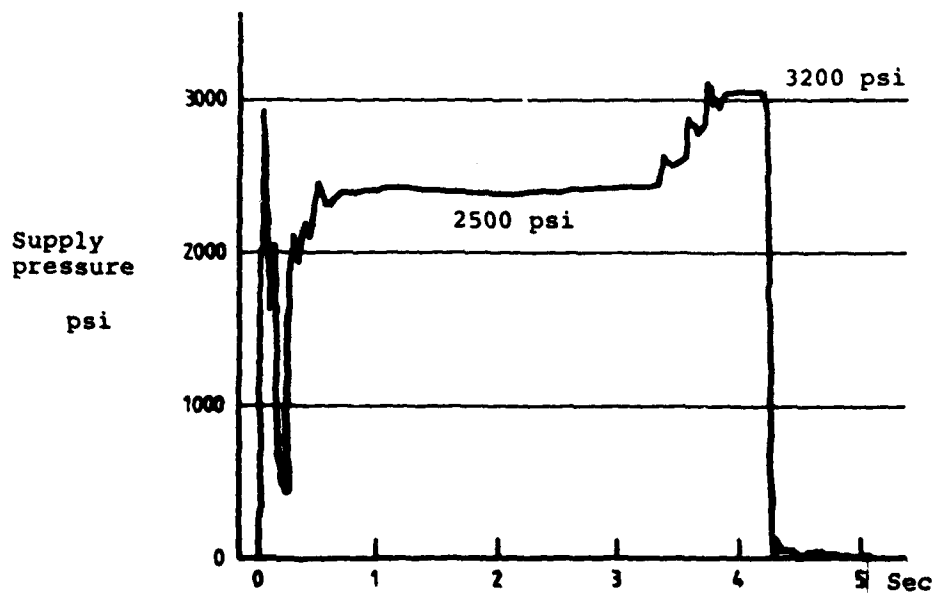
FIG 2 MIRAGE MAIN UNDERCARRIAGE LOWERING LATERAL JACK PRESSURES - A3-03 STARBOARD

The pressure sequences for all operations of both port and starboard undercarriages of the three aircraft were practically identical showing both lowering and retraction cycles to be consistent. Typical traces of pressure during lowering and retraction are shown on Figs. 2 and 3 with explanations in Tables 2 and 3.

Reference	Event	Approx Pressure p.s.i.	
		Supply	Return
A	Pressure applied to release up-lock and lower leg.	3000	0
A-B	Leg falls; pressure in return side moves lock piston compressing spring. Flow out of jack restricted.		
B-C	Pressure fluctuates as leg 'bounces' on jack.		
C-D	Steady lowering established. Return pressure on piston balances gravity moment plus supply pressure acting on smaller piston area. Return pressure diminishes as leg gets more vertical.	2500	1800
D-E	Leg down, flow ceases, return pressure drops, supply pressure increases to system pressure.	3200	
E-F	When return pressure falls to 116 psi, spring moves locking piston, displacing fluid through the restrictor and maintaining a pressure of 116 to about 80 psi.		
F	When fully locked the micro switch operation cuts off hydraulic pressure. Supply and return pressures fall to very low values.	0	22

Note: Flow rates and pressures across the restrictor during C-D and E-F both correspond to the specified restrictor performance.

This was slower than normal operation but engagement of the lock with pressure variation as shown on the upper trace of Fig. 2 E-F was evident.

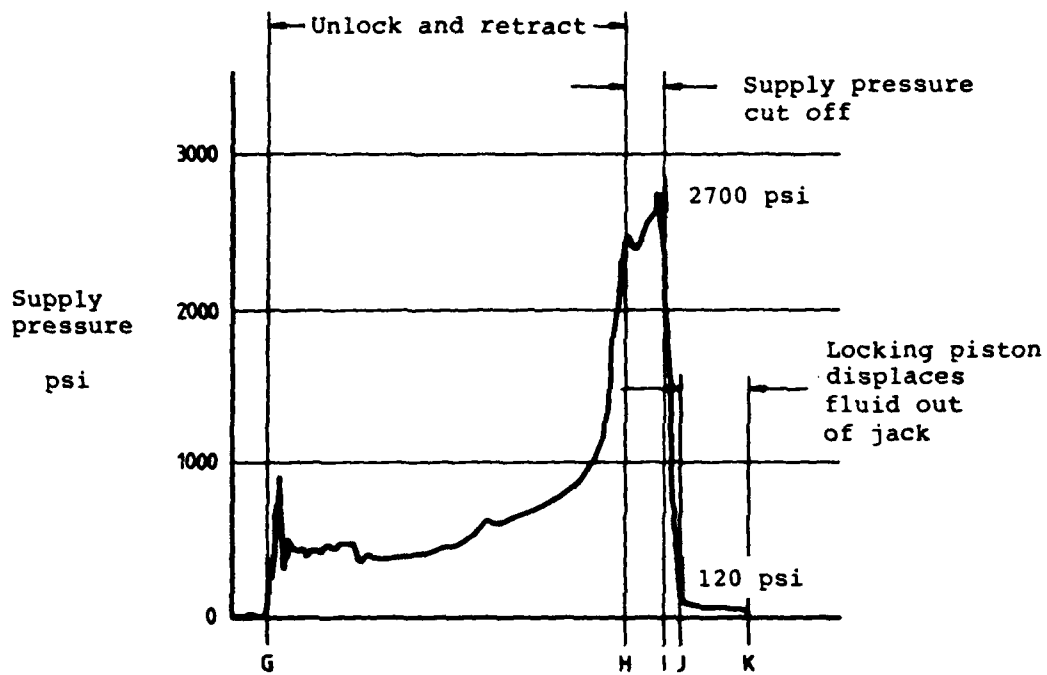
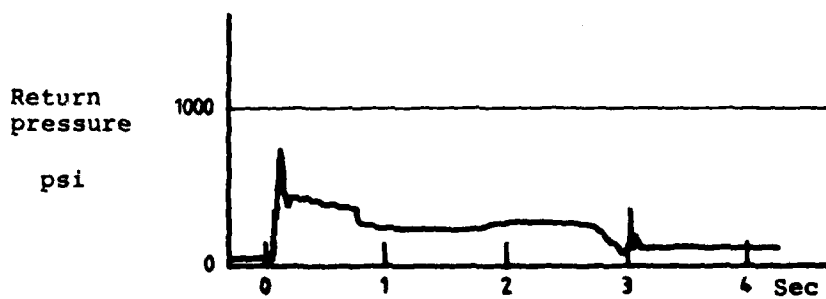
FIG 3 MIRAGE MAIN UNDERCARRIAGE RETRACTION LATERAL JACK PRESSURES A3-03 STARBOARD

Reference	Event
G	Pressure surge into jack on selection "up" unlocks locking piston and accelerates jack causing surge in return line. (Note: one-way restrictor in "supply" line to jack allows full flow for retraction).
G-H	Leg retracts with increasing pressure as gravi moment increases. Internal "snubbing" in jack slows leg just before "up" (H) increasing "sup" pressure and reducing "return" pressure.
H-I	Leg "Up" doors close, supply pressure cut at I
I-J	Pressure decreases to about 120 psi.
J-K	Locking piston moves under influence of spring to displace fluid out of jack against one-way restrictor. This corresponds to the final stage of "Lowering" (E-F) Fig. 2. At K pressure in supply lines fell to less than 30 psi. Return line pressure also less than 30 psi.
