LIBBY DAM AND LAKE KOOCANUSA PROJECT, MONTANA

LEFT BANK SLOPE

LIBBY DAM-LAKE KOOCANUSA PROJECT

EXECUTIVE SUMMARY

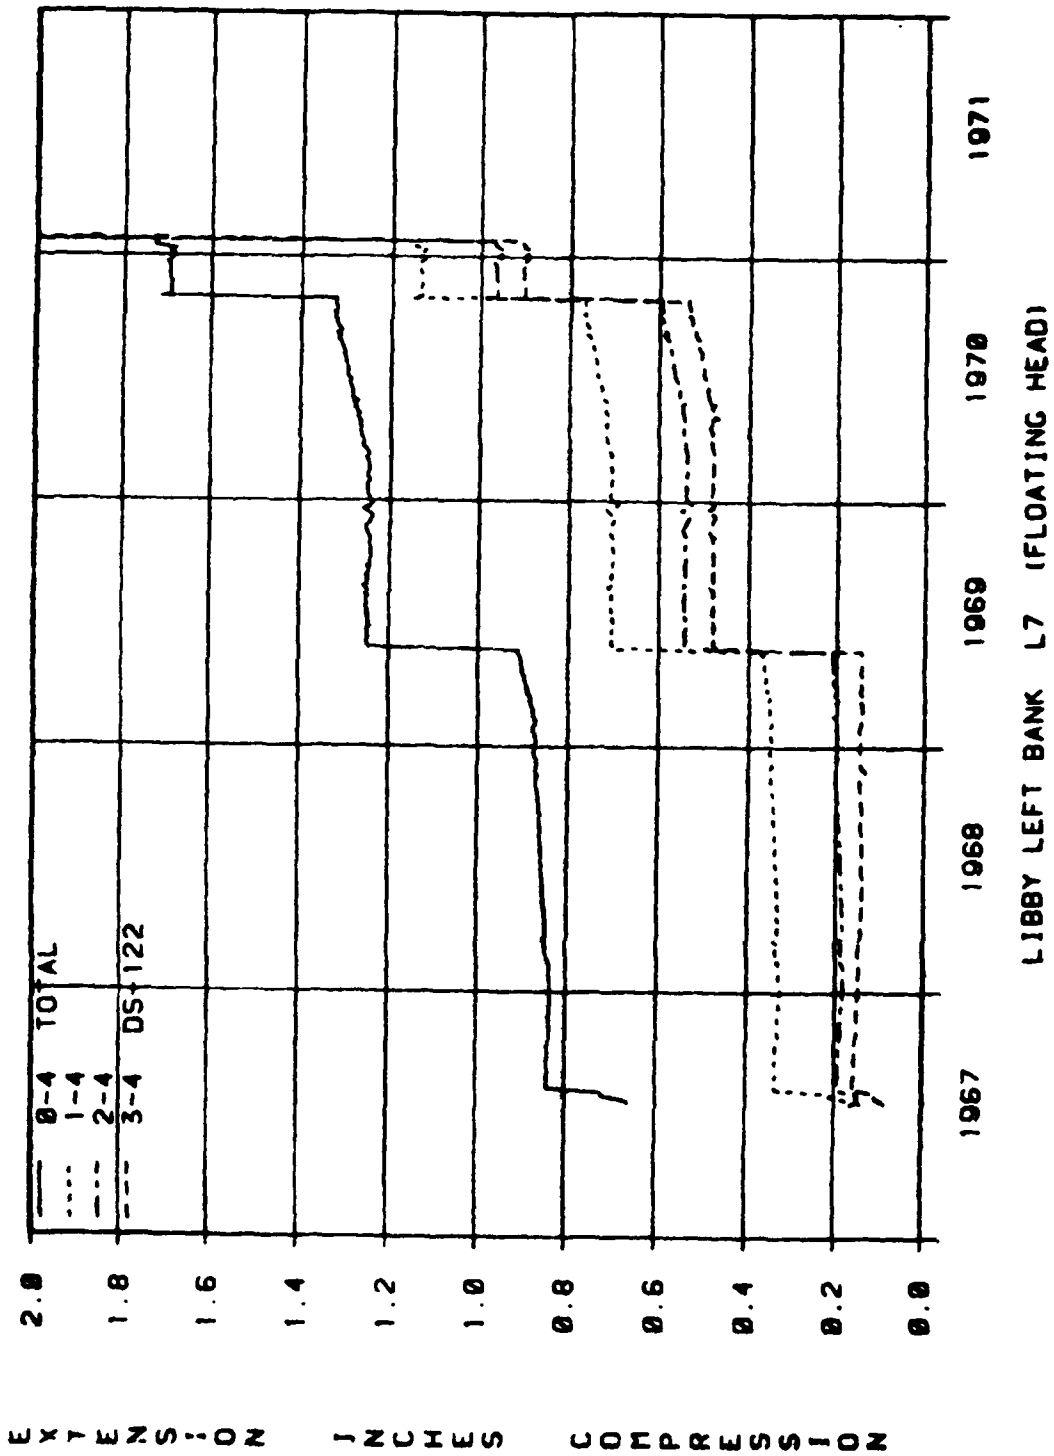
FIGURE 3.3

f. Late in March 1970, L-7 again began to indicate valleyward creep of the rock mass outboard of the DS+122 (figure 3.3). Some acceleration of this creep began in May and continued throughout the summer. The District forecast that a second step or failure would occur and that the magnitude of the movement was already greater than the precursor to the first step. When the Board of Consultants met at Libby on 29-30 July 1970, they were presented not only with a revised design of this section of the highway encompassing large amounts

g. Early in October 1970 the accelerating movement registered by L-7 leveled off followed, between 30 October and 2 November, by a sudden jump of 0.37 inch on the DS+122. A minor local earthquake was recorded at the Libby Dam Seismic Station, 3 miles up valley on 31 October. Thus after 7 months of accelerating creep the second step failure occurred and was of the same order of magnitude as the first step failure had been after a much longer period of total creep and a much shorter period of acceleration. This suggested that about the same amount of movement was required to develop sufficient friction to arrest the wedge. The District immediately informed higher authority informally and began to prepare a more formal notification. The letter to the Division Engineer, dated 8 January 1971, clearly stated, "the past record of activity in terms of strain build-up followed by sudden movement indicates . . . eventual failure of the rock wedge bounded by the DS+122 Joint and one or more east-west trending downstream joints." The letter was forwarded to OCE 10 days later.

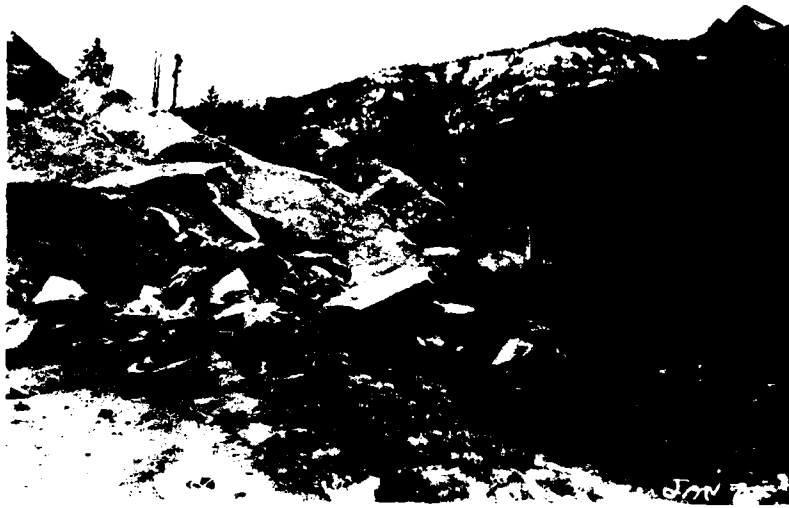
3.8a View downstream to rubble pile showing damage to refrigeration plant.

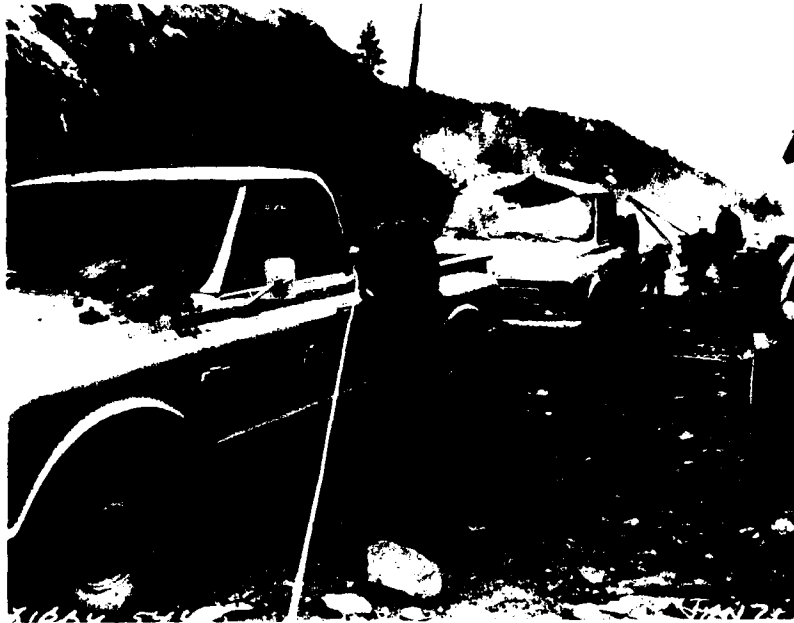
3.9a View of damage to Government vehicles parked in front of Instrumentation/Concrete Laboratory building.

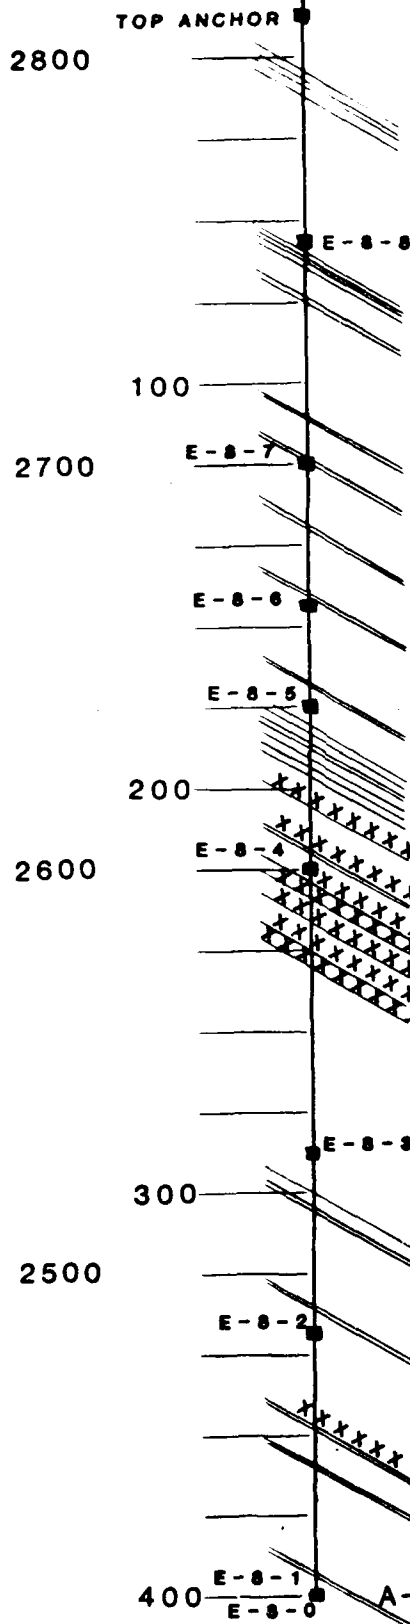
E-8

DISTURBED ZONES SHOWN MOSTLY INVOLVE UNDESIGNATED BEDDING FAULT ZONES BELOW THE 930 BEDDING FAULT. NUMEROUS HIGH ANGLE, E-W FRACTURES THROUGHOUT BADLY FRACTURED.
