PARK RIVER BASIN
WEST HARTFORD, CONNECTICUT

HARTFORD RESERVOIR NO.3 DAM
CT 00002

PHASE I INSPECTION REPORT
NATIONAL DAM INSPECTION PROGRAM

APRIL 1980

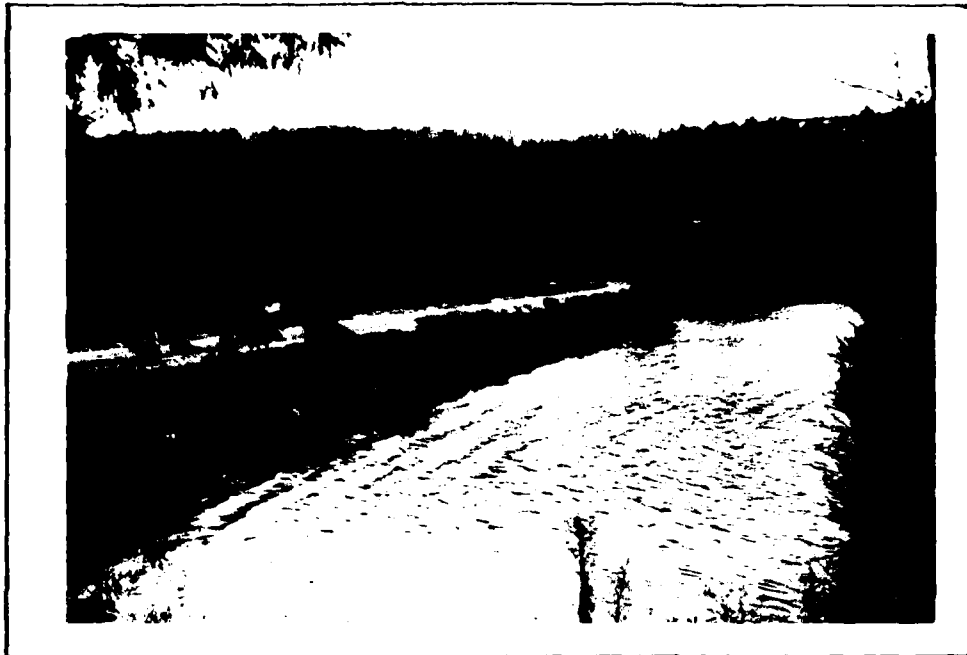
UPSTREAM FACE OF THE DAM AS VIEWED FROM THE LEFT ABUTMENT.
(11/13/79)

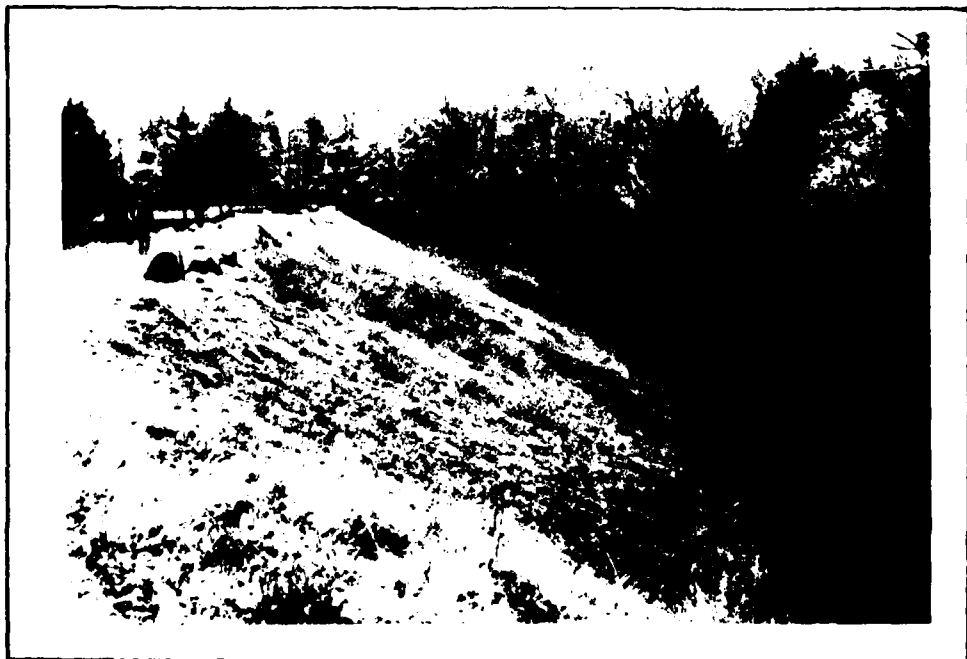
DOWNSTREAM FACE OF THE DAM AS VIEWED FROM THE RIGHT ABUTMENT.
(11/13/79)

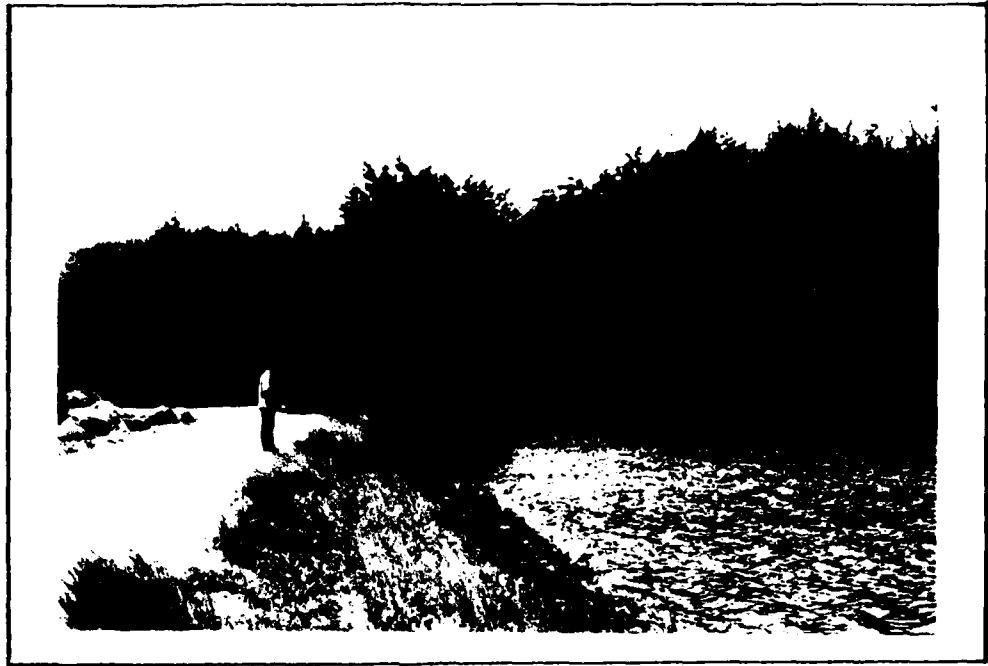
The upstream slope is relatively steep and the stability of the slope should be investigated. The root systems of the trees growing from the upstream face of the dam and in the vicinity of the downstream toe also present hazards to the structural integrity of the embankment. High winds could uproot the trees and dislodge portions of the embankment while the roots create potential seepage paths through the dam.

1. TREES AND VEGETATIVE COVER ON THE UPSTREAM FACE OF DAM.
(11/13/79)

1. To investigate the source of the seepage at the downstream toe and recommend a method of seepage control.
2. To perform slope stability analyses to assess the need for stabilizing the embankment.
3. To direct the removal of trees from the upstream face of the dam and from the vicinity of the downstream toe.
4. To design and direct the installation of upstream controls for the high and low level outlet pipes.

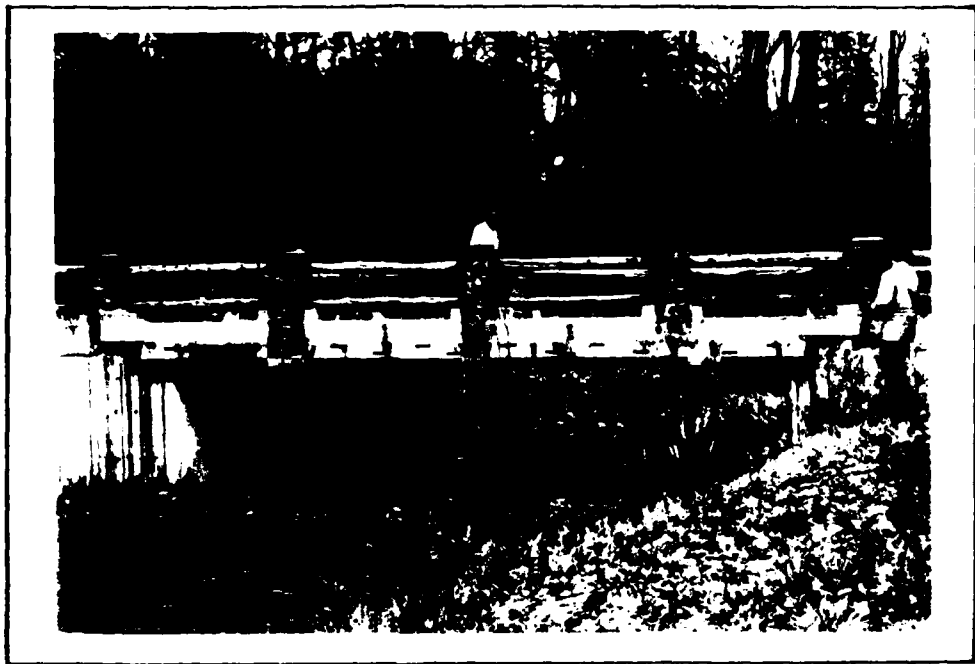
c. Appurtenant Structures. The spillway section appears to be in satisfactory condition. Improvements to the spillway outlet channel have been proposed which would widen and straighten the channel for a distance of 630 feet downstream of the weir.

5. BRIDGE OVER SPILLWAY FOR RESERVOIR 3.
(11/13/79)

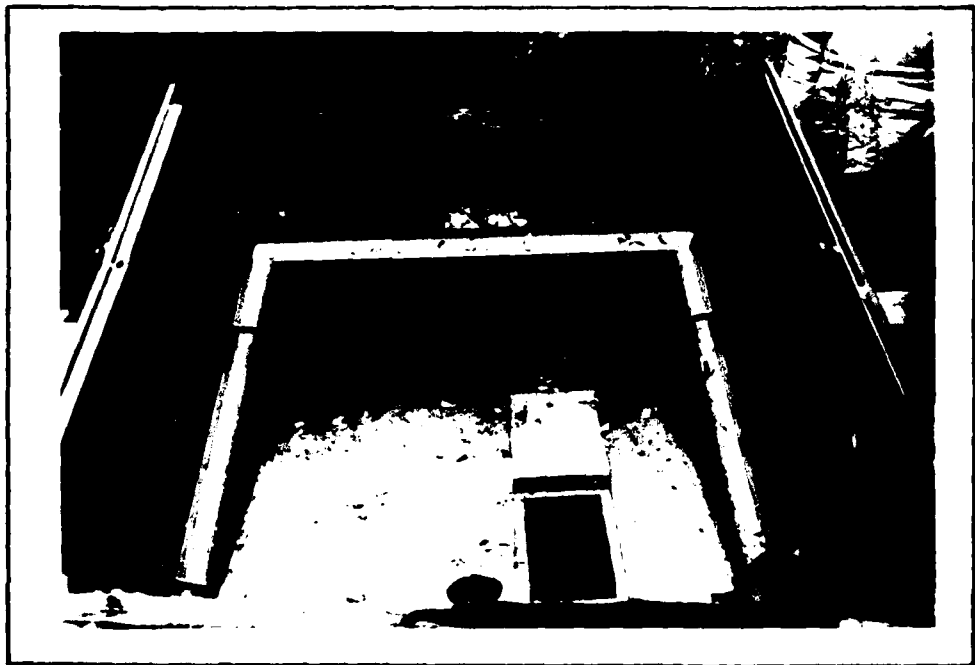
An outlet chamber houses the sluice gate for the diversion pipe which transfers water from Reservoir No. 3 to Reservoir No. 5. Access to this chamber is provided through two metal hinged doors as pictured on page C-3. The gate and outlet chamber appear to be in good condition.

6. ENCLOSURE FOR GATE SYSTEM WHICH CONTROLS DIVERSION DISCHARGE
TO RESERVOIR 5.
(11/13/79)
