LOWER HOUSATONIC RIVER BASIN
WATERBURY , CONNECTICUT

MAD RIVER DAM
CT 00030

PHASE I INSPECTION REPORT
NATIONAL DAM INSPECTION PROGRAM

JANUARY 1980

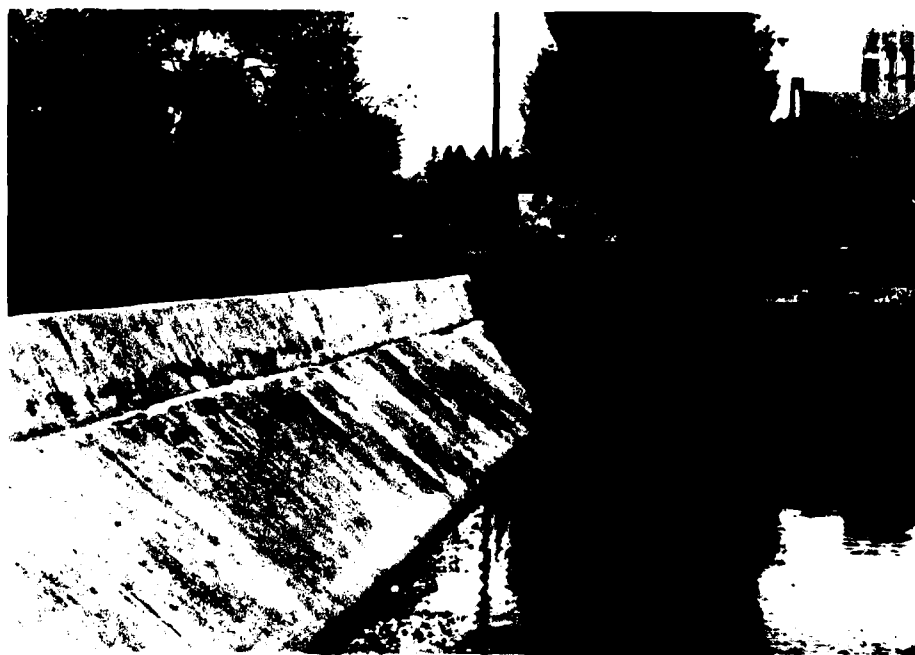
1) Upstream Face - The upstream face appears to be a sloping concrete stone faced masonry wall. A new 3-ft-high concrete parapet wall has been constructed on top of the masonry wall along the right side of the dam from the spillway to the right abutment. On the left side of the spillway, the new concrete parapet wall is approximately 30 feet long and connects to a previously existing stone wall on top of the dam. The parapet wall is in good condition, with only minor spalling observed. Some efflorescence of the concrete was noted along the upstream face. (See photo no. 1 and photo no. 4.)

PHOTO #4: Upstream face of dam looking towards right abutment. Note 3-foot parapet wall on top of concrete face and earth embankment at right side of dam.

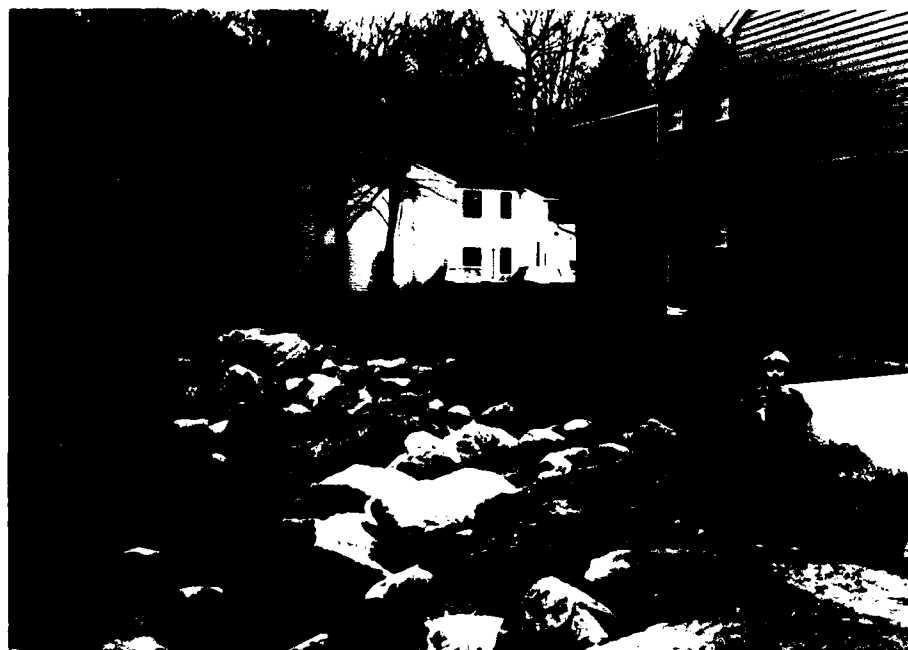
Photo #14: Apartment Buildings in Downstream Impact Area
