HOWARD RESERVOIR DAM

CT 00015

PHASE I INSPECTION REPORT
NATIONAL DAM INSPECTION PROGRAM

DEPARTMENT OF THE ARMY
NEW ENGLAND DIVISION, CORPS OF ENGINEERS
WALTHAM, MASS. 02154

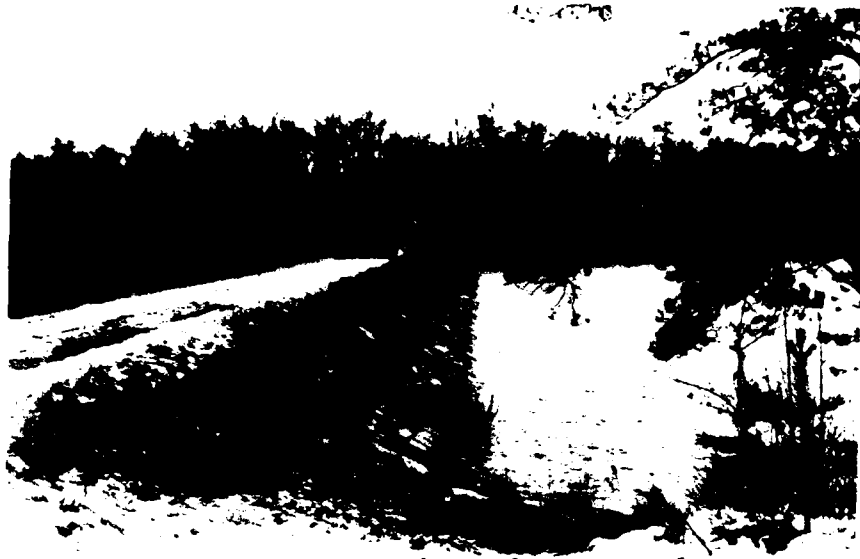
Overview of dam from left abutment

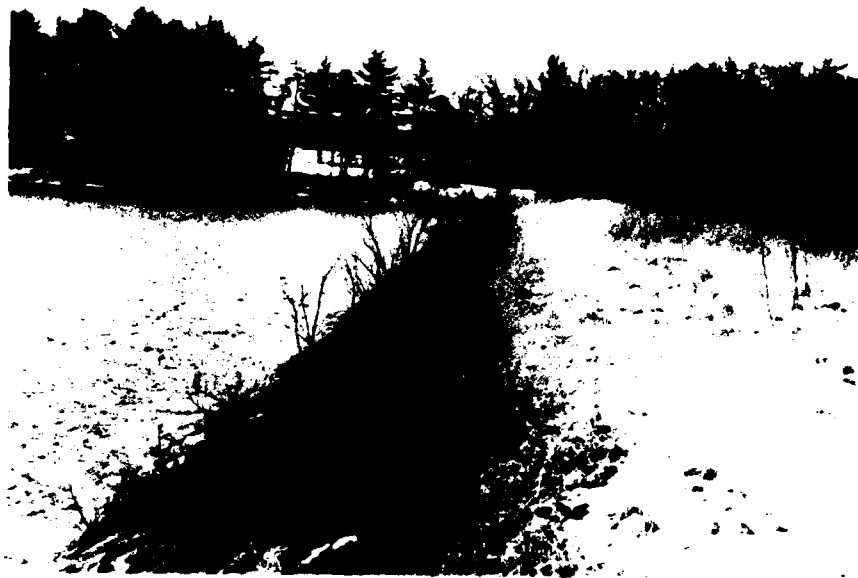
Overview of dam from right abutment

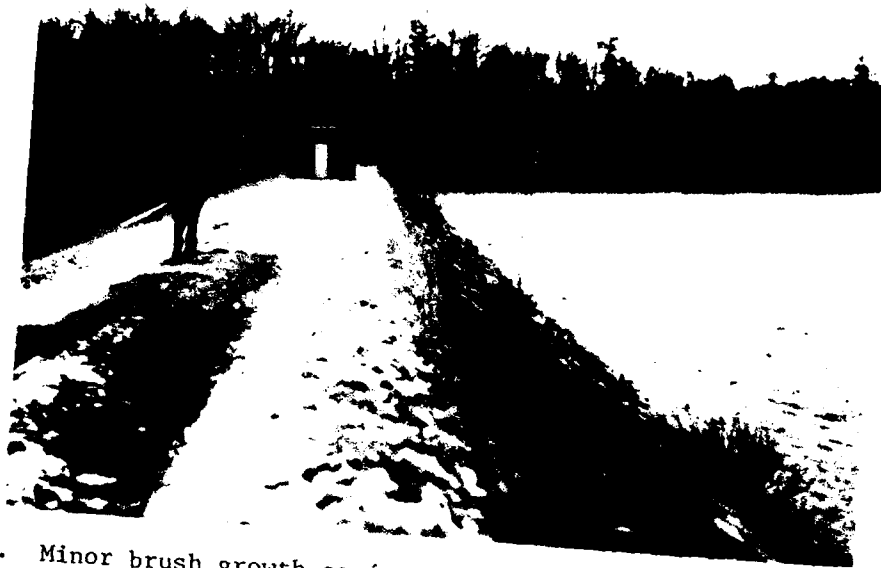
The upstream slope is hand-placed rock riprap and extends to within 2 ft. of the dam crest. The riprap is in generally good condition with no evidence of sags or bulges. However, there is some minor brush growth coming through the riprap (see Photo No. 1, Appendix C).

1. Minor brush growth coming through riprap on upstream slope.
