PEQUONNOCK RIVER BASIN
BRIDGEPORT, CONNECTICUT

FOREST LAKE DAM
CT 00078

PHASE I INSPECTION REPORT
NATIONAL DAM INSPECTION PROGRAM

AUGUST 1978

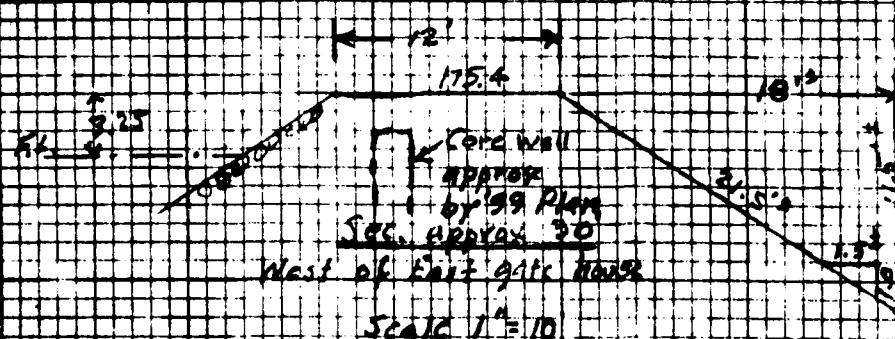
NOTE: Top of dam and spillway covered with trees and undergrowth.

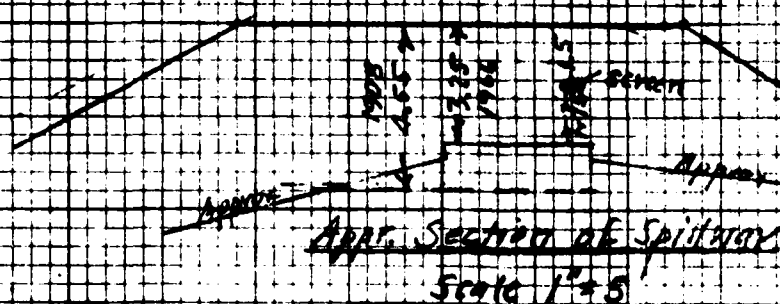
PRESSENT
Shed = 145 sp. m
H = 3' Max
C = 27
L = 35.5
Q = 500 cfs

$Q = C A H^{3/2}$
 $= 27 \times 35.5 \times 5.2 = 500 \text{ cfs}$

$H = 0.5$
 $C = 27$
 $L = 35.5$
 $Q = 1.48 \times 10^3 \times 0.5^{3/2} = 495 \text{ cfs}$

NOTE: Evident spillway is inadequate; that screen should be removed, and that other measures should be taken to provide required safety.
