LAKE HOUSATONIC DAM AND DIKE

CT 00026

PHASE I INSPECTION REPORT NATIONAL DAM INSPECTION PROGRAM

AUGUST 1981

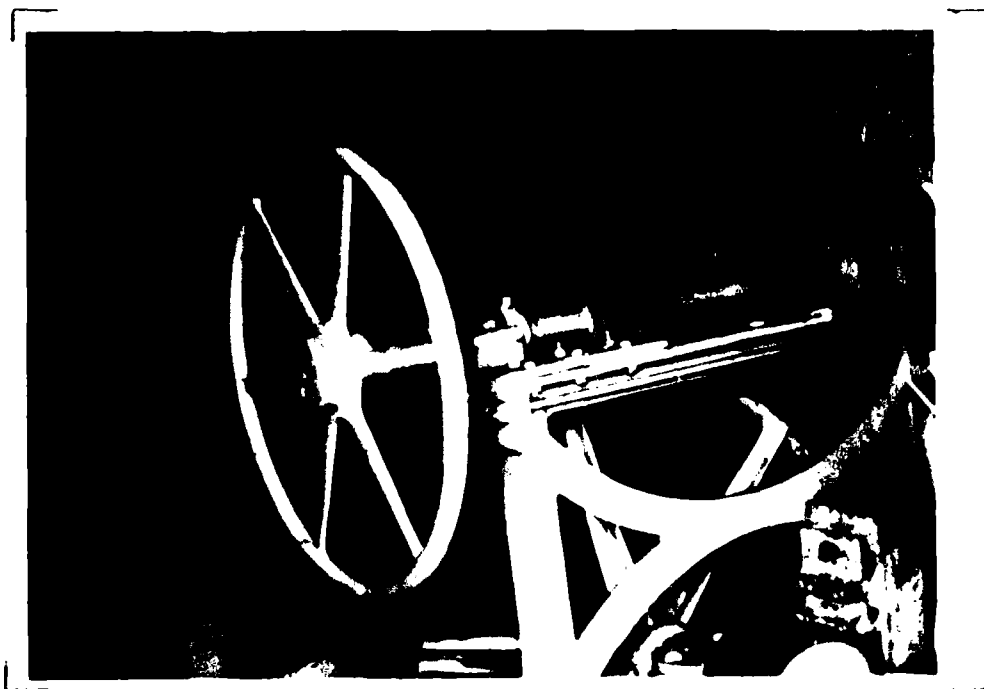
Photo 11 Interior of right gatehouse and gate hoist mechanism. Note belt driven alternate gate hoist system.
