Special Report 84-12

Cold Regions Research &
Engineering Laboratory

Deteriorated concrete panels on buildings at Sondrestrom, Greenland

Charles Korhonen

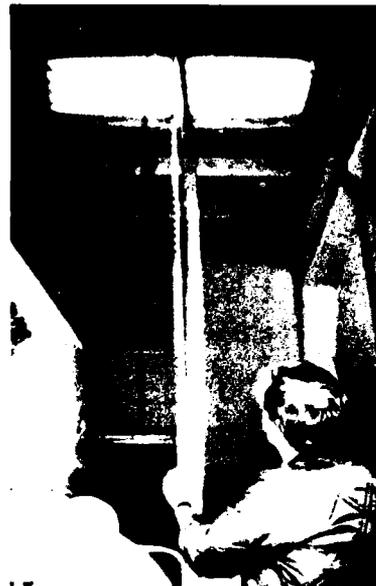
b. Bowed equipment support rod, representing a $1/16$ -in. movement.

Figure 3. Measurements that suggest buildings have settled differentially.
