EASTON RESERVOIR DAM  
CT 00020

PHASE I INSPECTION REPORT  
NATIONAL DAM INSPECTION PROGRAM

SEPTEMBER 1978

Date of Inspection: 2 AUGUST 1978

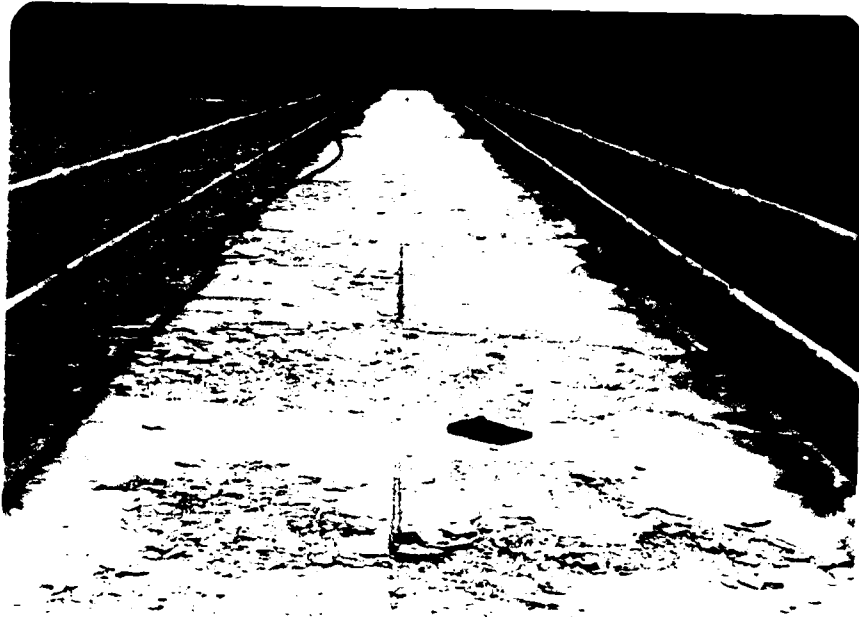
2) Top of Dam - The top surface of the dam for nearly the full length has many areas of surface spalling, joint spalling and general deterioration. The coping has deteriorated and spalled at several areas west of the gatehouse. To the east of the gatehouse, the lip at both the upstream and downstream face, for nearly the entire length, has deteriorated and spalled. At about Station 7+15, the lip has deteriorated to such an extent that the anchorage for the post of the railing has completely pulled away from the concrete.

PHOTO #5: View along crest of dam, looking east.

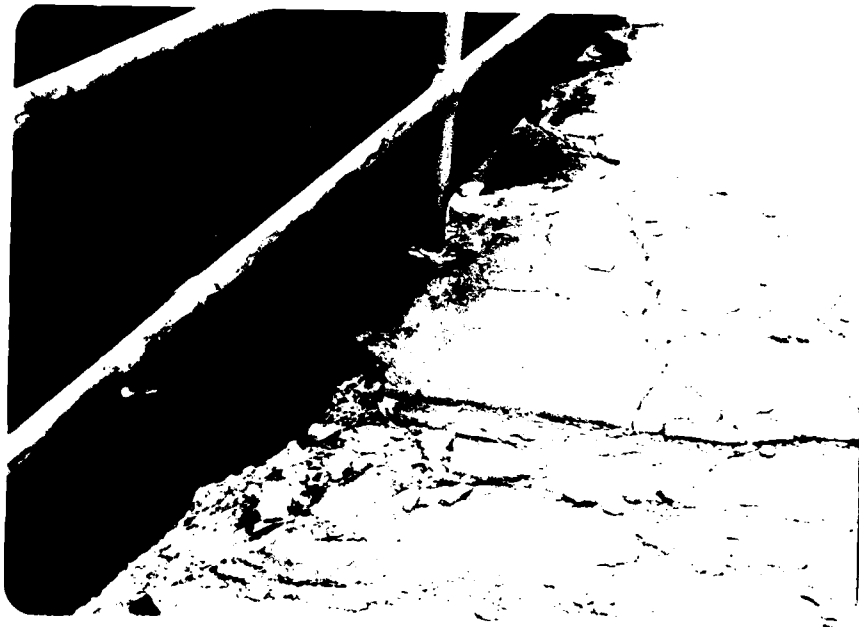
PHOTO #6: Typical concrete surface conditions along edge and top of crest.

a. Concrete surfaces of downstream face and top of dam affected by spalling should be repaired.

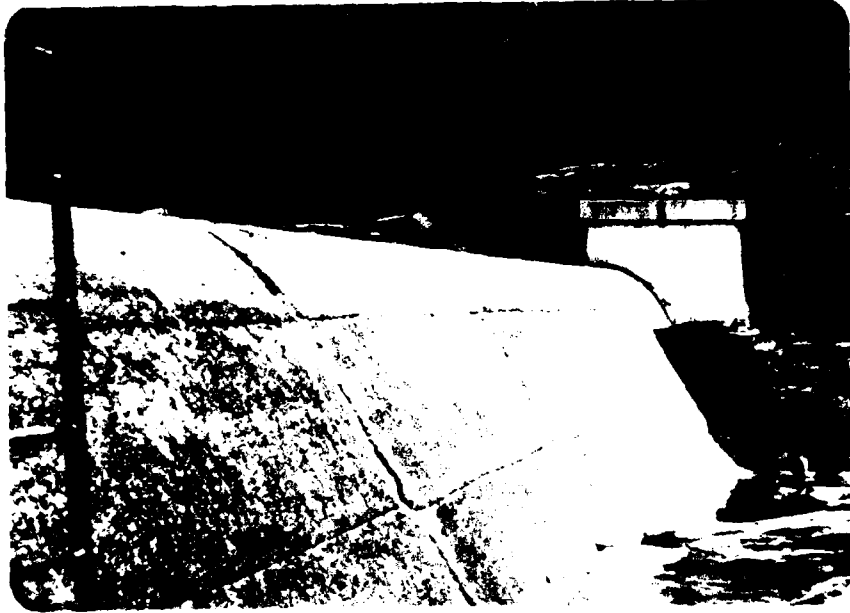
4) Spillway - The spillway is in good condition. There is some horizontal scouring of concrete, exposing the aggregate, at about 4 feet down from the crest of the spillway between Station 9+40 to Station 9+70. At the spillway section adjacent to the dam there is a wet spot several feet long at a horizontal pour joint about 5 feet down from the top of spillway. There is some joint spalling at the vertical construction joint at Station 9+70. There is some slight spalling of the downstream face beyond Station 9+90. At about Station 9+80 at the crest of the spillway there is an area about 2 feet long and several inches deep that has deteriorated and spalled off.

PHOTO #9: Downstream face of the spillway, looking east.

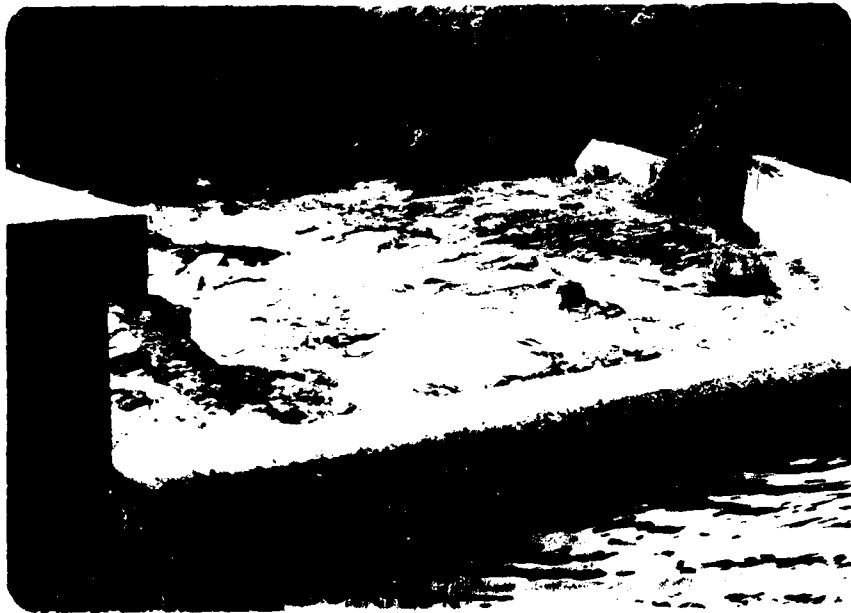
PHOTO #10: View over the top of the spillway, looking south.

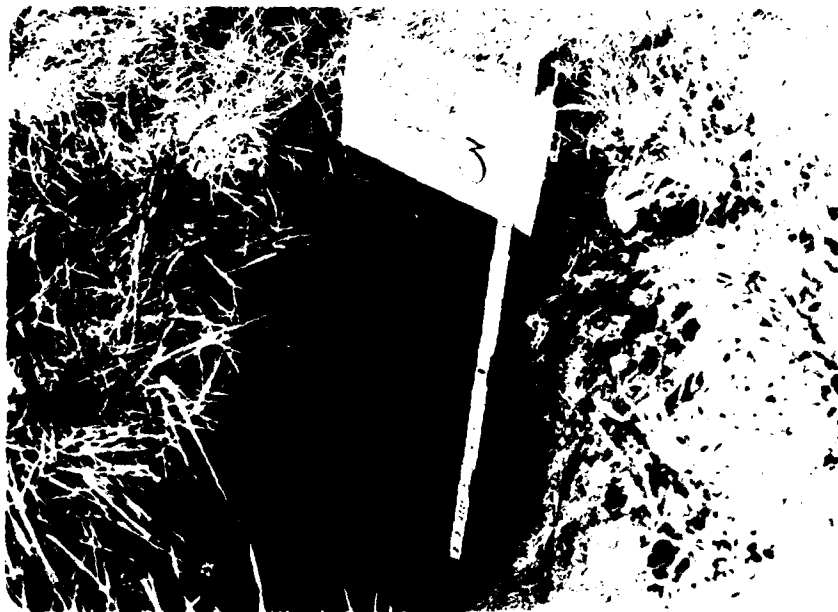
PHOTO #12: Borrow hole in earth embankment.
