BRISTOL RESERVOIR DAM
CT. 00008

PHASE I INSPECTION REPORT
NATIONAL DAM INSPECTION PROGRAM

Identification Number:	CT 00008
Name:	Bristol Reservoir Dam
Town:	Bristol
County and State:	Hartford County, Connecticut
Stream:	Pequabuck River
Date of Inspection:	September 21, 1978

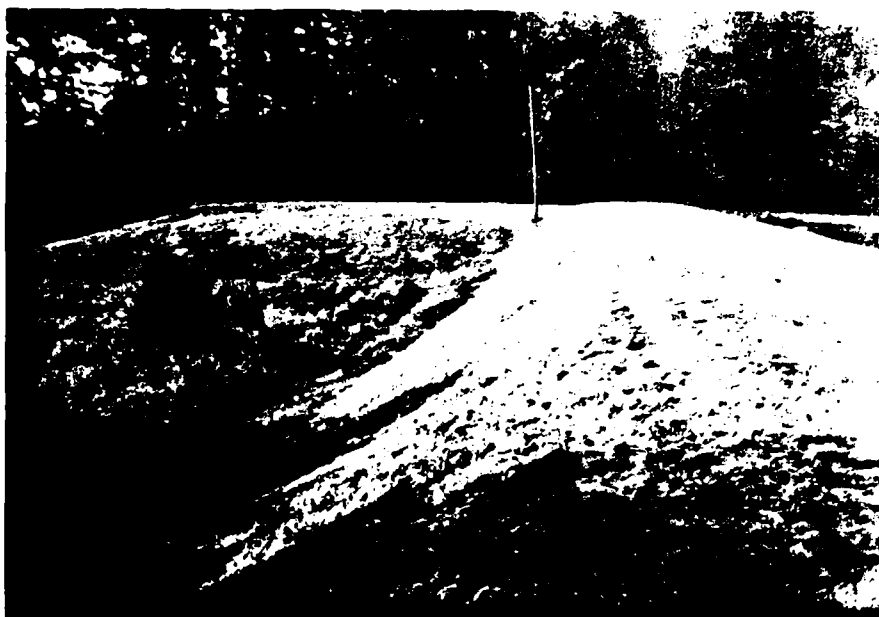
PHOTO 1
CREST OF DAM

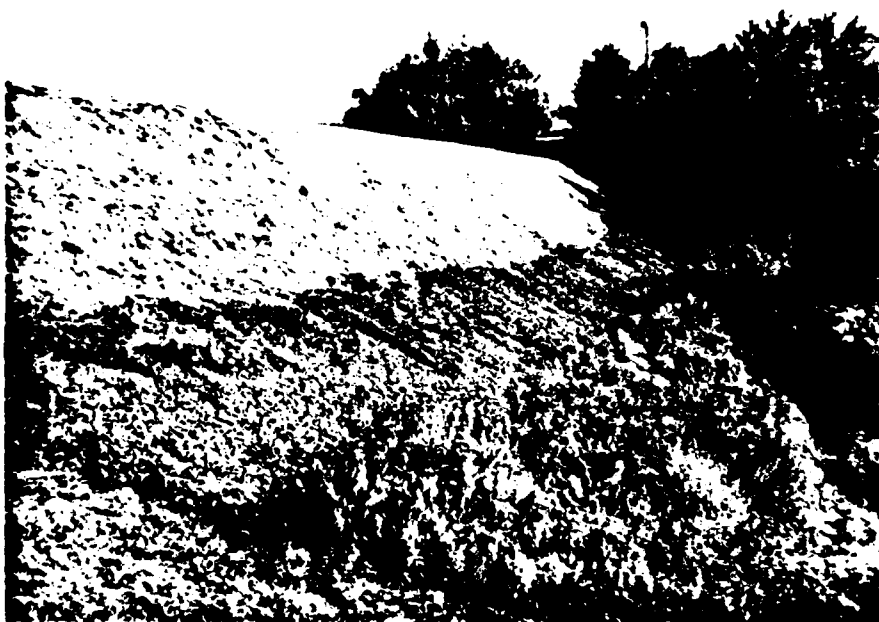
PHOTO 2
DOWNSTREAM FACE OF DAM

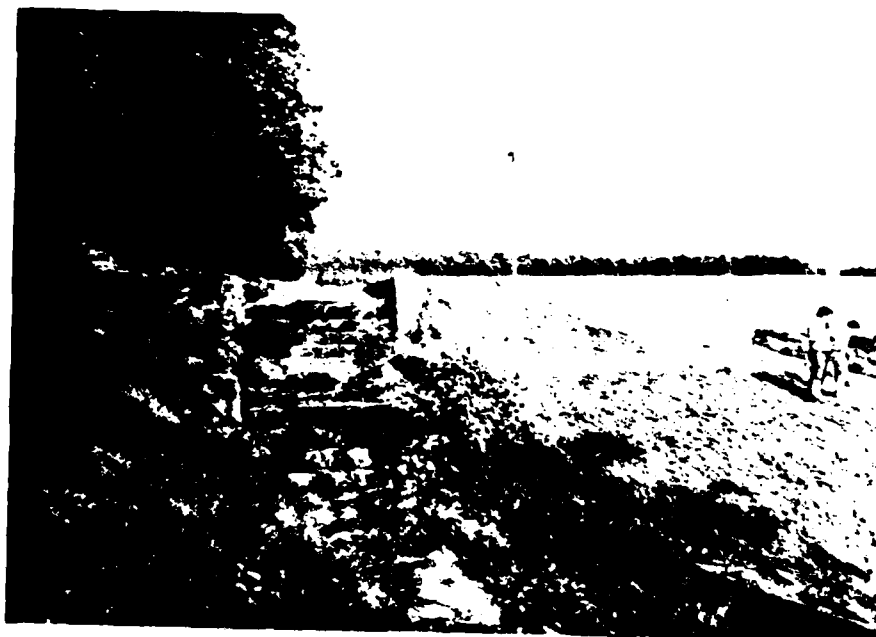
c. Appurtenant Structures - The appurtenant structures are the spillway, the diversion conduit and the spillway channel. The fieldstone spillway shown in Appendix C, Photos 3 and 4, appears to be in fair condition with a considerable amount of grass growing through the mortar joints.

c. Visual Observations - The spillway at the time of the inspection was in fair condition with evidence of water seepage at the lower end and grass and brush growing up through joints (Appendix C, Photo 4).

PHOTO 4
SPILLWAY LOOKING UPSTREAM

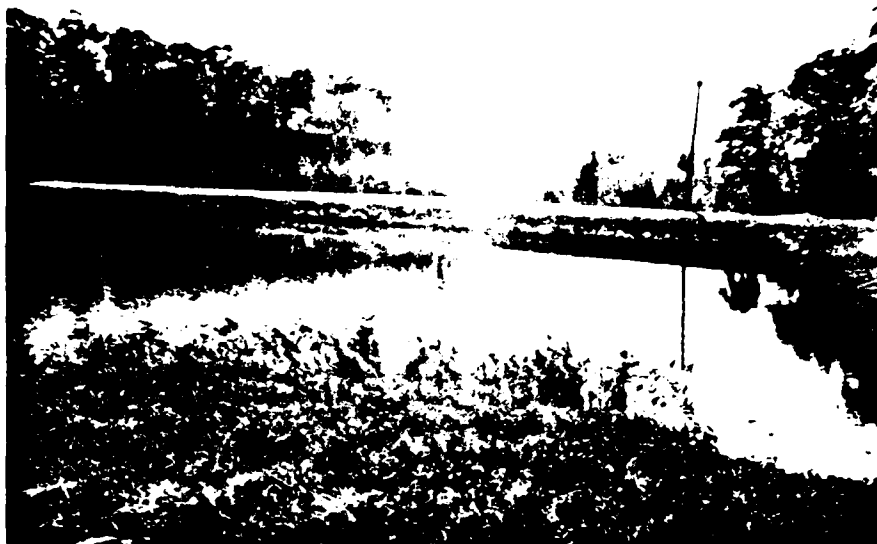
PHOTO 5
UPSTREAM FACE DAM
