NATIONAL DAM INSPECTION PROGRAM UNION POND DAM (CT
00013) UPPER CONNECTIC... (U) CORPS OF ENGINEERS WALTHAM
MA NEW ENGLAND DIV FEB 79

4. TITLE (and Subtitle) Union Pond Dam, Upper Connecticut River Basin Phase I Inspection Report NATIONAL PROGRAM FOR INSPECTION OF NON-FEDERAL DAMS		5. TYPE OF REPORT & PERIOD COVERED INSPECTION REPORT

UNION POND DAM

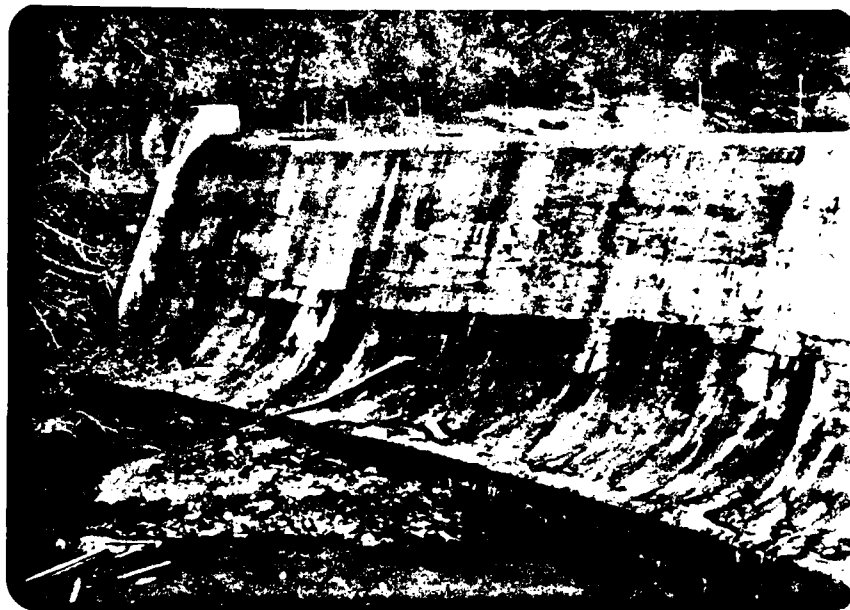
Downstream Face - The downstream face of the dam is exposed down to the rock foundation. The dam shows considerable efflorescence and spalling as shown in Photos 1, 3, and 4. Some cracks appear to be at least 2 to 3 feet deep. Seepage was observed through cracks in the dam, through the concrete-rock interface, through the exposed bedrock immediately downstream of the dam, and from weep holes near the toe of the spillway. At the time of the inspection, discharge from the seeps was small, however as the water level in the pond is raised, it is likely the amount of seepage will increase. (See Photos 4 and 6). The bedrock exposures are arkose sandstone with near-horizontal bedding.

PHOTO NO.3 - General view of downstream face of right spillway section, right abutment, and low level waste gate outlet.

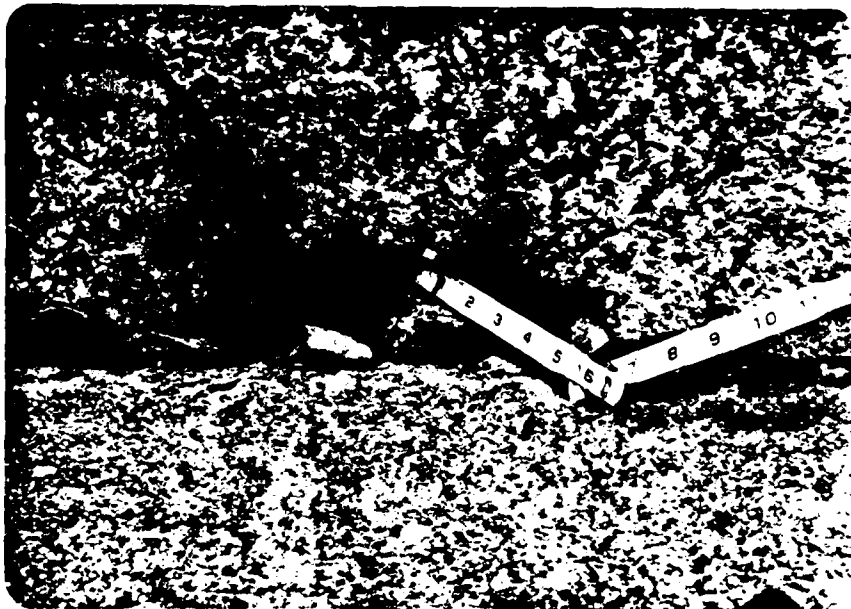
PHOTO NO.5 - Close-up of void in left spillway section downstream face. Note deteriorated gunnite facing.
