HOUSATONIC RIVER BASIN
ANSONIA, CONNECTICUT
QUILLINAN RESERVOIR DAM
CT 00024

PHASE I INSPECTION REPORT
NATIONAL DAM INSPECTION PROGRAM

February 1980

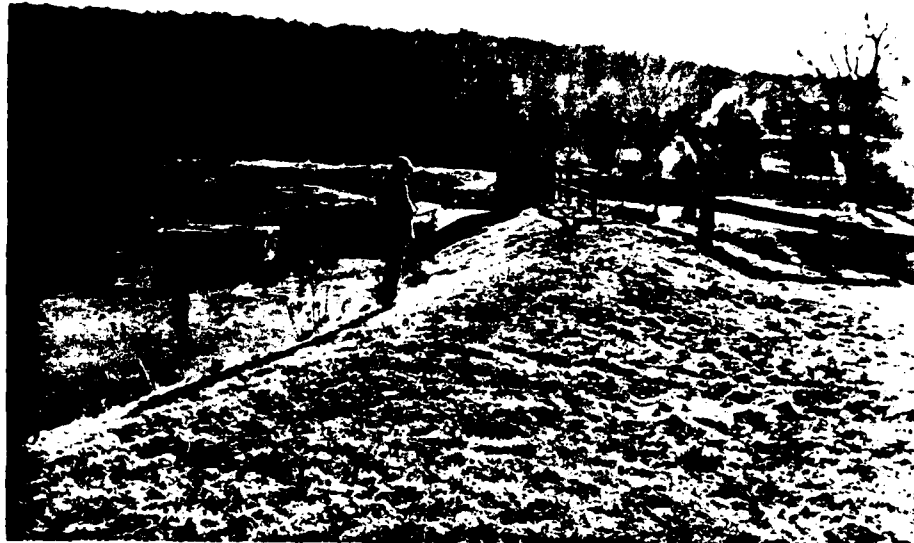
Crest - The crest of the earth embankment is very irregular and ranges from 0.5+ feet below to 1.5+ feet above the top of the masonry section of the dam (Photos 1, 2 and 4). Several paths (or ruts) from pedestrian traffic were noted on the left embankment.

Upstream Slope - Erosion was noted along the water line of the upstream slope of the left section of embankment (Photo 1 and 2). This erosion extends from the riprap protection (just below the water line) to 3+ feet up the slope. A small area of erosion was also noted at the embankment to the right of the spillway. This area is 4+ feet long and is located at the water line just opposite the supply intake and gate tower. Small brush was also observed on several portions of the upstream slope.

Photo 1 - Upstream slope and top of dam from right abutment. Gate structure for supply intake at left (Jan. 1980)

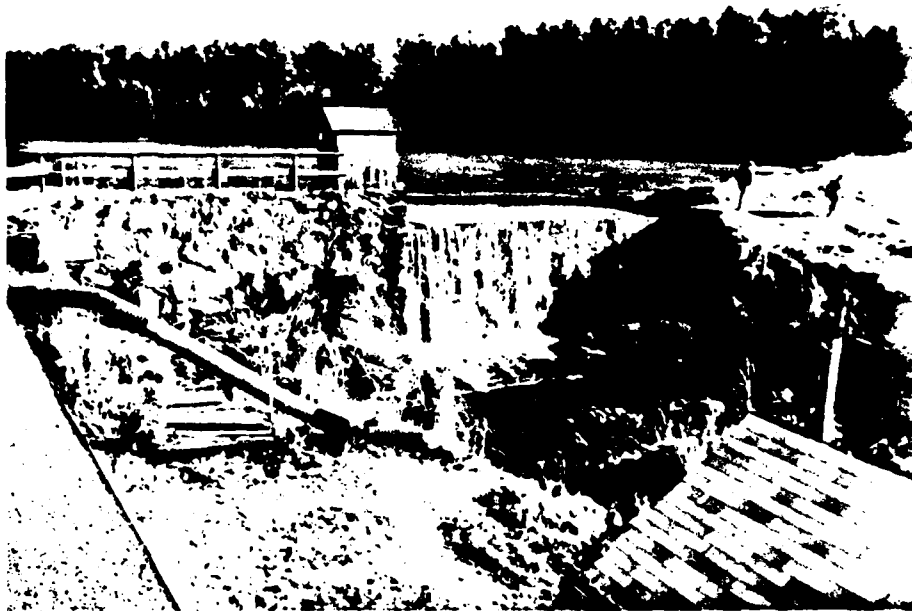
Downstream Slope - The downstream slope of the masonry section is covered with grass, weeds and brush, which is growing out between the masonry joints of the stone masonry (Photos 3 and 5). Seepage through the joints was noted at the lower portion of the masonry section and in several joints approximately 7 feet below the top of the masonry. The total seepage flow is approximately 0.5 to 1 gallon per minute (gpm). Many of the joints in the masonry are cracked and leaching at the areas of seepage, leaving the mortar soft and non-cohesive (Photo 6). The toe of the masonry section is also wet and covered with brush (Photo 3). The downstream slope of the left earth embankment has a grass cover with some brush. No cracks or seepage was observed.

Spillway - The downstream face of the masonry spillway is slightly deteriorated near the top. The spillway crest is in good condition. The spillway apron is severely damaged with spalling at the central and left portions (Photo 3). A scour area in the discharge channel approximately 2 feet wide and 2 feet deep was noted along the toe of the spillway apron.

c. Appurtenant Structures - The gate house at the right end of the spillway and low-level conduit, including the butterfly valve and valve stand, are in good condition (Photos 3 and 7).

Photo 3 - Downstream face of masonry section with spillway (Jan 1980)

5. Cracked masonry joints of the spillway training walls should be sealed to prevent further deterioration.
6. The concrete damage at the spillway apron should be repaired or the apron replaced. Erosion at the toe of the apron should be filled and riprapped.

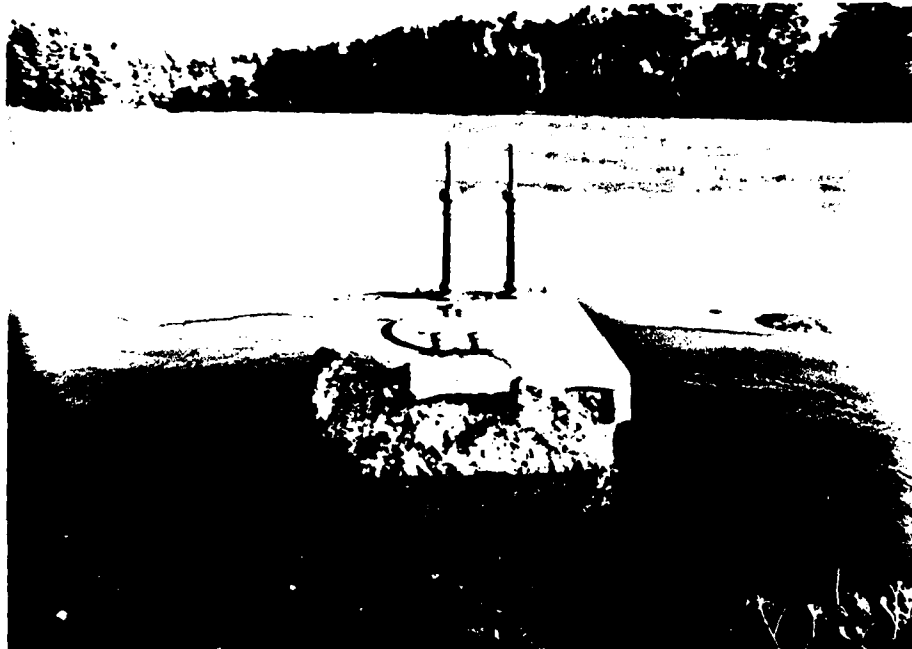
The concrete gate tower for the supply intake is deteriorated; including exposed aggregate, severe spalling, and cracking (Photo 8).

Photo 8 - Gate structure for supply intake (Jan 1980)

5. Repair of the concrete intake and gate tower for the supply line.
6. Origin and significance of seepage at the abandoned chlorinator chamber and location of the 4 inch drain pipe.
7. A comprehensive program for further investigation of the dam. Of particular importance are:
 - a. Condition of the masonry spillway and the concrete apron when no water is flowing over the spillway. This should include investigation into the extent of the scouring at the toe of the apron and the affect of this erosion on the stability of the concrete apron.
 - b. Effect of the fill at the toe of the left embankment on possible seepage through the dam and monitoring of this seepage.
 - c. Development of a program to reduce or stop seepage through the masonry section of the dam.

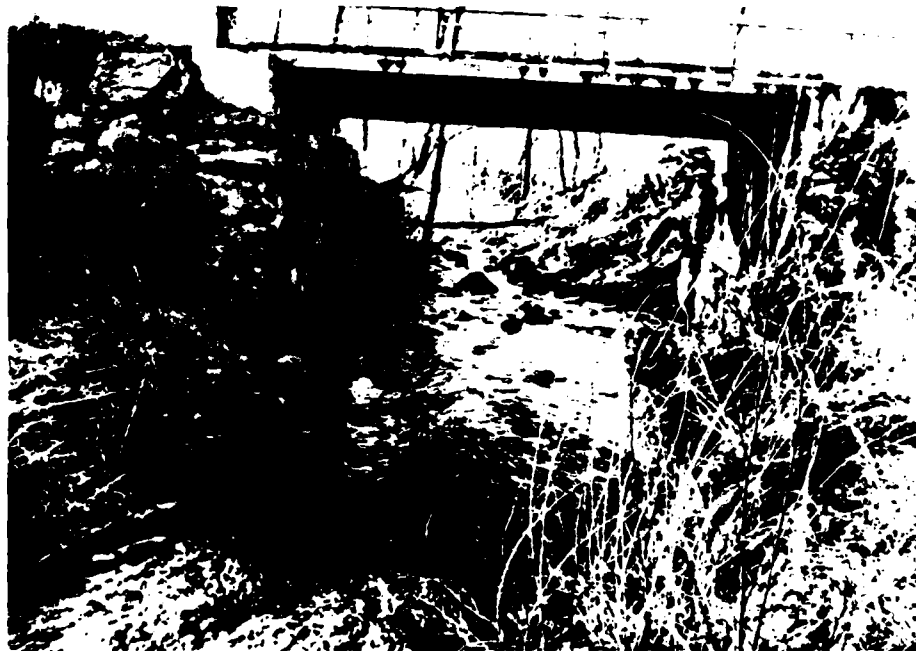
Photo 10 - Downstream channel from spillway (Jan 1980)

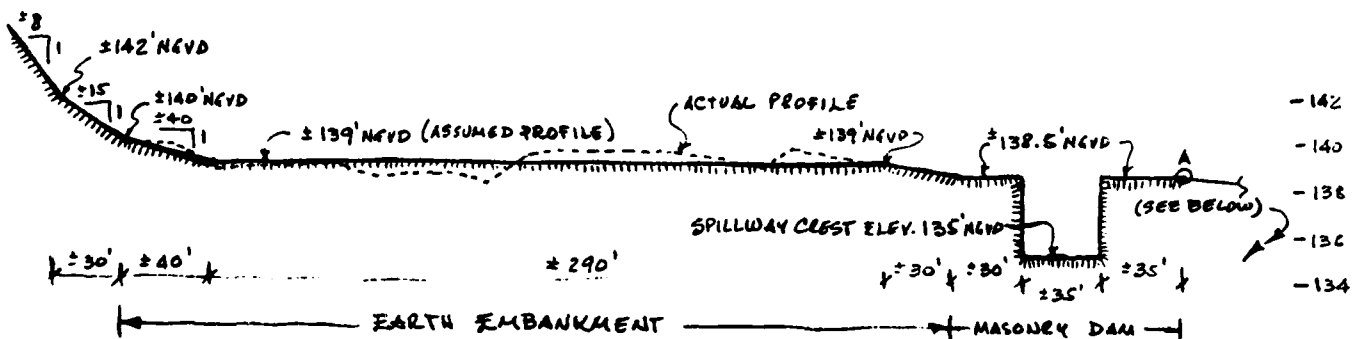
QUILLINAN RESERVOIR
- OVERFLOW PROFILE -

THE TOP ELEVATION OF THE LEFT EMBANKMENT VARIES FROM (+) 138' NGVD TO (+) 140' NGVD AND PRESENTS WITHIN THESE LIMITS A VERY IRREGULAR OVERFLOW PROFILE (SEE SKETCH BELOW). THE RIGHT EMBANKMENT FALLS TO (+) ELEV. 138' NGVD ((+) 0.5' LOWER THAN THE TOP OF THE MASONRY DAM), AND TIES WITH THE PARKING AREA OF THE ANSONIA-DERBY WATER CO. BUILDING TO FORM THE OVERFLOW SECTION. IT WILL BE ASSUMED THAT THIS BUILDING (FF. ELEV. (+) 139.8' NGVD) CLOSES VERTICALLY, ABOVE GROUND ELEV. (+) 138.5' NGVD AT THE RIGHT SIDE OF THE OVERFLOW SECTION. TO THE LEFT, THE DAM AND ADJACENT TERRAIN RAISE GRADUALLY AS SHOWN BELOW ON THE OVERFLOW PROFILE ASSUMED FOR THIS COMPUTATION.
