HOUSATONIC RIVER BASIN

CHESTNUT RIDGE RESERVOIR DAM
CT 00075

PHASE I INSPECTION REPORT
NATIONAL DAM INSPECTION PROGRAM

AUGUST, 1979

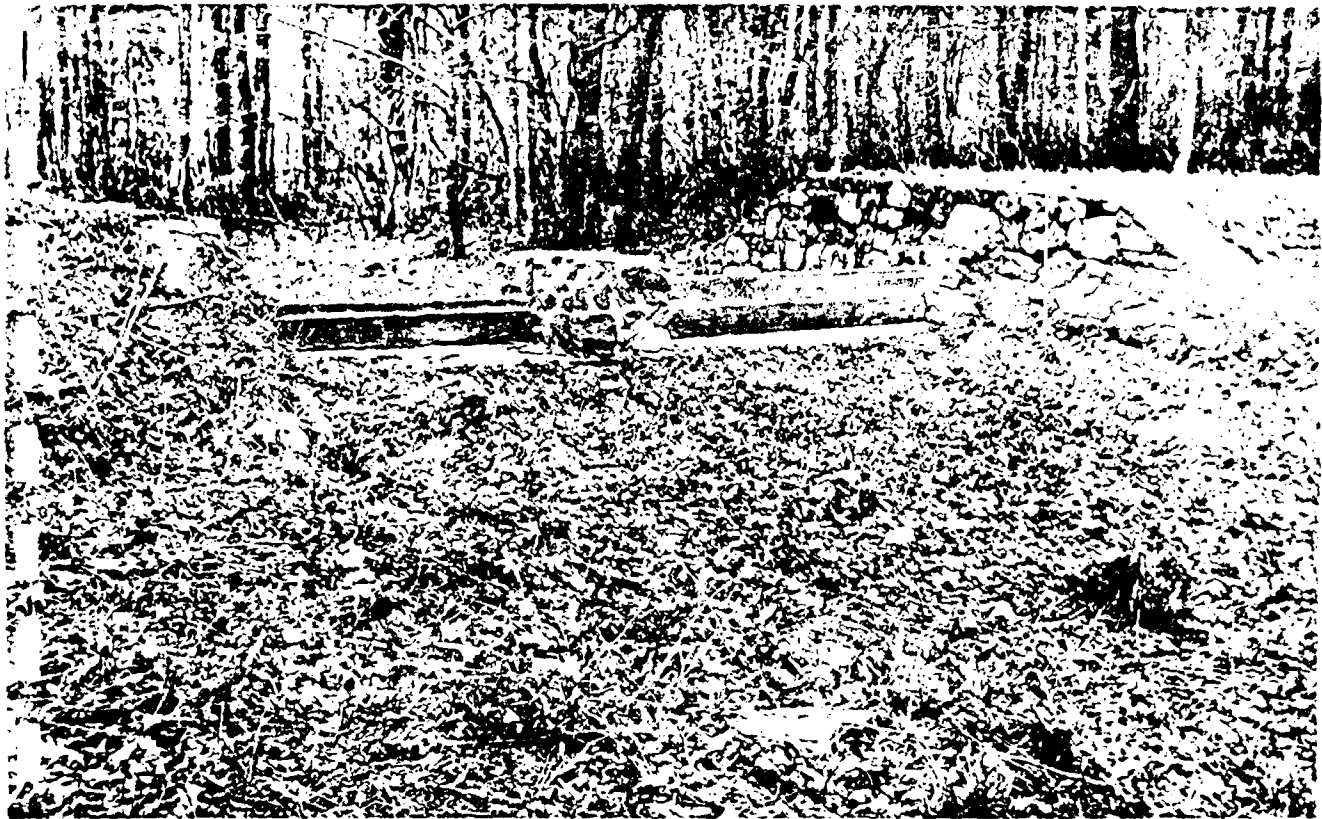
Photo 2

Look downstream at spill way structure
and center portion of dam. Dam is in
fair condition. Right flash board is
left flash board is 12" - 4 rods of
against right abutment.

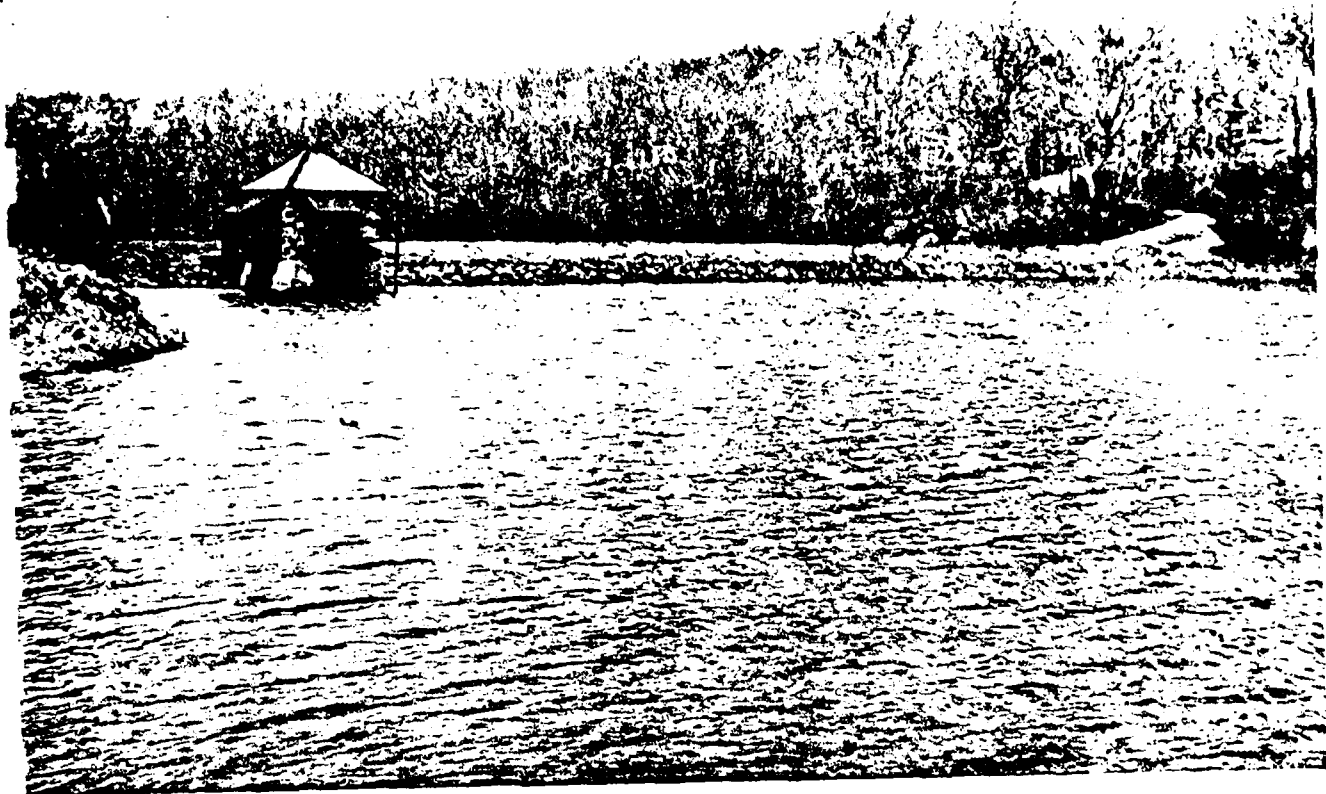
#1

Looking at dam from west side.
 Gate house at left.

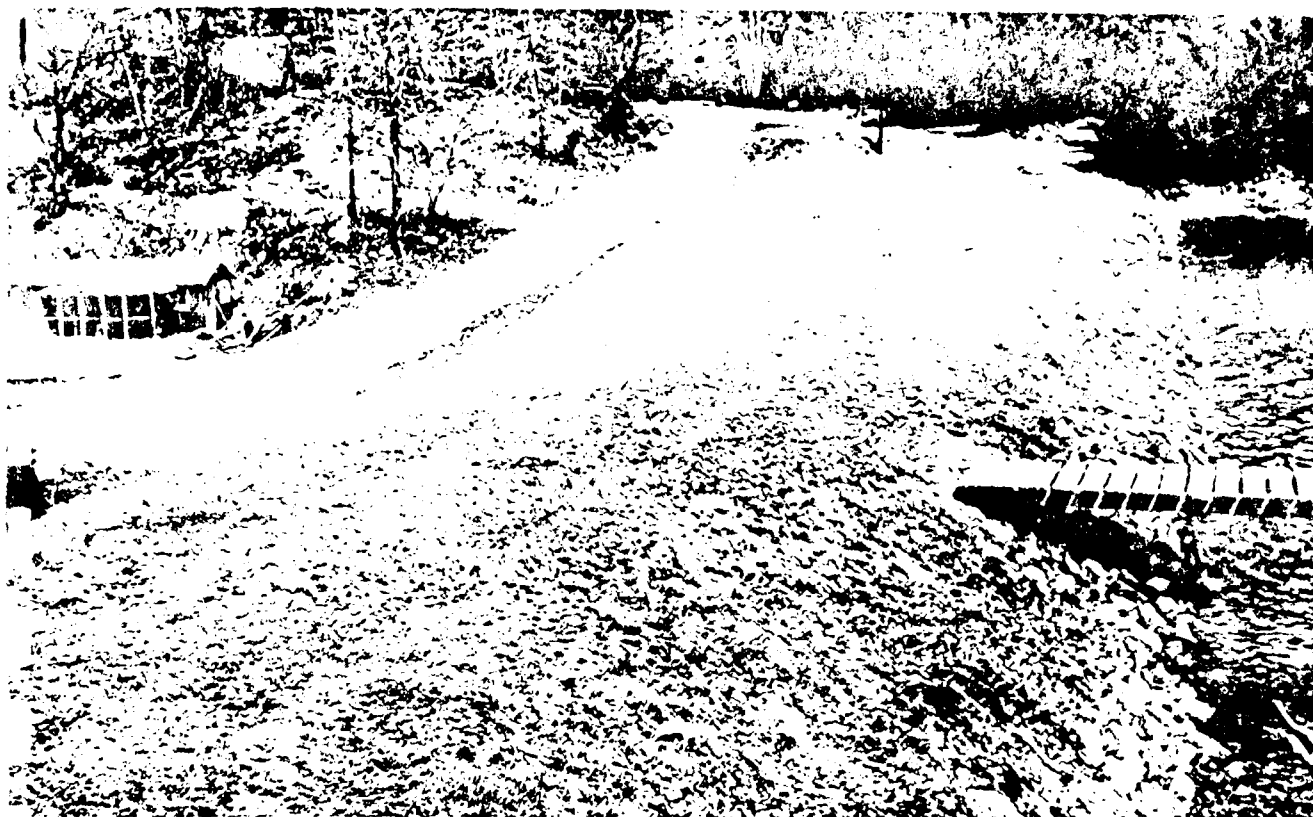
Look east over dam. Note spillway
rip-rap on water side which rises to
 $\pm 1'$ above spillway elevation. Walkway
to gate house at right center.

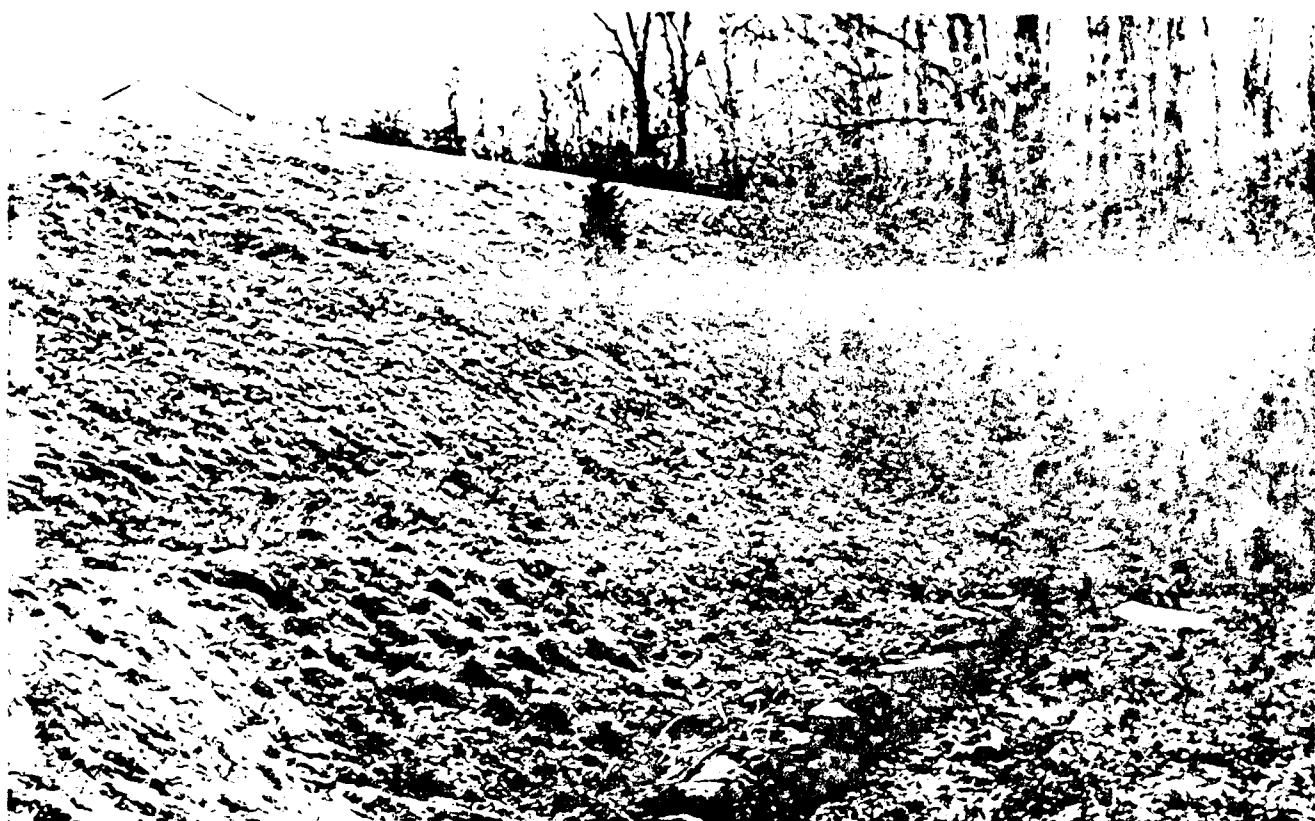
Look E west of construction slope.
 Entire slope is not covered with rock.
 Note large stone retaining wall at stream.

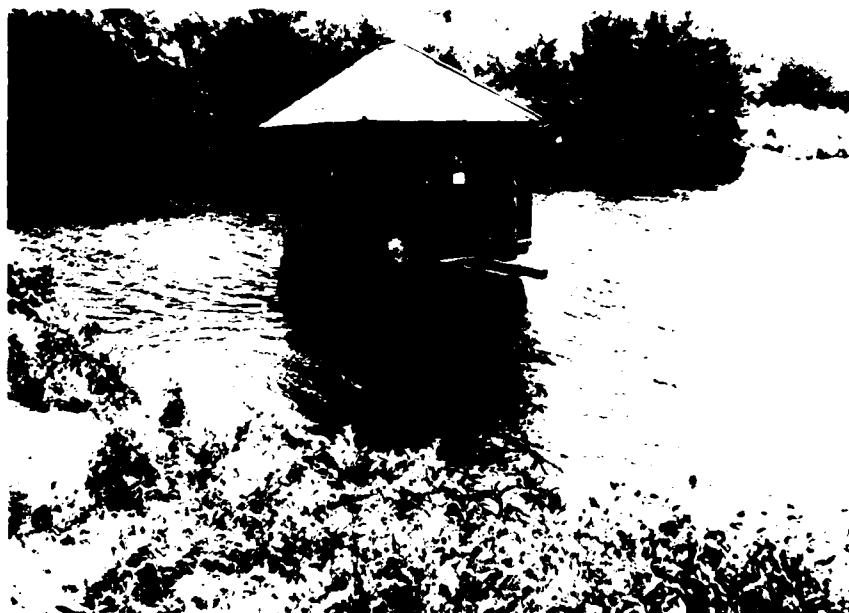
The stone masonry walls and the concrete substructure of the gatehouse are in good condition. No cracking or spalling of the concrete or masonry was observed (Photo 12).

Photo 12 - Gatehouse in reservoir from left abutment of dam. Note valve stand above water surface near gatehouse. (Aug 79)
