**SOUTHWESTERN COASTAL BASIN  
GREENWICH, CONNECTICUT**

**MIANUS FILTER PLANT DAM  
CT 00040**

**PHASE 1 INSPECTION REPORT  
NATIONAL DAM INSPECTION PROGRAM**

**FEBRUARY, 1980**

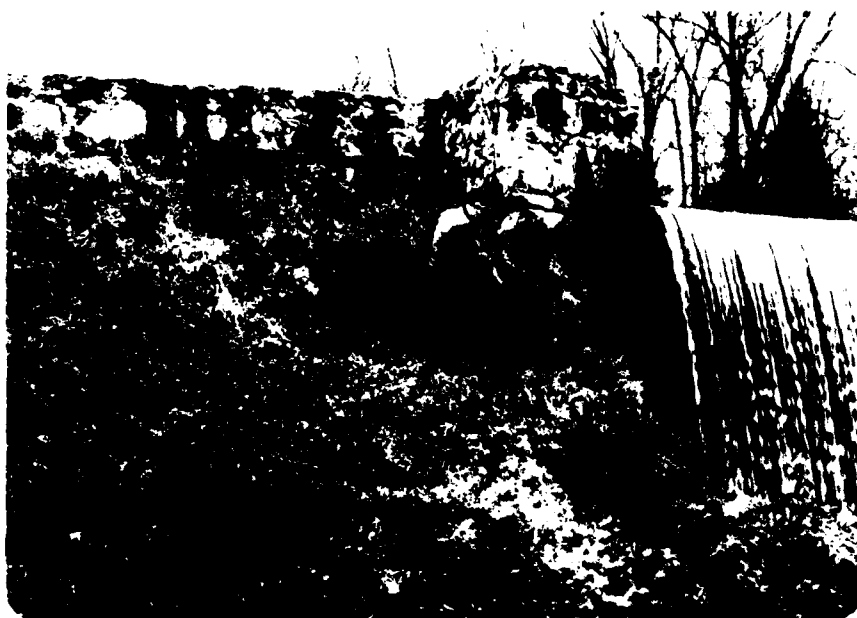
3. **Downstream Slope:** The downstream slope is also stone masonry with a nearly vertical face. There are numerous places where seepage is steady on the face of each abutment (Photos C-8, 9). The condition of the joints is quite poor (Photo C-9) and one joint on the west abutment has a void which measures 18 inches deep (Photo C-10). A few loose stones were noted on the east abutment and grass was growing from some of the joints. The fill on the downstream face of the west abutment seemed to be quite moist, indicating that seepage occurs below grade as well as above.

C-8 SEEPAGE POINT BELOW WEST CREST

- a. **Operation and Maintenance Procedures:**
  - 1. Trees from the floor of the upstream riverbed should be removed as soon as possible.
  - 2. The seepage on the downstream face should be monitored to note any change from the existing conditions.

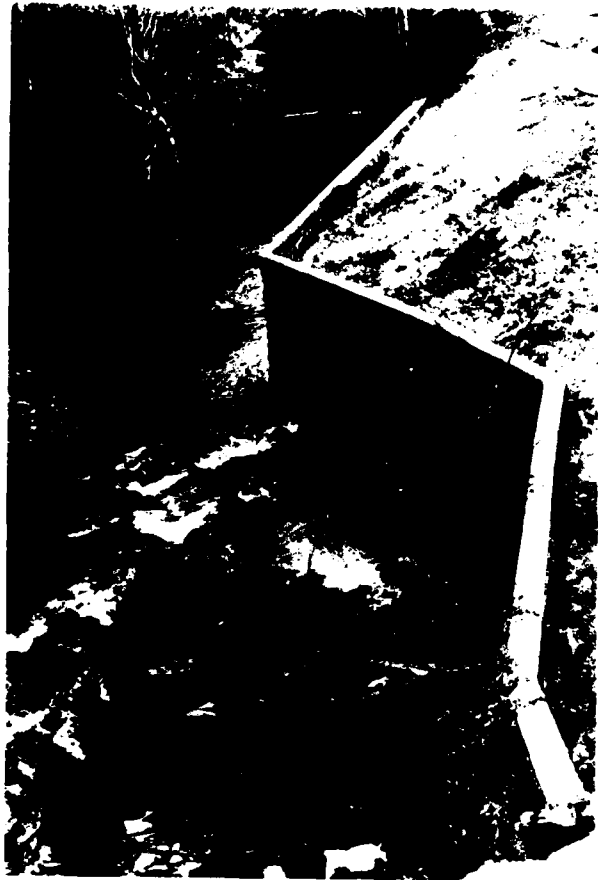
- e. **Downstream Channel:** The spillway and downstream channel retaining walls appear to be founded on bedrock and are generally in fair condition (Photo 11). Some trees overhang the west side of the channel and access to this side is difficult. There is a metering weir about 440 feet downstream of the spillway which appears to be in good condition. On the right side of the spillway channel just below the face of the dam there are some holes behind the retaining walls noted. The cause is unknown; however, it appeared to be related to erosion.

C-11 400' ELEVATION RETAINING WALL -  
LOOKING FROM WEST CLIFF
