HOUSATONIC RIVER BASIN
DANBURY, CONNECTICUT

MARGERIE LAKE RESERVOIR DAM
CT 00063

PHASE I INSPECTION REPORT
NATIONAL DAM INSPECTION PROGRAM

DECEMBER 1978

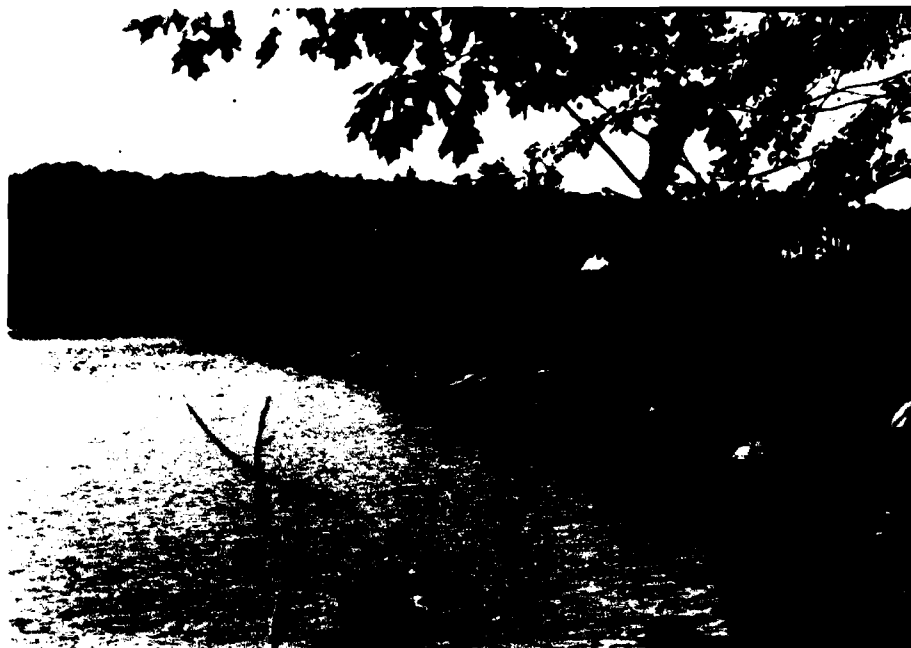
3. Upstream slope of north dike from right abutment.

3. Two small chuckholes in the main dam approximately 40 ft. left of the spillway left training wall should be filled.
4. Riprap missing on the upstream slope of the north dike should be replaced in the area adjacent to the earth ramp near the center of the dike.
