WAUBEEKA LAKE DAM

CT 00065

DANBURY, CONNECTICUT

PHASE I INSPECTION REPORT

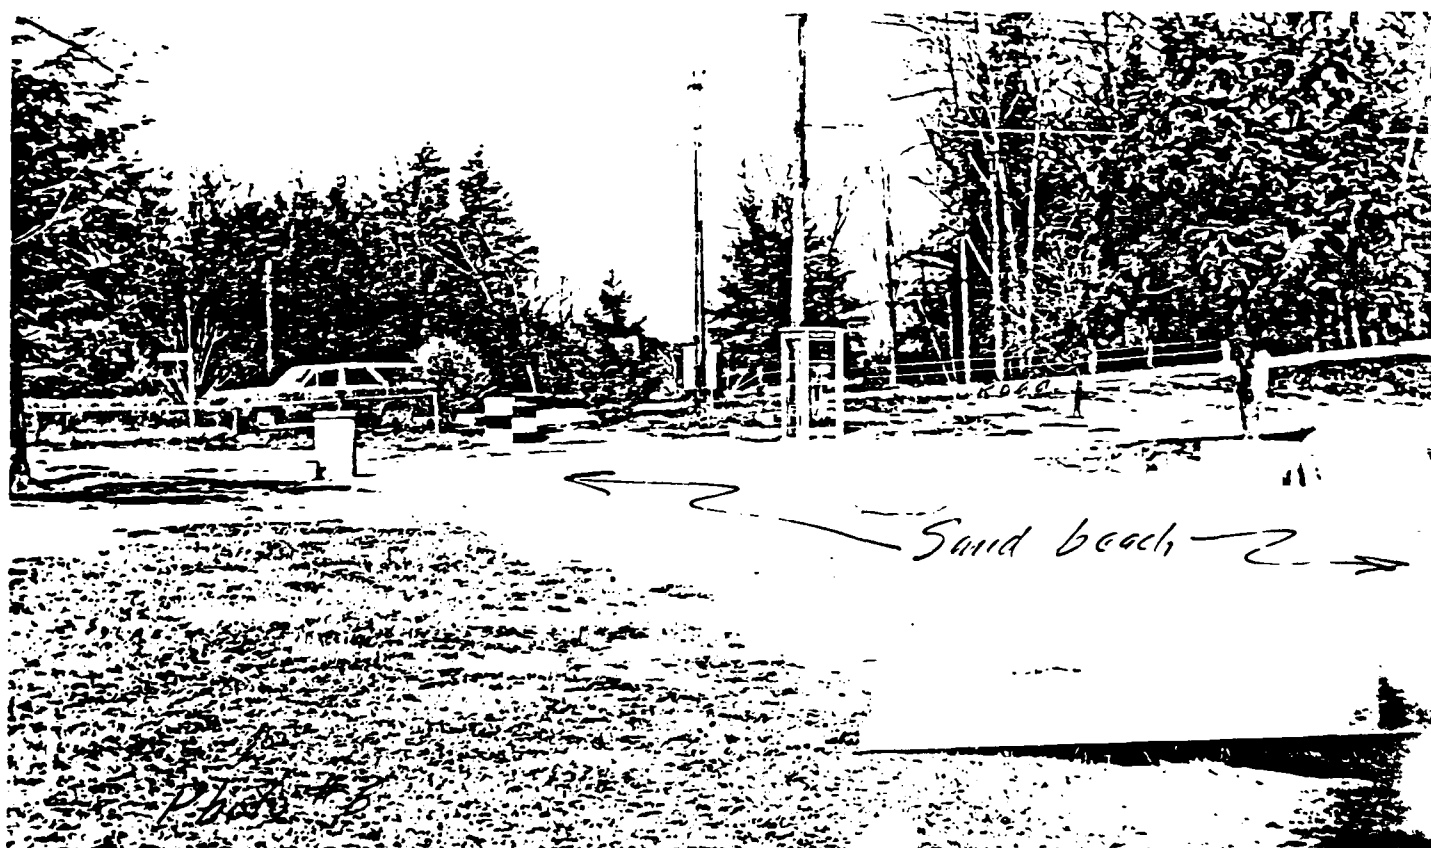
Looking  $\pm$  N.W. over part of back.  
Road in background. Photo #6 shows  
area to right of this photo.
