**PEMBERWICK DAM  
CT 00042**

**PHASE 1 INSPECTION REPORT  
NATIONAL DAM INSPECTION PROGRAM**

**DEPARTMENT OF THE ARMY  
NEW ENGLAND DIVISION, CORPS OF ENGINEERS  
WALTHAM, MASS.**

**FEBRUARY, 1980**

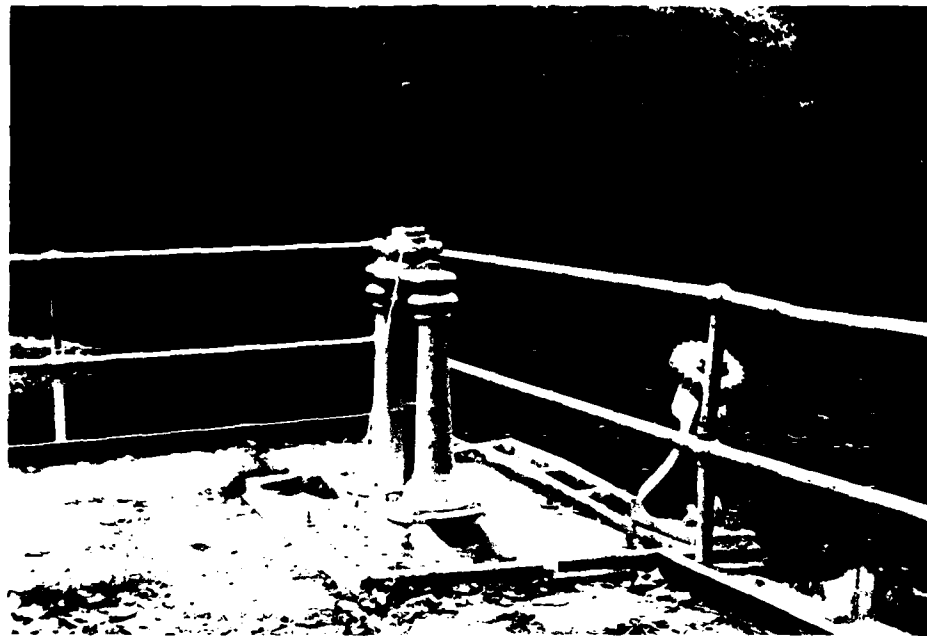
The outlet works, consisting of pipes through the dam, have been inoperable for many years. The high level outlet was sealed in 1978 to control leakage and the inlet for the low level outlet is suspected to be below the present sediment level.

C-5 OUTLET WORKS CONTROL MECHANISM

4. The damaged fence on the west abutment should be repaired.
5. The seepage on the downstream face should be monitored to note any change from the existing conditions.
6. The low level outlet should be brought back to an operating condition to allow the pond to be lowered.
7. Institute a program of annual periodic technical inspection with special emphasis on the joint between the dam and the rock abutments at the valley walls.
8. Develop a formal flood warning and surveillance plan, including round-the-clock monitoring during heavy precipitation.
