CONNECTICUT COASTAL BASIN

# CHASMARS POND DAM CT 00059

## PHASE I INSPECTION REPORT NATIONAL DAM INSPECTION PROGRAM

MAY 1981

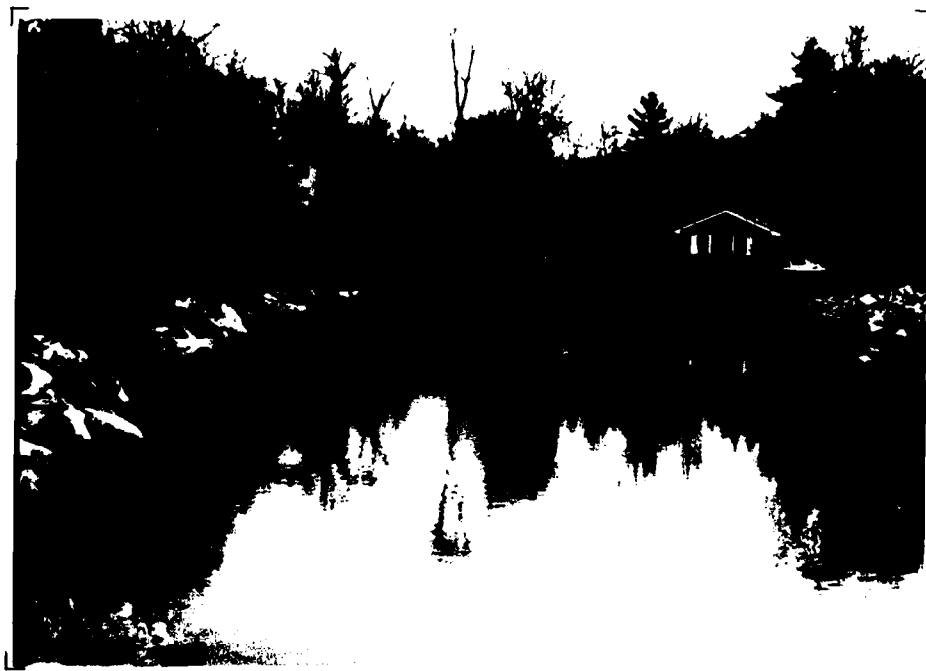
Photo 10 Downstream home along Fivemile River within impact area.
