CONNECTICUT WESTERN COASTAL AREA
STAMFORD - NEW CANAAN, CONNECTICUT

LAUREL RESERVOIR DAM
CT 00049

PHASE I INSPECTION REPORT
NATIONAL DAM INSPECTION PROGRAM

AUGUST 1978

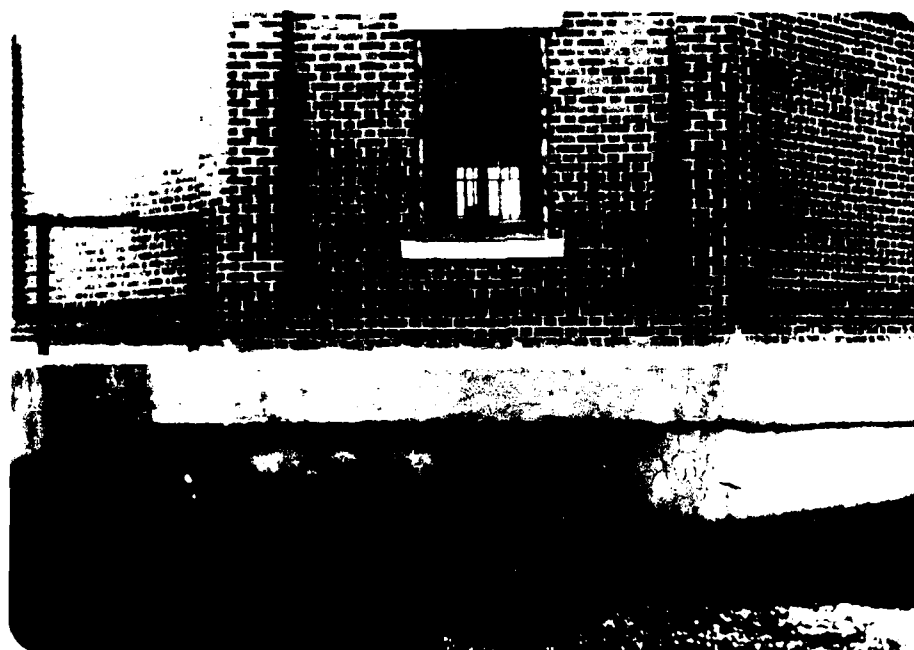
PHOTO #9: Control Tower.

AREA EVALUATED	CONDITION
<u>OUTLET WORKS - CONTROL TOWER</u>	
a. Concrete and Structural	
General Condition	Concrete (gunite) in good condition, some spalling at water line
Condition of Joints	
Spalling	
Visible Reinforcing	None observed
Rusting or Staining of Concrete	None
Any Seepage or Efflorescence	None
Joint Alignment	
Unusual Seepage or Leaks in Gate Chamber	
Cracks	Gunite separating from original concrete at bottom of application (2'-3' below water line)
Rusting or Corrosion of Steel	None
b. Mechanical and Electrical	
Air Vents	
Float Wells	
Crane Hoist	
Elevator	
Hydraulic System
