**SOUTHWESTERN COASTAL BASIN  
GREENWICH, CONNECTICUT**

**AMERICAN FELT DAM  
CT 00043**

**PHASE 1 INSPECTION REPORT  
NATIONAL DAM INSPECTION PROGRAM**

**FEBRUARY, 1980**

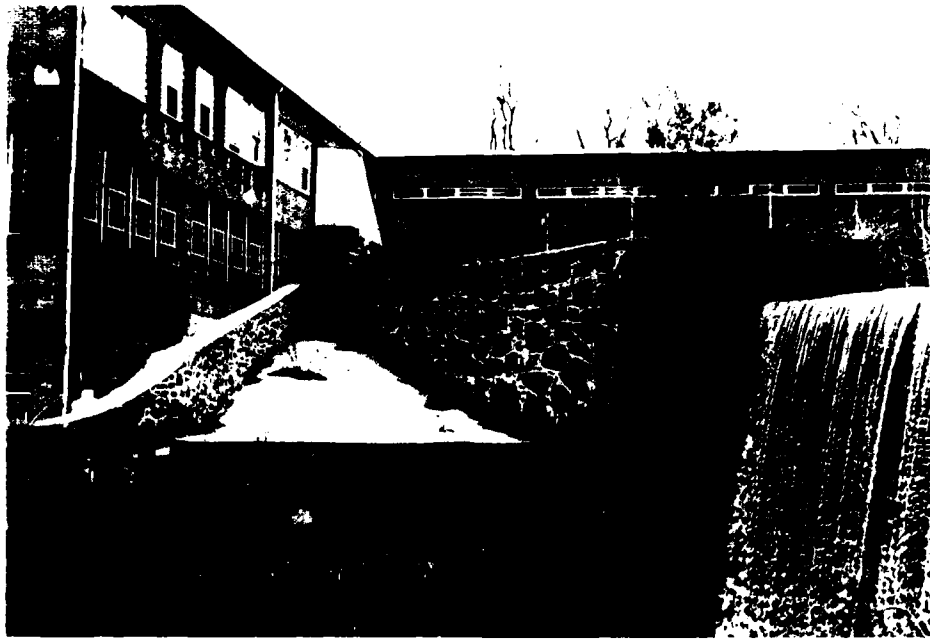
C-7 WEST OVERFLOW CHANNEL
