PRITCHARDS POND DAM
CT 00033

NAUGATUCK RIVER BASIN
WATERBURY, CONNECTICUT

PHASE I INSPECTION REPORT
NATIONAL DAM INSPECTION REPORT

Name of Dam : Pritchards Pond Dam
Identification Number : CT 00033
Town : Waterbury
County and State : New Haven County, Connecticut
Stream : Hopeville Pond Brook
Owner : Risdon Manufacturing Company, 2100 South Main Street,
Waterbury, Connecticut
Date of Inspection : December 3, 1980

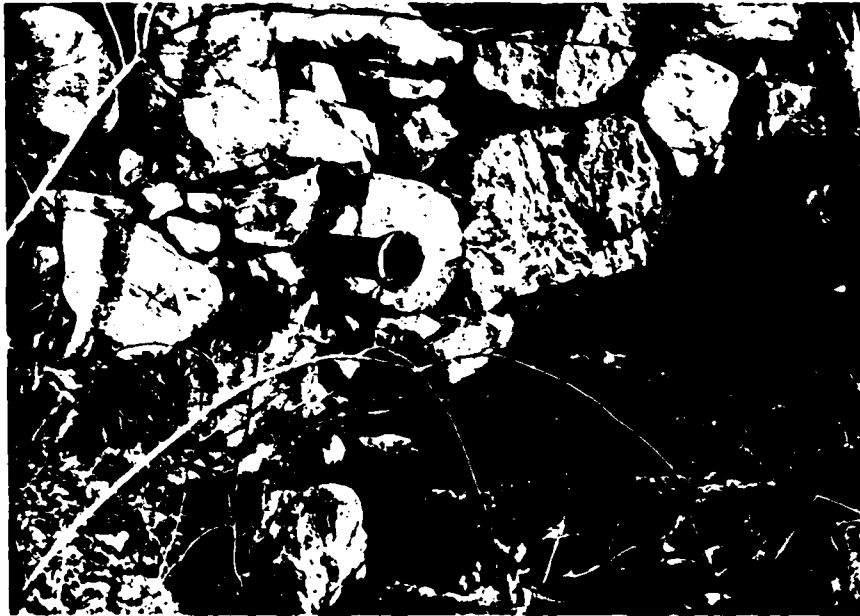
6. Spillway and outlet discharge pipes.

AREA EVALUATED	CONDITION
<p><u>OUTLET WORKS - TRANSITION AND CONDUIT</u></p> <p>General Condition of Concrete</p> <p>Rust or Staining on Concrete</p> <p>Spalling</p> <p>Erosion or Cavitation</p> <p>Cracking</p> <p>Alignment of Monoliths</p> <p>Alignment of Joints</p> <p>Numbering of Monoliths</p>	<p>6" Cast Iron Pipe protruding from d/s face of dam.</p>
