HOUSATONIC RIVER BASIN  
DANBURY, CONNECTICUT

EAST LAKE RESERVOIR DAM

CT. 00066

PHASE I INSPECTION REPORT  
NATIONAL DAM INSPECTION PROGRAM

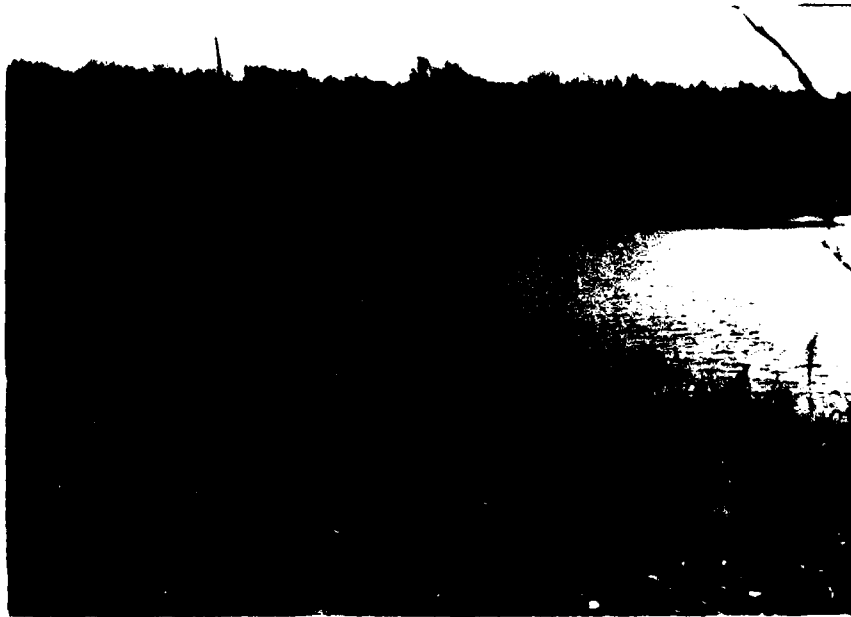
Overview from left abutment

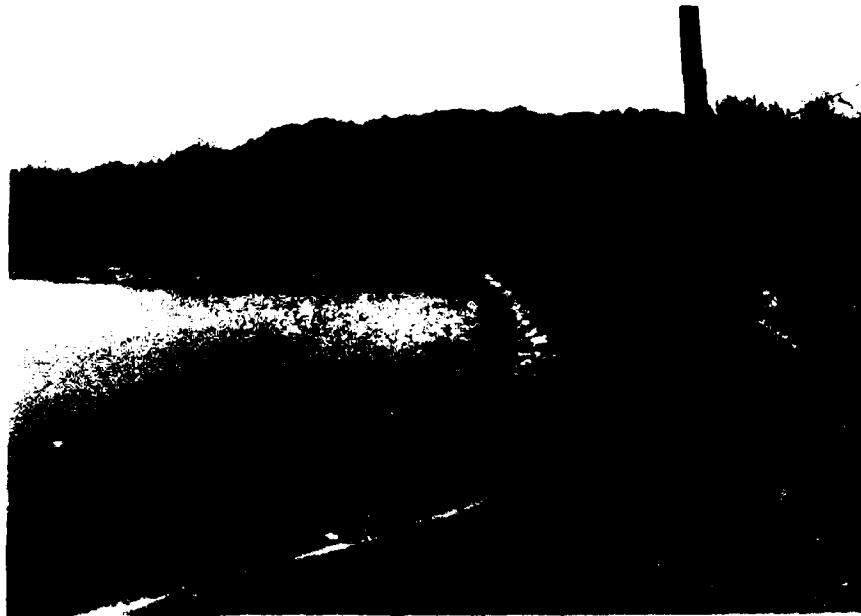
Overview from right abutment

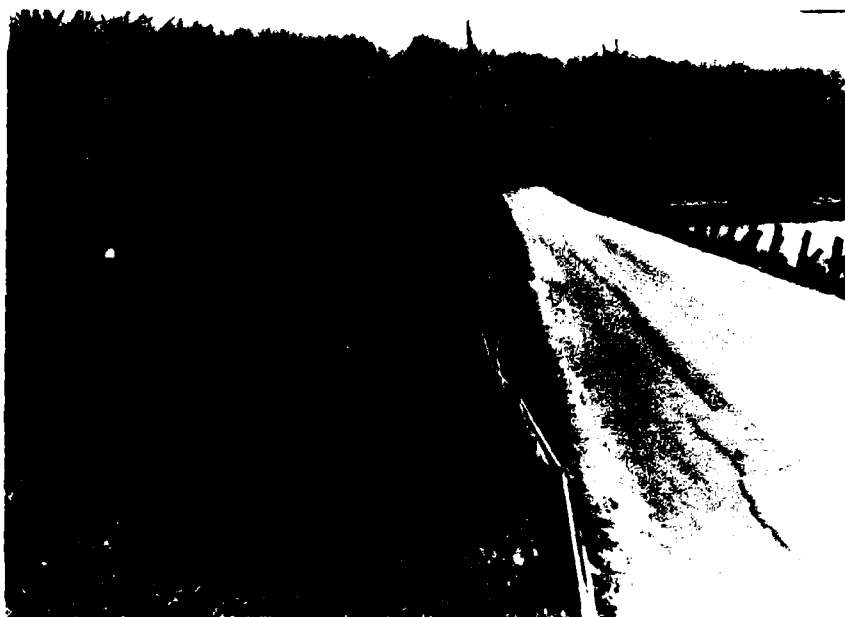
The downstream slope of the dam is also very steep at the top and it would seem that the highway has been raised and widened without a corresponding fattening of this slope. Within the west third of the dam, for example, longitudinal cracks are evident in the surface of the road indicative of sloughing. There is also as much as 2-3 ft. differential between gutter and crown on the downstream side. The tilting of the guard rail posts associated with slope sliding is illustrated in Photo No. 1 (Appendix C).

1. Downstream slope from left abutment

1. Growth on the slopes and at the downstream toe of the dam should be removed and controlled on a regular basis.
2. Seepage zones should be isolated and monitored monthly during periods of high reservoir level, and at least once a year, for changes in seepage volume and turbidity. Seepage zones noted are in the vicinity of the main outlet valve house and from 25-50 ft. downstream, and in the area at the toe of the left abutment.
3. Rodent infestation of the embankment should be controlled.
4. At the main outlet, the outlet pipe valve and bypass valve should be inspected both for operability and leakage. The 12 in. dia. outlet valve at the left abutment should also be inspected. All valves found to require repair should be restored to a serviceable condition.

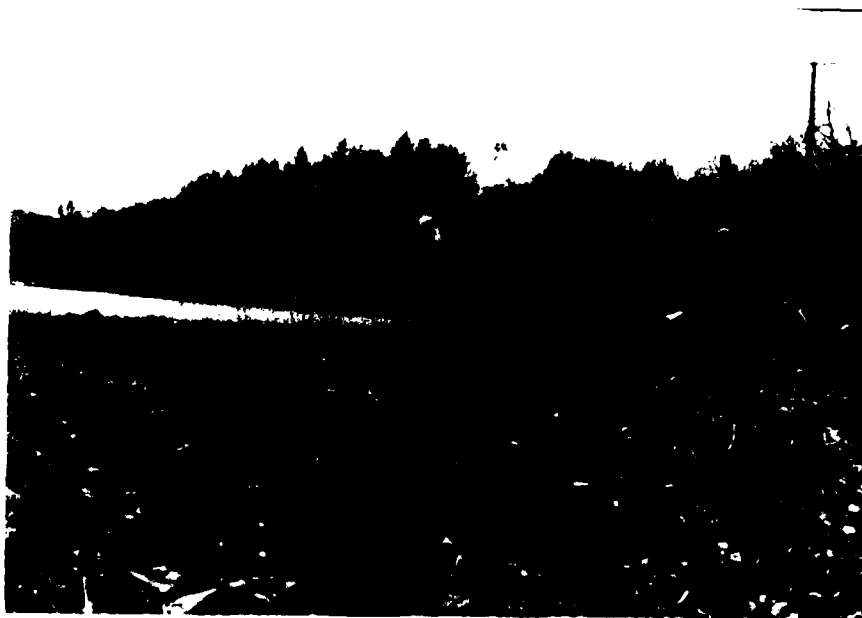
3. Spillway sill and discharge channel, looking towards reservoir

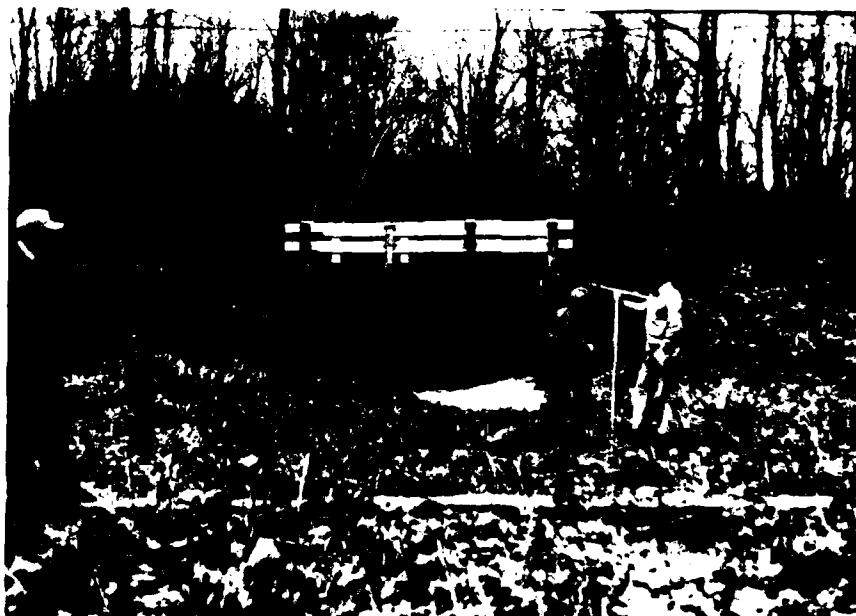
The highway bridge over the spillway channel appears of more recent construction and probably replaces an original bridge which had a much wider waterway. Although the

4. Spillway sill and discharge channel looking downstream, showing bridge

1. Determine whether additional spillway capacity is required, and whether the bridge across the outlet channel should be lengthened or the outlet channel deepened.
2. Determine the source of apparent leakages at and downstream of the toe of the embankment in the vicinities of the 16 in. dia. main outlet and the 12 in. dia. left abutment outlet pipes.
3. Examine the configuration of the roadway on the crest of the dam and provide for its adequate support by the dam embankment.
