HOUSATONIC RIVER BASIN
DANBURY, CONNECTICUT

EUREKA LAKE DAM
CT 00077

PHASE I INSPECTION REPORT
NATIONAL DAM INSPECTION PROGRAM

AUGUST, 1979

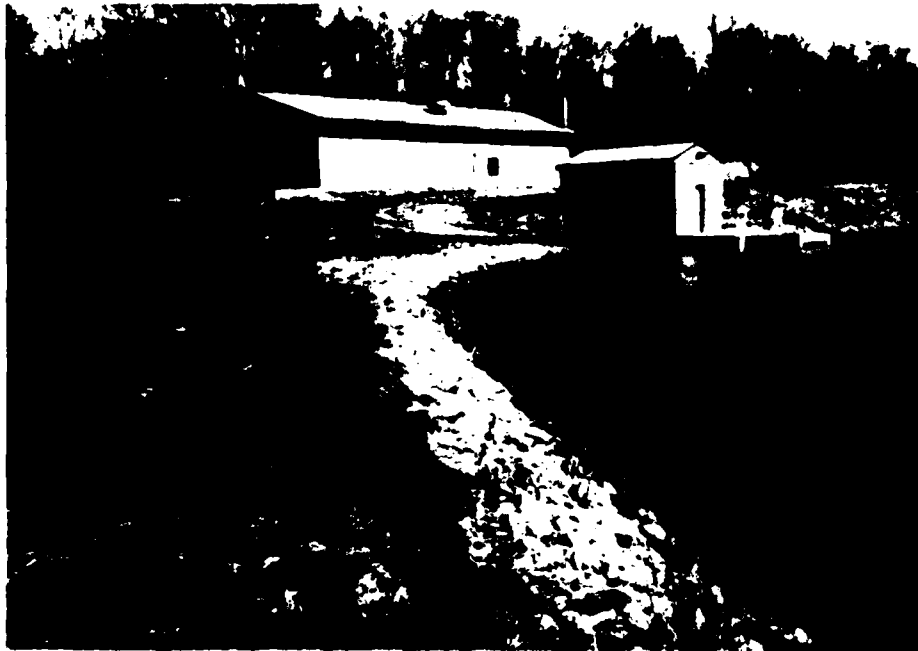
Crest - The crest of the dam has a grass and weed cover. No misalignment, visible depressions or cracks were observed (Photo 1).

Upstream Slope - The slope protection is hand-placed riprap which did not have any visible displacements or areas needing replacement, although there is some vegetation between the stones (Photo 1).

Photo 1 - Crest and upstream slope of reservoir dam from left end
(May 1979)

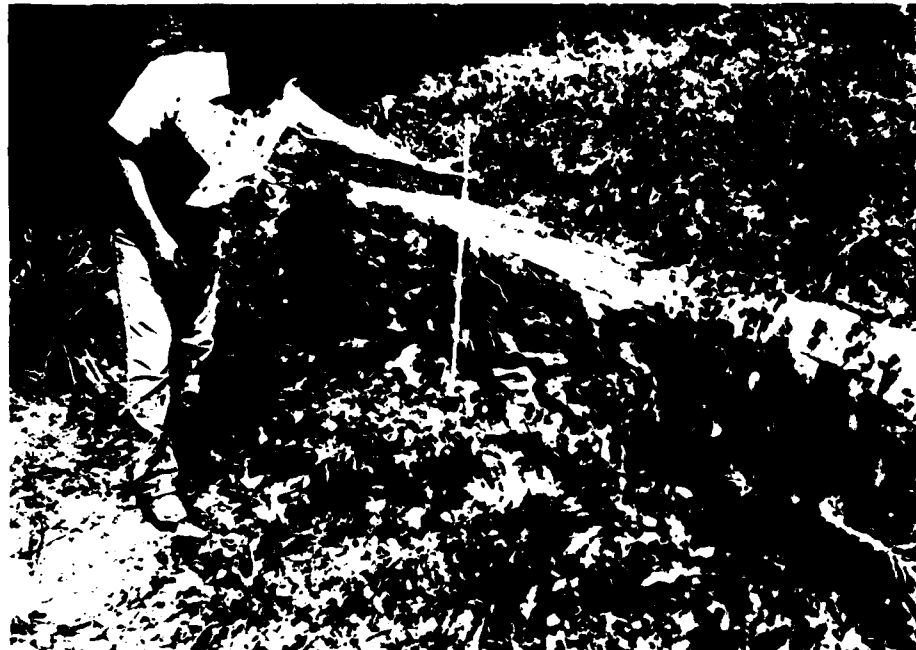
Photo 8 - Masonry training wall of spillway channel from upstream. Note large crack at base of wall (August 1979)
