**SOUTHWESTERN COASTAL BASIN
NEW CANAAN, CONNECTICUT**

**.NEW CANAAN RESERVOIR DAM
CT 00055**

**PHASE 1 INSPECTION REPORT
NATIONAL DAM INSPECTION PROGRAM**

FEBRUARY, 1980

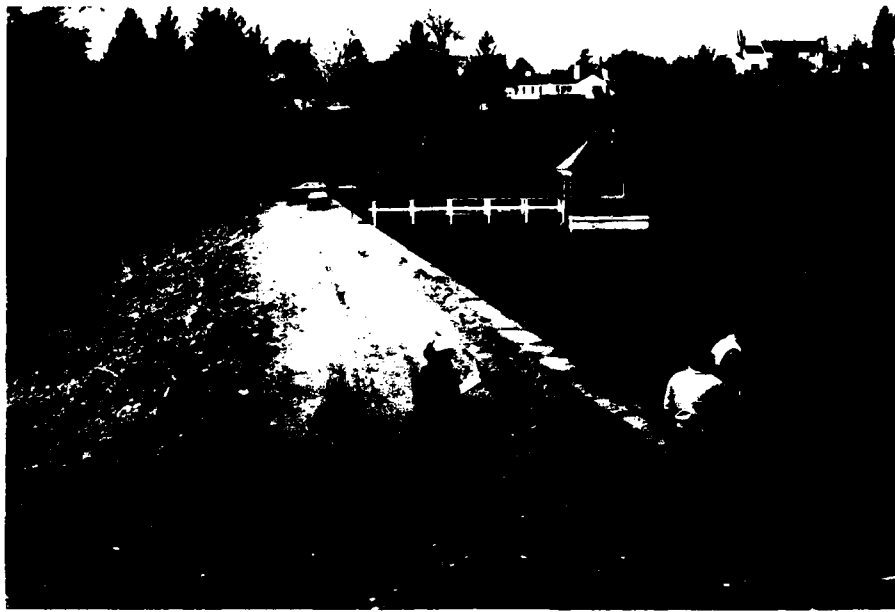
1. **Crest:** In general, the top of the dam is level with no indication of misalignment or settlement although it has been recently regraded indicating possible past settlement. The top of the dam is earth with a low concrete wall on the upstream side (Photos C-1, C-2). A road traverses the entire length of the dam and is carried over the spillway on a steel bridge with a timber deck (Photo C-4). Minor rusting of the steel was noted and the wood deck is slightly deteriorated. Reportedly, this bridge is too narrow to provide access for chemical trucks to the filter house. The top has an average width of approximately 21 feet.

C-1 CREST OF DAM - LOOKING FROM EAST ABUTMENT

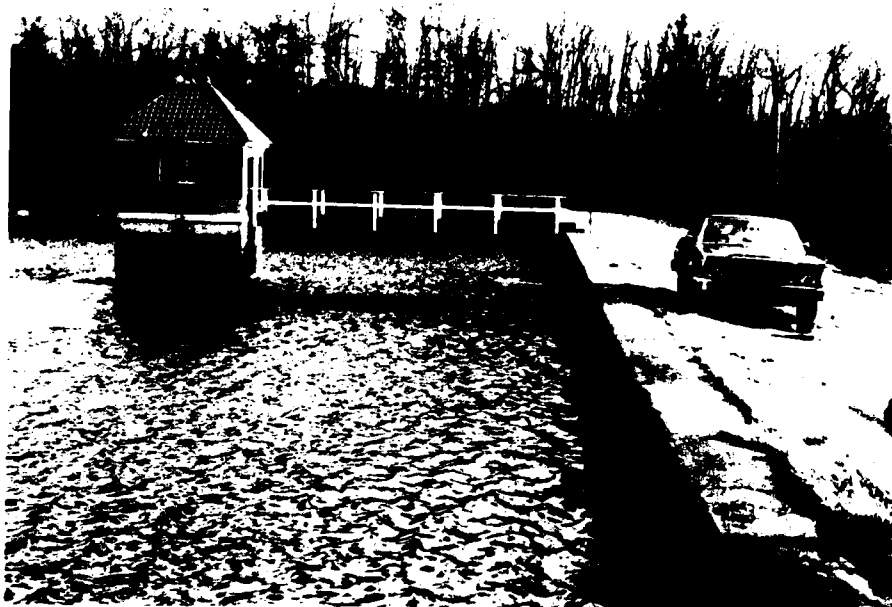
4. **Gate House:** The gate house is a concrete and brick structure located in the reservoir 38 feet upstream of the dam and is generally in good condition (Photo C-2). Access to the house is via a steel service bridge with a timber deck (Photo C-8). The steel portion appears sound; however, the deck is deteriorating and the wood railing is in poor condition.

C-2 DAM CREST AND GATE HOUSE - LOOKING EAST

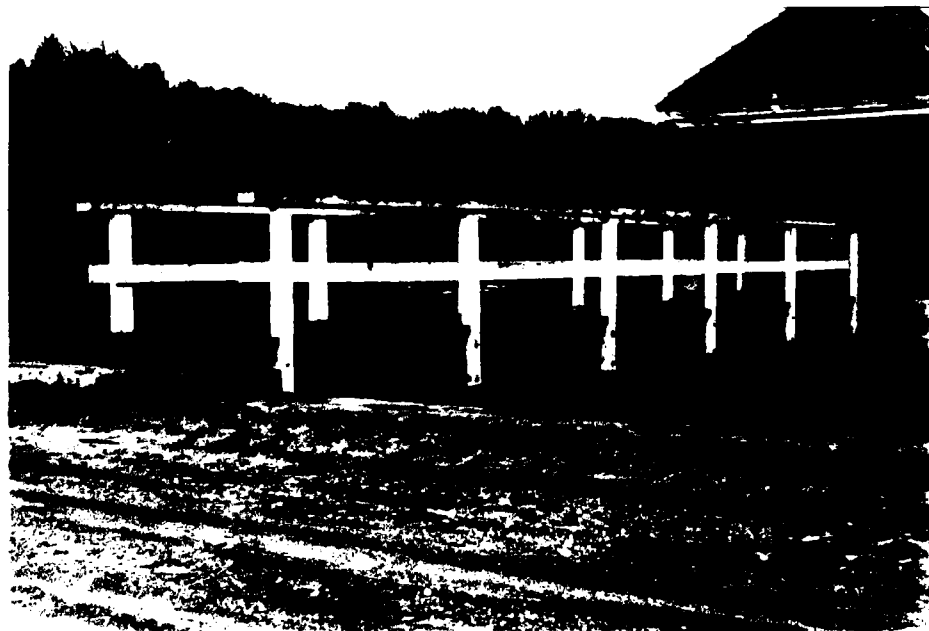
C-8 GATE HOUSE AND SERVICE BRIDGE

The timber decks and the railing of the service bridges and the spalling concrete surfaces of the wall along the upstream face of the dam, the spillway wingwalls and training walls should be rehabilitated.

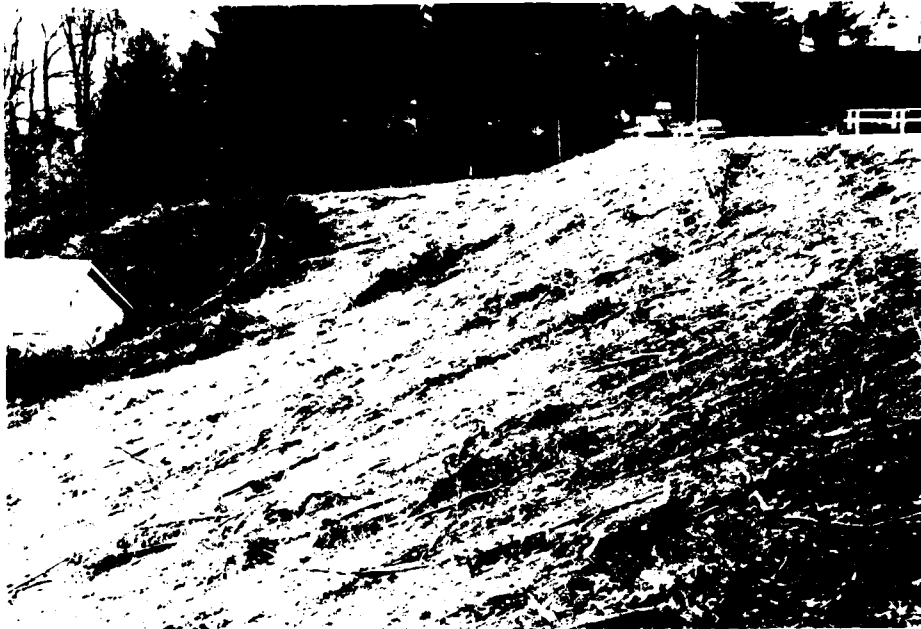
3. **Downstream Slope:** The downstream face is an earth embankment with a slope of approximately 3H:1V (Photos C-13, C-14). There is a rock outcrop in the center of the embankment at the toe. Evergreen trees which were planted on the embankment in the early 1940's had recently been cut; however, the stumps remain. Because of the recent removal of the trees, the slope is essentially unvegetated, resulting in the formation of minor gullies from storm runoff. A few trees remain along the edges of the dam primarily along the spillway discharge channel. Seepage was noted from one location at each edge of the embankment, both with steady clear flows of 5 to 10 GPM (Photo C-16). These have reportedly been in existence since at least 1932. Other wet spots on the embankment were noted, although they may have been due to a recent rainfall (Photo C-15).

C-13 DOWNSTREAM FACE OF DAM - LOOKING WEST

1. Ground cover vegetation should be established on the downstream face as soon as possible.
2. The remaining trees on the edges of the embankment should be removed.
3. The seepage on the downstream slope should be monitored to note any change from the existing conditions.
4. The concrete wall on the upstream face of the dam, the spillway wing-walls, training walls, and discharge channel floor should be rehabilitated to their original condition.
5. The deck of the service bridge to the gate house should be rehabilitated.
6. Institute a program of annual periodic technical inspection.
7. Develop a formal flood warning and surveillance plan, including round-the-clock monitoring during heavy precipitation.

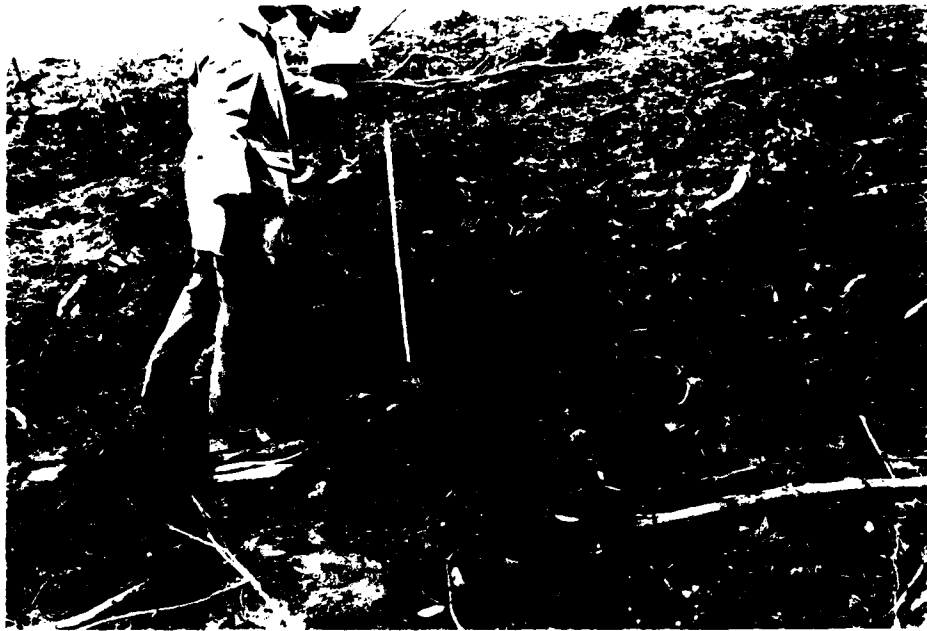
C-15 TYPICAL WET SPOT ON DOWNSTREAM FACE

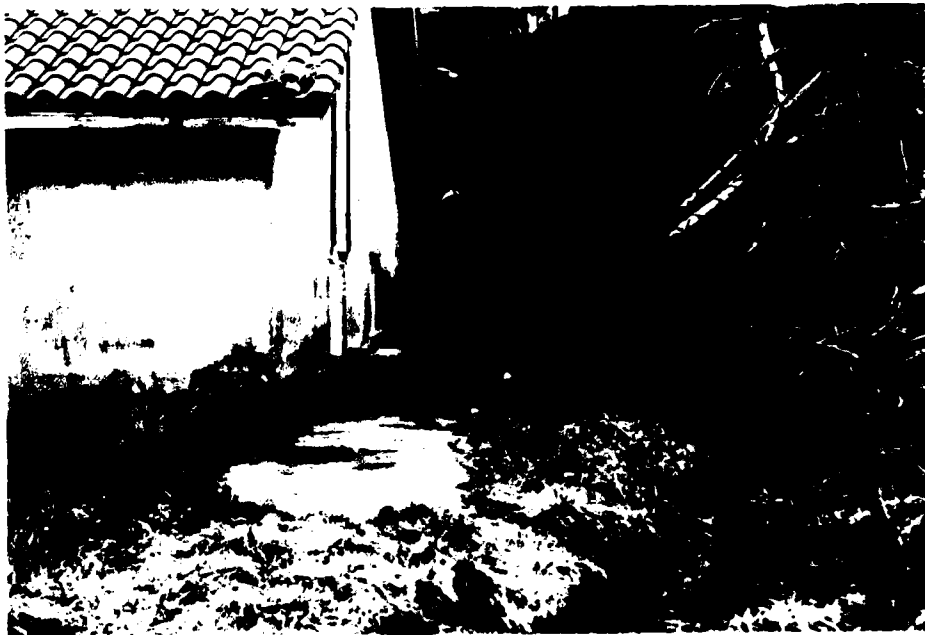
Visual observations of the earth embankment, overflow spillway, and outlet structure did not disclose any signs of major structural instabilities. However, slight seepage is surfacing somewhat below mid-height of the dam embankment near the east crotch (with the point of seepage emergence covered by recently felled trees), and at about the level of the toe in the west crotch. Because the geometry of the core in the dam is unknown, the flow path for the observed seepage cannot be estimated.

C-16 SEEPAGE POINT (UNDER TREE PILE) AND FLOW FROM SEEPAGE (LOWER RIGHT CORNER OF PHOTO)

- c. Investigate the significance of the seepage observed on the downstream face of the dam embankment, and the composition and adequacy of the embankment; and develop any necessary remedial actions.
