N. STAMFORD RESERVOIR DAM

CT. 00048

PHASE I INSPECTION REPORT
NATIONAL DAM INSPECTION PROGRAM

FEBRUARY 1979

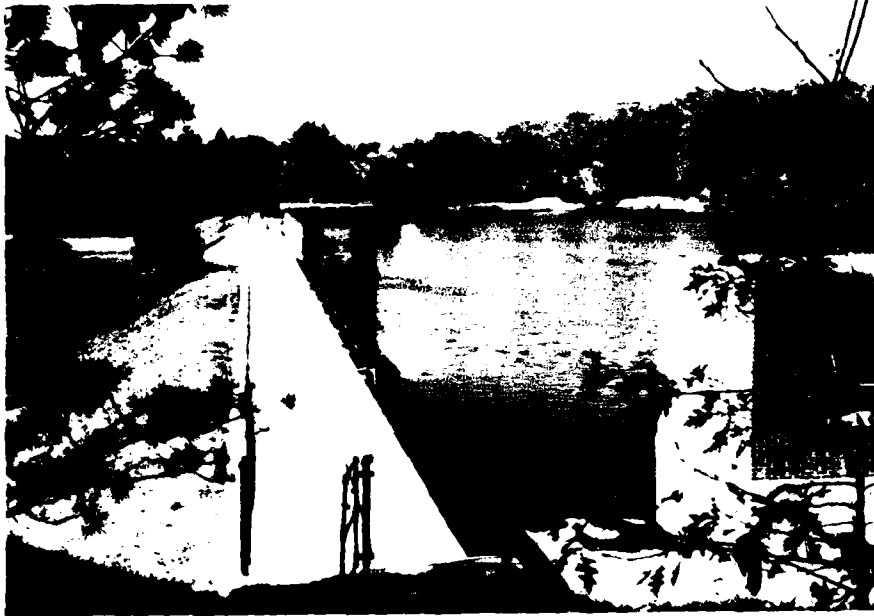
Overview from left abutment: gravity section foreground, spillways right background.

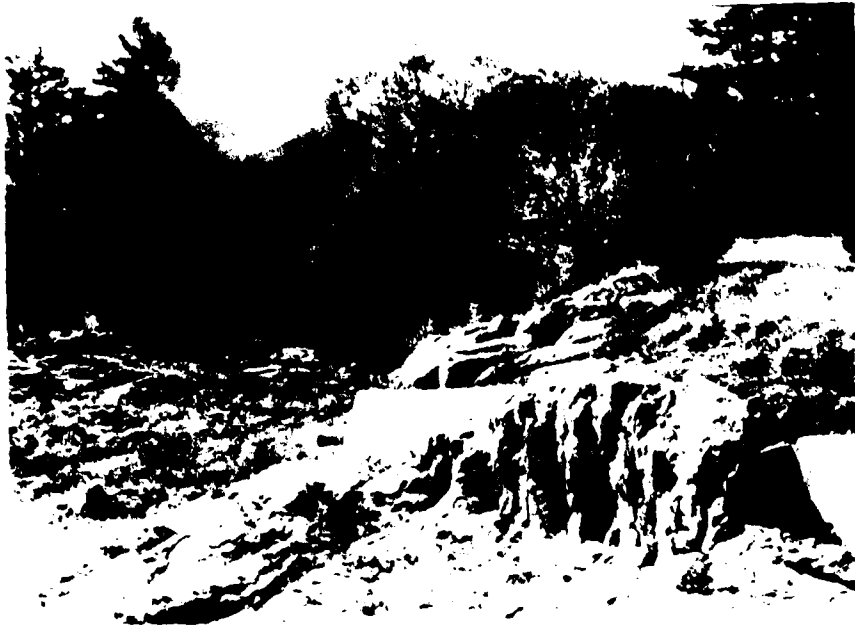
11. Downstream channel from new spillway section, showing highway bridge.
