<sup>2</sup> SAMUEL P. SENIOR RESERVOIR DAM  
(CT 00108)  
and  
POPPS MOUNTAIN DIKE  
(CT 00022)

<sup>5</sup> PHASE I INSPECTION REPORT  
<sup>1</sup> NATIONAL DAM INSPECTION PROGRAM

PHASE I INSPECTION REPORT  
SAMUEL P. SENIOR DAM CT 00108

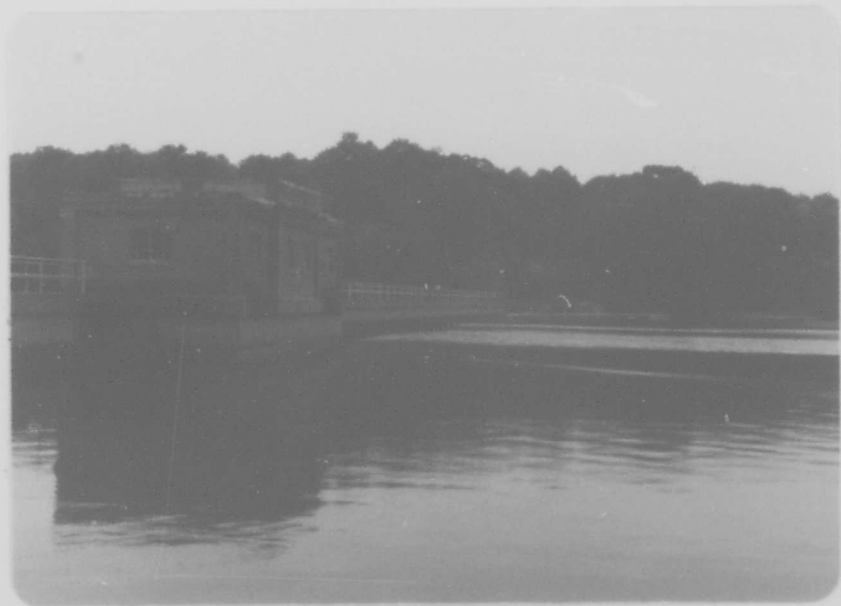
1) Upstream Face - At or above the water line, slight spalling was evident. Generally the concrete was in good condition.

2) Upper Gate House - This structure, located on upstream face of dam, was clean and neat. Gates are reportedly operated once a year, and were inspected by divers in 1977 with minor repair work required at stem guides. There are cracks in the brickwork in the northwest, west, and southwest walls. The cracks are wide enough to allow daylight through in some places. The building has 100 amp, 240 volt electrical service for lights and a deicer which is located adjacent to the spillway.

PHOTO #4: Upstream face of the dam and upper gate house.

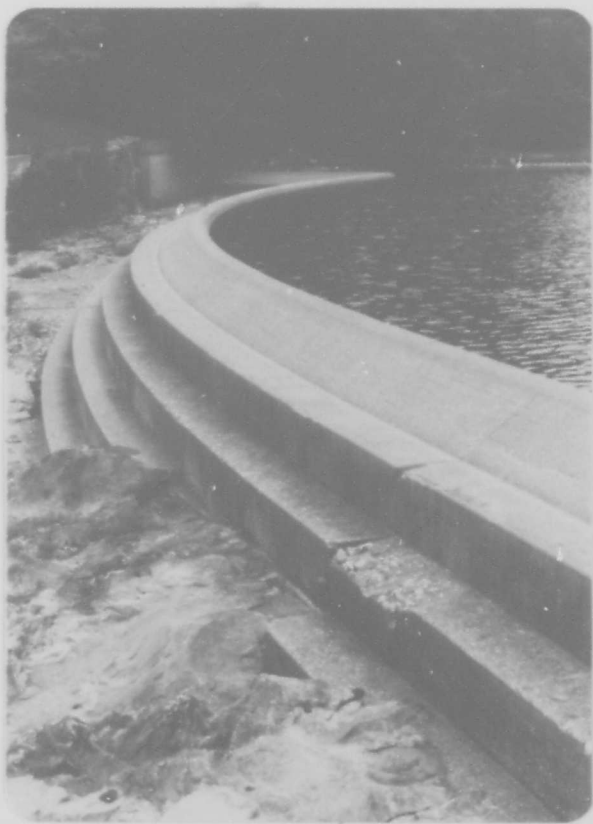
3) Spillway - The concrete in the spillway and steps was found to be in generally good condition. A crack was noted at the crest of the spillway, where it meets the training wall. Some surface spalling of the concrete steps was observed.

PHOTO #5: View of the spillway, looking west.

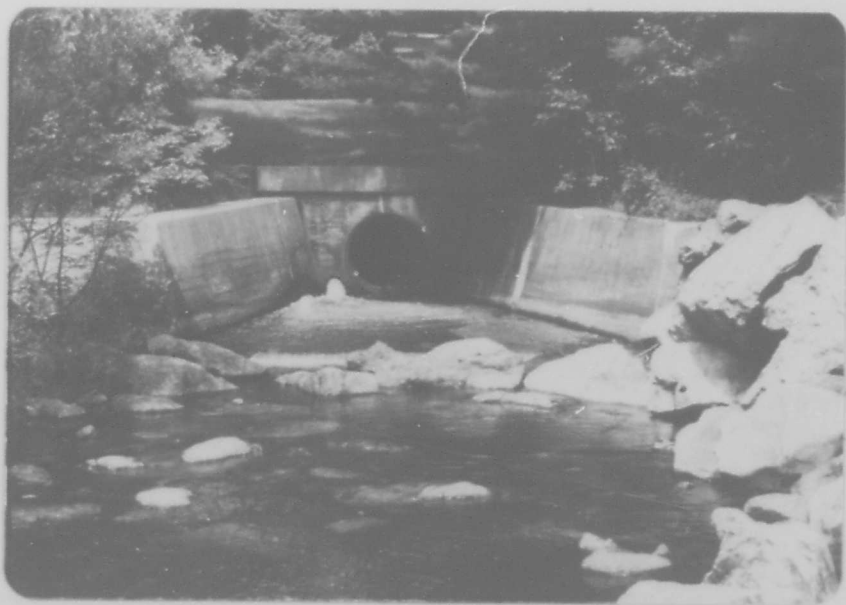
1) Spillway Channel - The spillway channel is in good condition. Low concrete walls on the right and left side of the channel are also in good condition. Layered mica gneiss bedrock is exposed in the bottom of the spillway channel from the spillway weir to the large pool at the end of the left concrete training wall. A small amount of seepage was noted in the channel floor. A rock fall has occurred in the upper part of the channel from its east bank, however, it does not restrict flow. The blow-off discharge structure is in excellent condition.

PHOTO #8: Blow-off discharge point, showing the wingwalls and riprap.

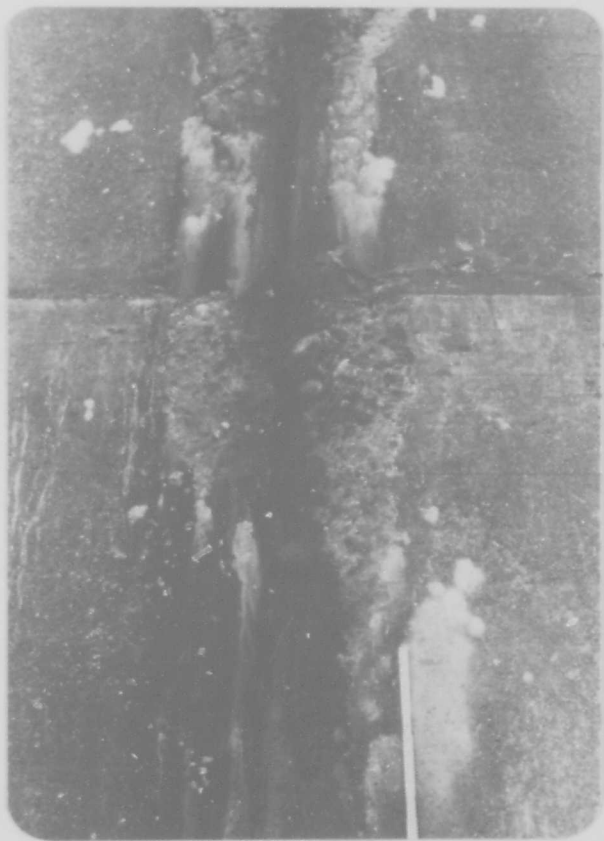
2) Downstream Face - There was evidence of wet spots, staining, efflorescence and joint spalling at nearly every construction joint. From Station 1+90 to Station 2+30 about 30 feet above the berm there was a horizontal line of efflorescence at a horizontal pour joint. In the panel between Station 3+45 to 3+85, about 10 feet up from the top of the berm, there are four drilled holes about 2 inches in diameter, depth undetermined, spaced 3 to 4 feet apart horizontally, which were dry but showed evidence of efflorescence (the purpose of these holes is unknown). There was quite a bit of spalling below the holes and some slight spalling above them. The joint at Station 3+85 was wet and stained from about the berm to a height of 35 feet. For about 20 feet from the top of berm, the joint was badly spalled and quite deteriorated.

PHOTO #9: Typical spalling at a construction joint.

1) Spalling at joints along the downstream face should be repaired.

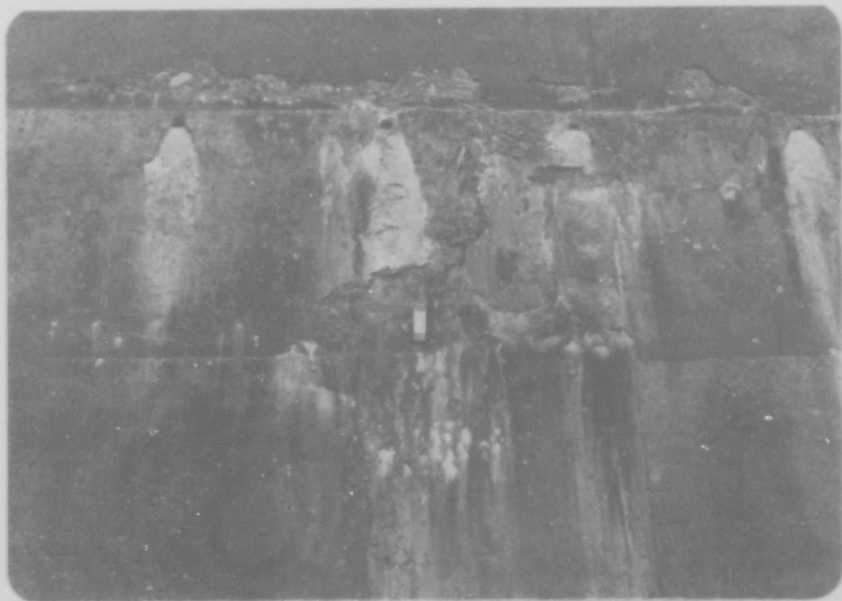
PHOTO #10: Holes cored in concrete dam-purpose unknown.

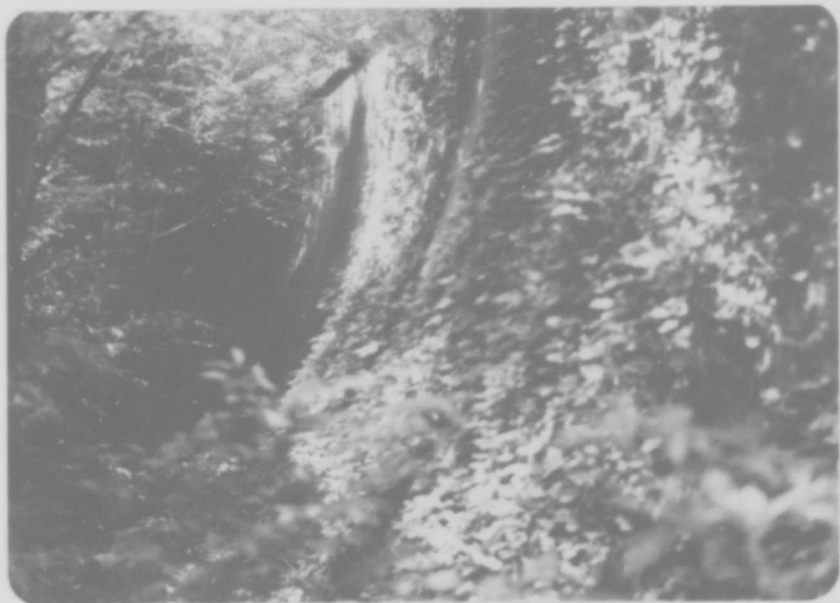
b. Dike. Visual observations indicated that the dike was in good condition. Although spalling has occurred at several joints, this does not affect the stability of the dike.

PHOTO #13: Downstream face of the concrete dike.
