HOUSATONIC RIVER BASIN,  
DANBURY, CONNECTICUT.

WEST LAKE RESERVOIR DAM  
( CT 00070 )

PHASE I INSPECTION REPORT.  
NATIONAL DAM INSPECTION PROGRAM

JULY 1980

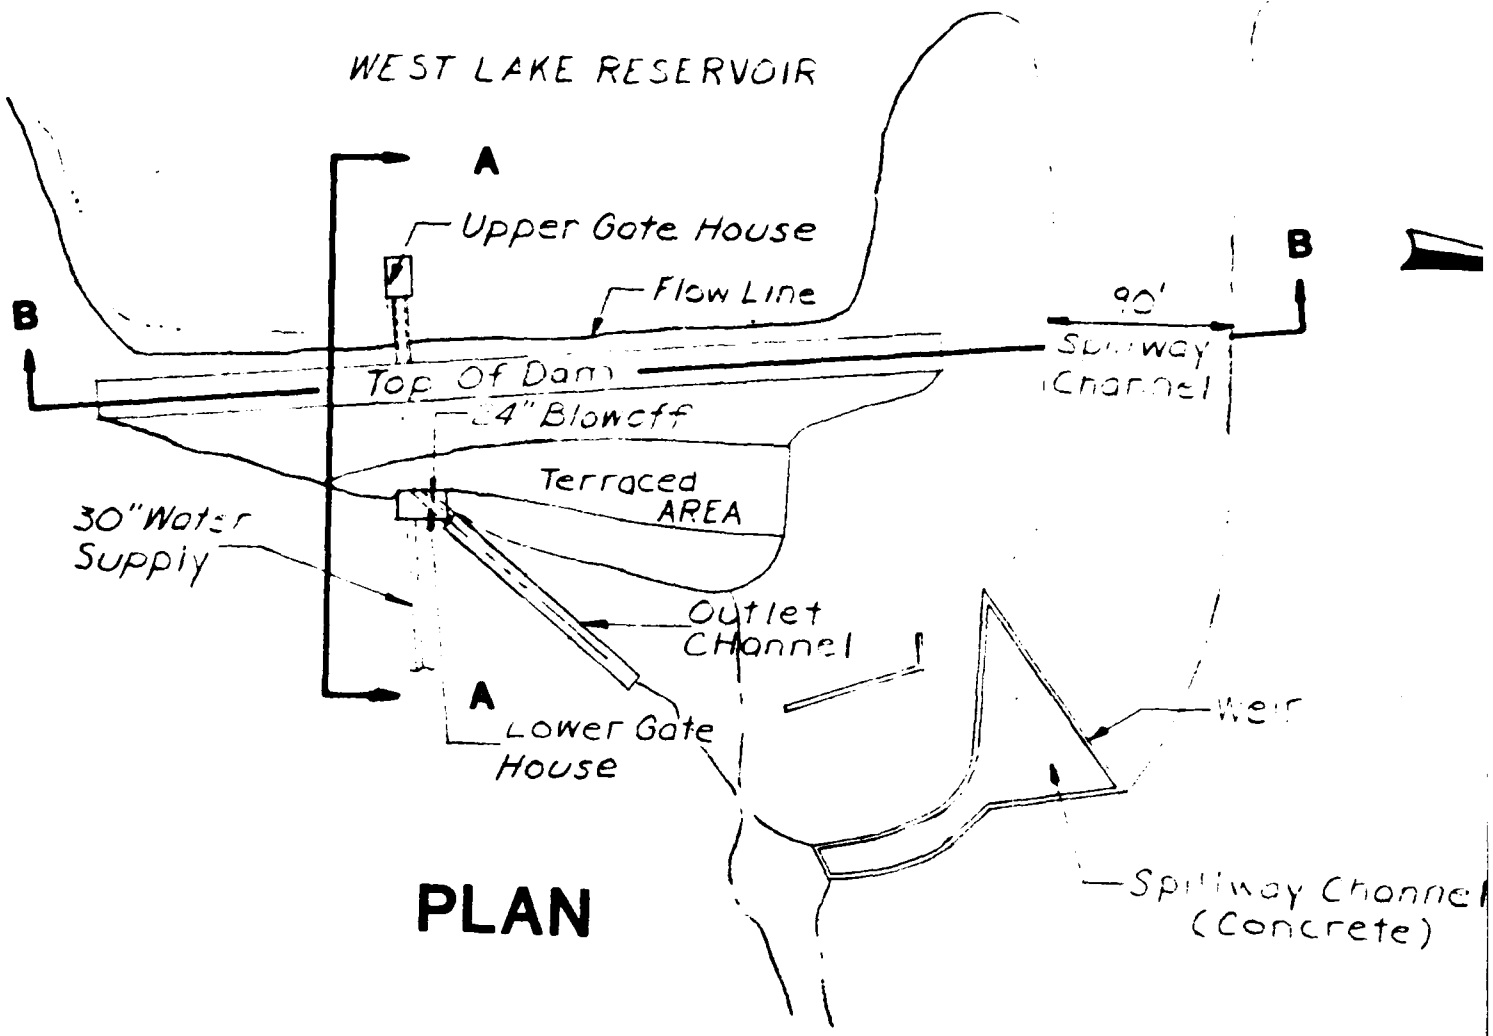
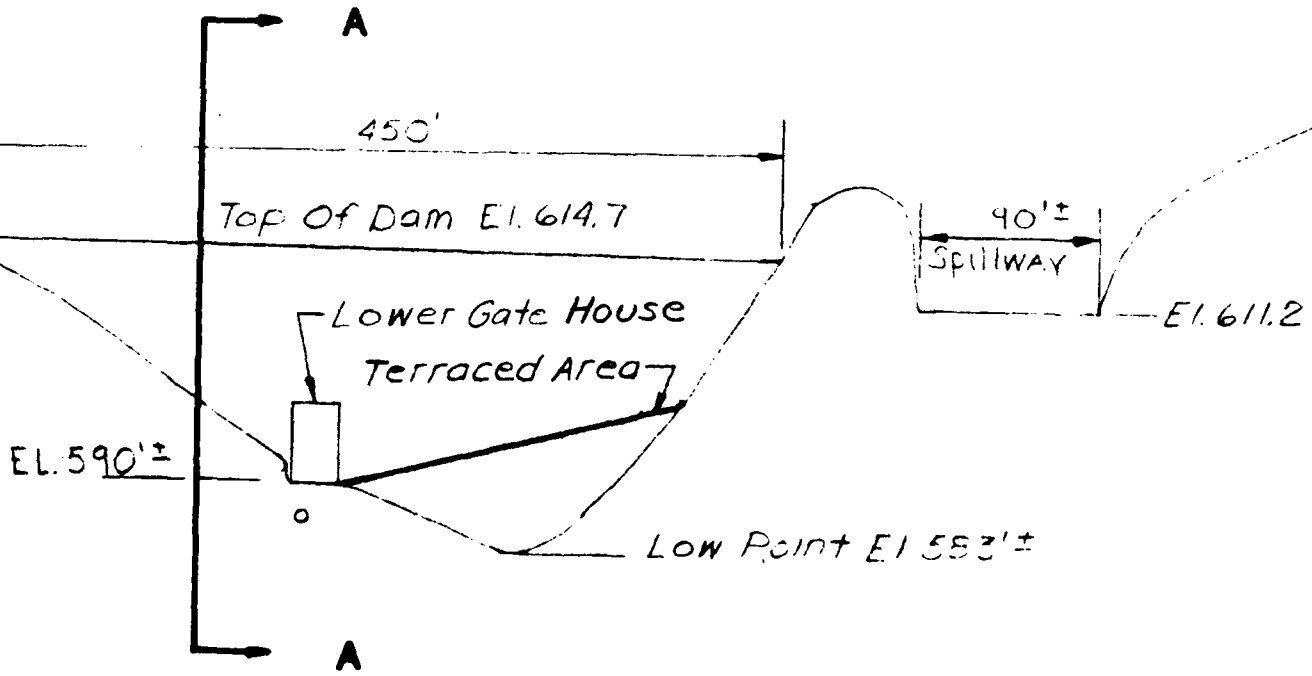
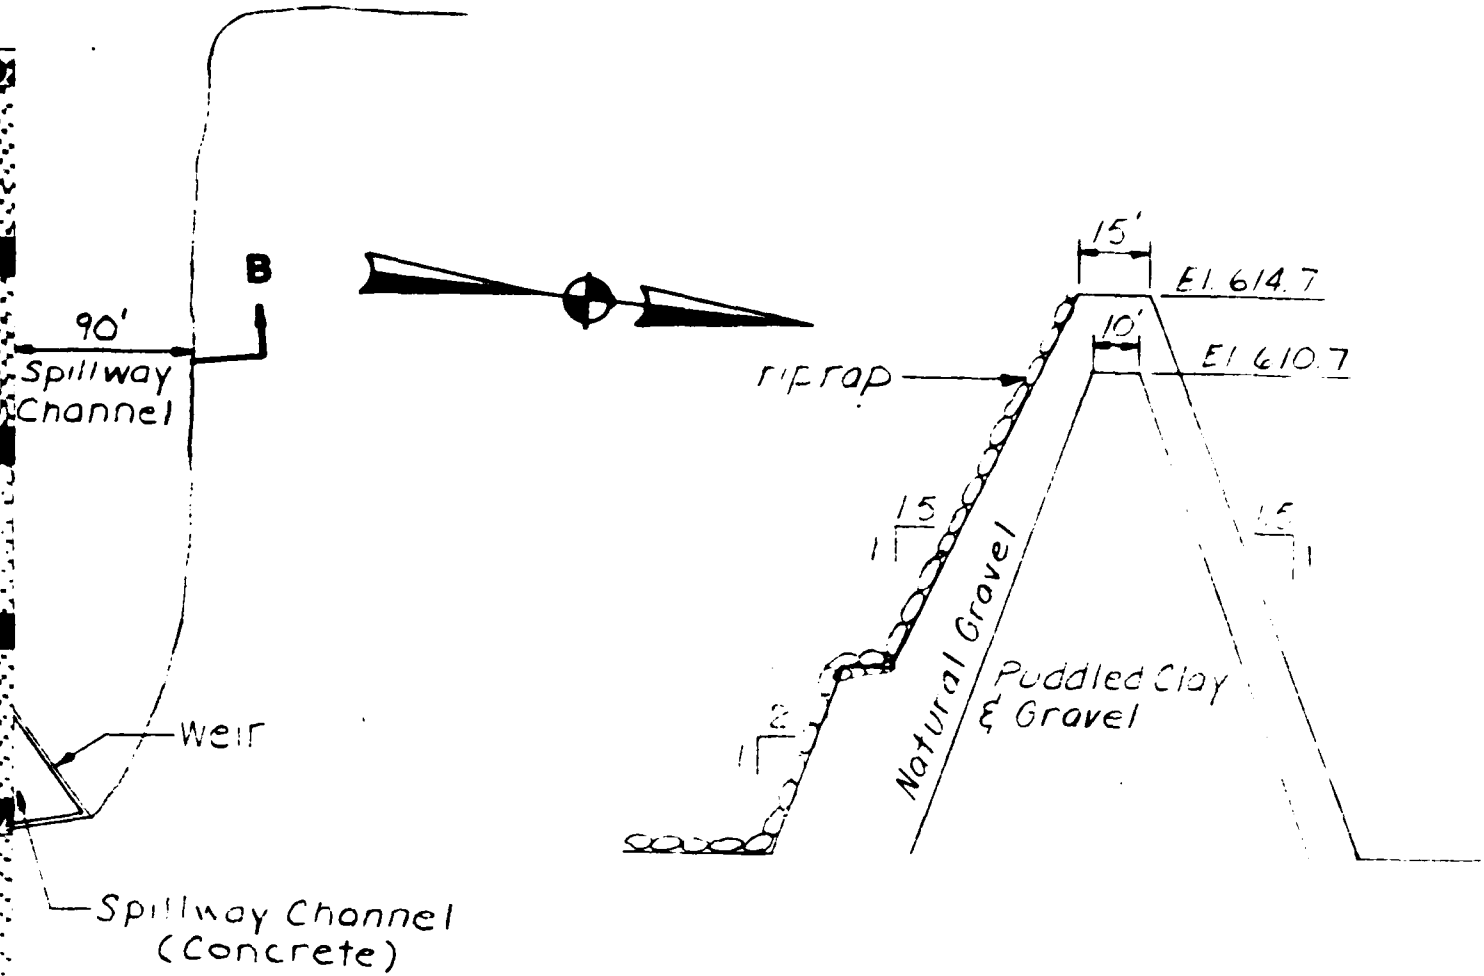
**PLATE 1**

No information on post-construction changes are available. However, comparing the drawings (sections) with actual conditions show a terraced area at the toe of the dam had been added (Appendix B - Plate 1).
