HOCKANUM RIVER BASIN
MANCHESTER, CONNECTICUT

PORTER RESERVOIR DAM
CT 00014

PHASE I INSPECTION REPORT
NATIONAL DAM INSPECTION PROGRAM

MAY 1980

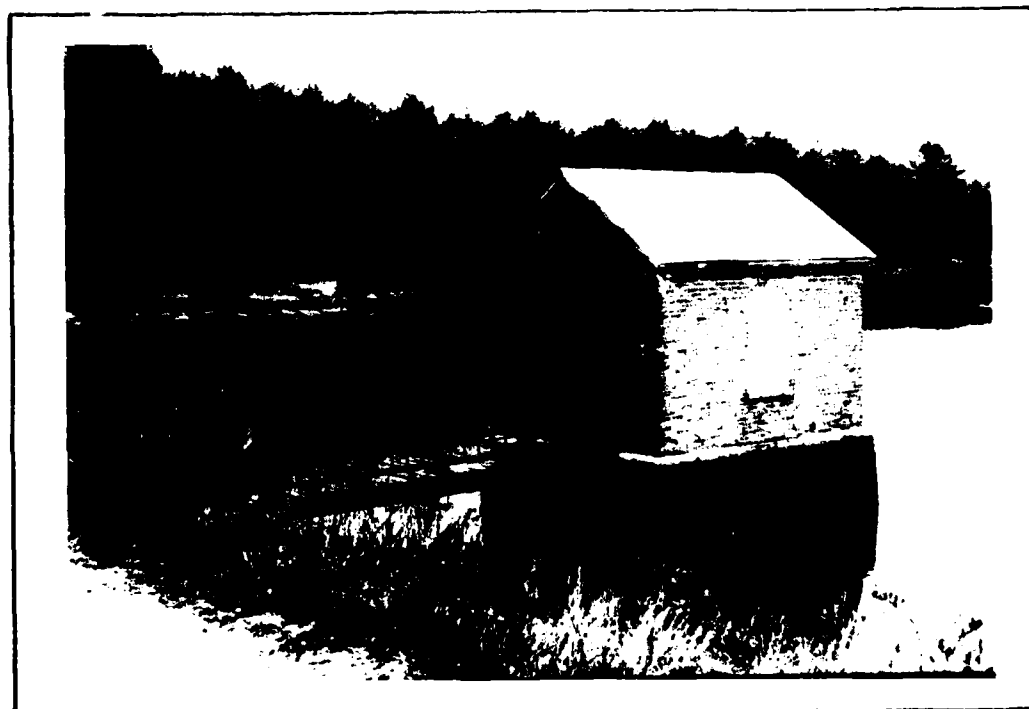
c. Appurtenant Structures. The masonry gatehouse and access bridge appeared to be in fair condition at the time of the inspection. The only deficiencies observed were cracks in the mortar between stone blocks near the water level.

2. GATEHOUSE AND CATWALK WITH THE RIGHT SHORELINE IN THE BACKGROUND. (11/14/79)

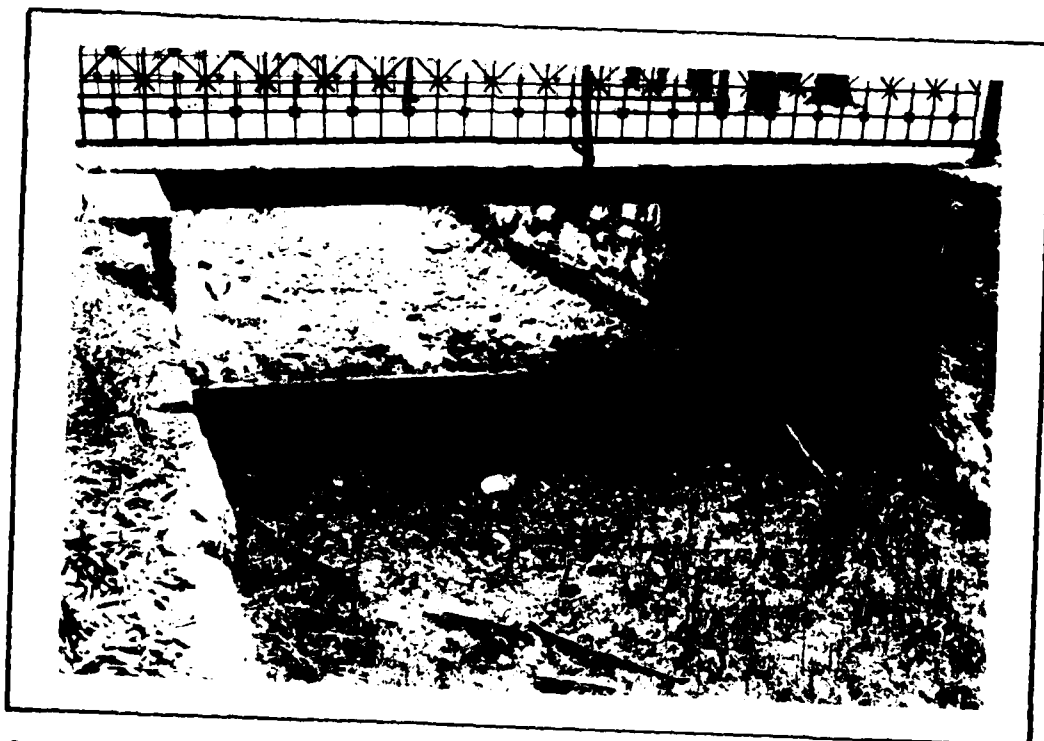
8. WEIR IN THE "WASTEWATER" SPILLWAY CHANNEL ABOUT 75 FEET DOWNSTREAM FROM THE RESERVOIR. (11/14/79)
