NATIONAL PROGRAM FOR INSPECTION OF NON-FEDERAL DAMS  
HIGHLAND LAKE DAM (CT.) (U) CORPS OF ENGINEERS WALTHAM  
MA NEW ENGLAND DIV JUN 79

| REPORT DOCUMENTATION PAGE | | READ INSTRUCTIONS<br>BEFORE COMPLETING FORM |
|---|---|---|
| 4. TITLE (and Subtitle)<br>Highland Lake Dam | | 5. TYPE OF REPORT & PERIOD COVERED<br>INSPECTION REPORT |

## PHASE I INSPECTION REPORT

### HIGHLAND LAKE DAM

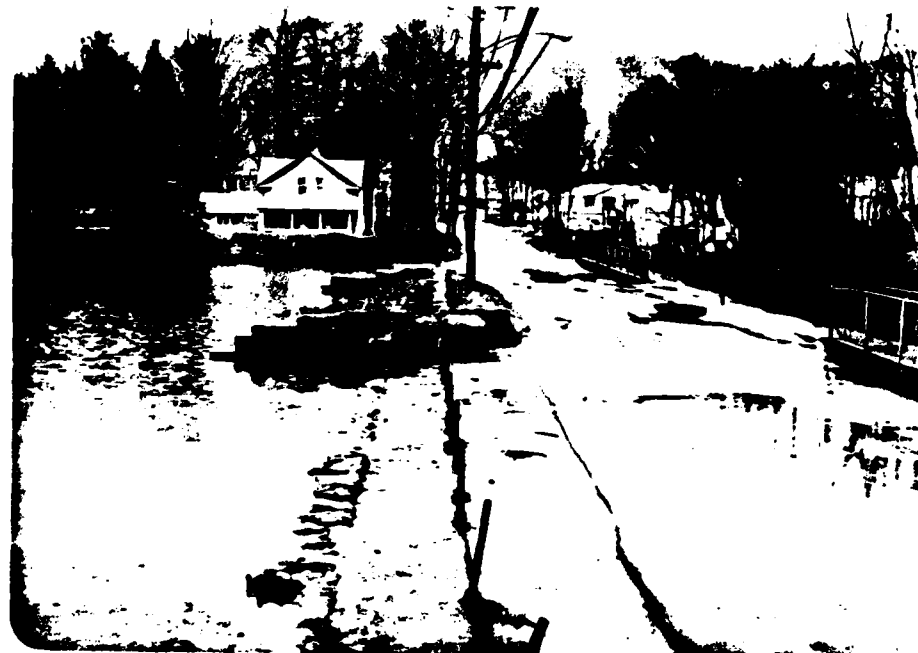
Crest - The crest of the dam serves as a roadway and is paved with a blacktop surface which is in fairly good condition (Appendix C, photo 1). Only a slight amount of surface cracking was observed in the pavement. The dam and roadway were constructed such that two 75 foot sections of the road acting as spillways are at an elevation approximately 1.5 feet lower than the rest of the road across the dam. The crest is approximately 40 feet wide, including a sidewalk and chain link fence along the downstream edge of the crest. Pedestrian traffic over the spillway sections is accommodated by boardwalks (Photos 5 & 6). A chain link fence exists along the upstream as well as the downstream edge of the boardwalks. Overhead utility lines run the length of the dam along the upstream edge of the roadway with 4 poles on the dam itself. There is a concrete floodwall along the upstream edge of the crest between the right spillway and the boat launching ramp at the right end of the dam (Photo 3). The concrete wall was built in 1973, and is in good condition. There are three openings in the wall to allow for access to the gatehouse and to boating facilities. The openings may be closed against rising waters by use of steel doors hinged on the wall at each opening.

Appurtenant to the dam at both the right and left abutments are earth dikes (Photo 2) which appear to be well maintained and in good condition, however, little is known about their construction. The crest and downstream slopes are covered with grass which appears to be mowed regularly, while the upstream slopes are protected by dumped rock riprap which, in general, is in good condition. On the dike to the right of the dam are four sets of concrete steps leading to the water. All of these appear in good condition and provide access to the water while eliminating the need for trespassing on the slopes. The dike at the left end of the dam is set back about 15 feet from the water's edge (normal pool elevation) where there is a dry-laid stone wall in good condition and several pine trees which do not appear to be detrimental to the dike (Photo 1).

PHOTO 1 - General view of crest of dam, showing the two spillways, boardwalks and dike at left end of dam.

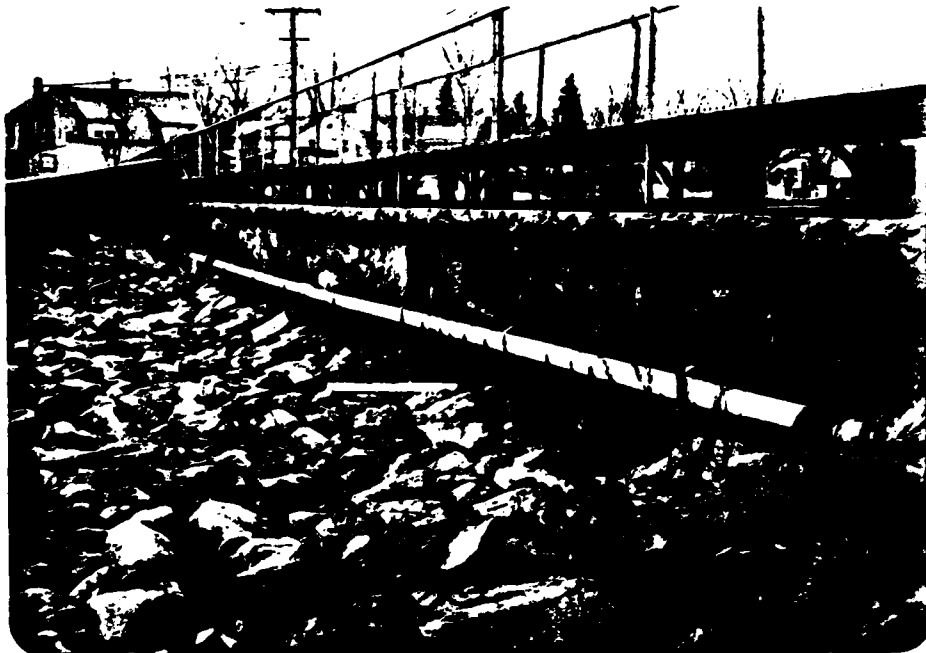
Downstream Face - The downstream face of the dam is a dry-laid granite block wall of undetermined thickness and with a maximum height of approximately 14 feet (Photos 5, 6 and 9). The wall is in good condition although it has many gaps between blocks where the roughly cut rock could not be laid tightly. Sand was observed in several of these gaps indicating a possible loss of material from within the dam. Along the two spillway sections the wall is capped with a more finely cut rock slab, while there was no cap along the other portions of the wall. A gas line is fastened to the outside of the wall with metal straps for nearly the entire length of the dam.

5. A rupture of the gas pipe along the downstream face of the dam during an emergency situation could cause a considerable worsening of conditions at the dam.

The spillways are part of a roadway, and therefore are spanned by a fenced-in boardwalk for pedestrian traffic. The boardwalk and fences are liable to become blocked due to floating debris. It appears that the pipe supports for the fence are anchored into the top of the downstream stonewall portion of the dam. It is conceivable that during heavy flows, debris caught by the fence and boardwalk could cause the water to exert enough pressure on the fence to cause it to break away from its anchoring, resulting in displacement and damage to the masonry portion of the dam.

PHOTO 5 - Downstream face of right spillway. Note gas pipe along masonry wall, and potential for obstruction due to boardwalk and fence.

1. Based upon the computations in Appendix D, the dam without the placement of sandbags at specific locations, will be overtopped at these locations by the test flood, rendering the dikes useless. A study should be undertaken to evaluate the possibility of improving the configuration of the dam so as to eliminate the need for sandbagging. The study should also include recommendations for the minimization of the obstruction of the spillways due to the boardwalk and fences along the roadway.

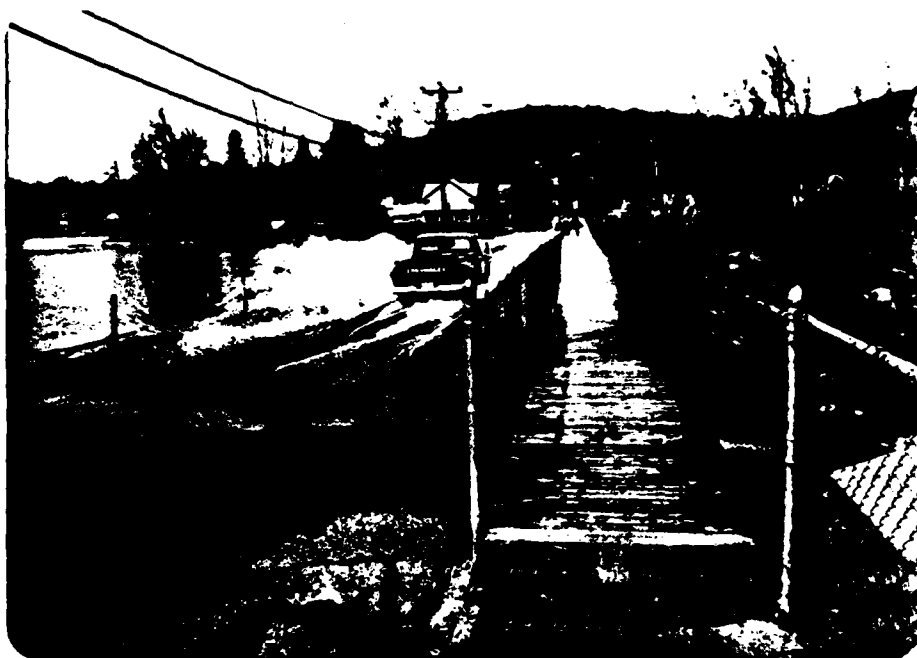
PHOTO 11 - View from right end of right spillway under over-flowing conditions.

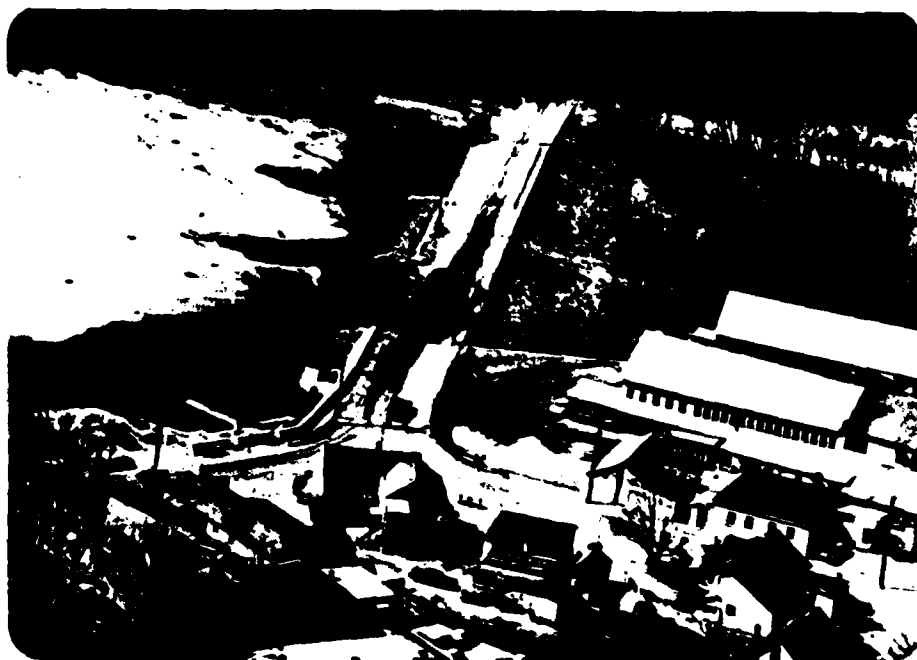
PHOTO 12 - Aerial view of dam. Note flow over right spillway while left spillway is dry.
