4. TITLE (and Sublite)		B. TYPE OF REPORT & PERIOD COVER	
	Beaver Brook Dam		INSPECTION REPORT	
	Housatonic River Basin, Milford	-	S. PERFORMING ORG. REPORT NUMB	
	NATIONAL PROGRAM FOR INSPECTION OF	NUN-FEDERAL		
	DAMS 7: AUTHOR(+)	· · · ·	8. CONTRACT OR GRANT NUMBER(+)	
	U.S. ARMY CORPS OF ENGINEERS			
877	NEW ENGLAND DIVISION			
	. PERFORMING ORGANIZATION NAME AND ADDRES	\$	10. PROGRAM ELEMENT. PROJECT, TAS	
142			AREA & WORK UNIT NUMBERS	
T				
A	DEPT. OF THE ARMY, CORPS OF ENGINE	CDC	12. REPORT DATE	
l	NEW ENGLAND DIVISION, NEDED	EKS	April 1984	
	424 TRAPELO ROAD, WALTHAM, MA. 022	54	25

Re: Beaver Brook Dam (a/k/a Milford Reservoir Dam) Milford, Connecticut

BEAVER BROOK DAM (a/k/a Milford Reservoir Dam) CT 00085 Town of Milford, New Haven County, Connecticut On the Beaver Brook Owned and Operated by The New Haven Water Company

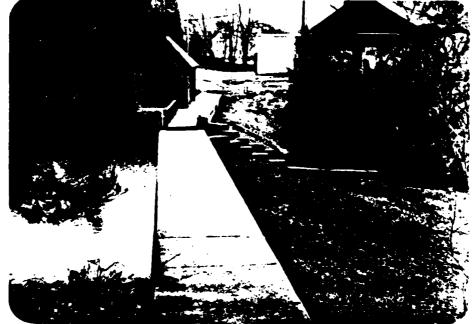
PHOTO NO. 2

DAM FROM RIGHT ABUTMENT.
