HOUSATONIC RIVER BASIN
DANBURY CONNECTICUT

PARKS POND DAM
CT 00071

PHASE I INSPECTION REPORT
NATIONAL DAM INSPECTION PROGRAM

JULY 1980

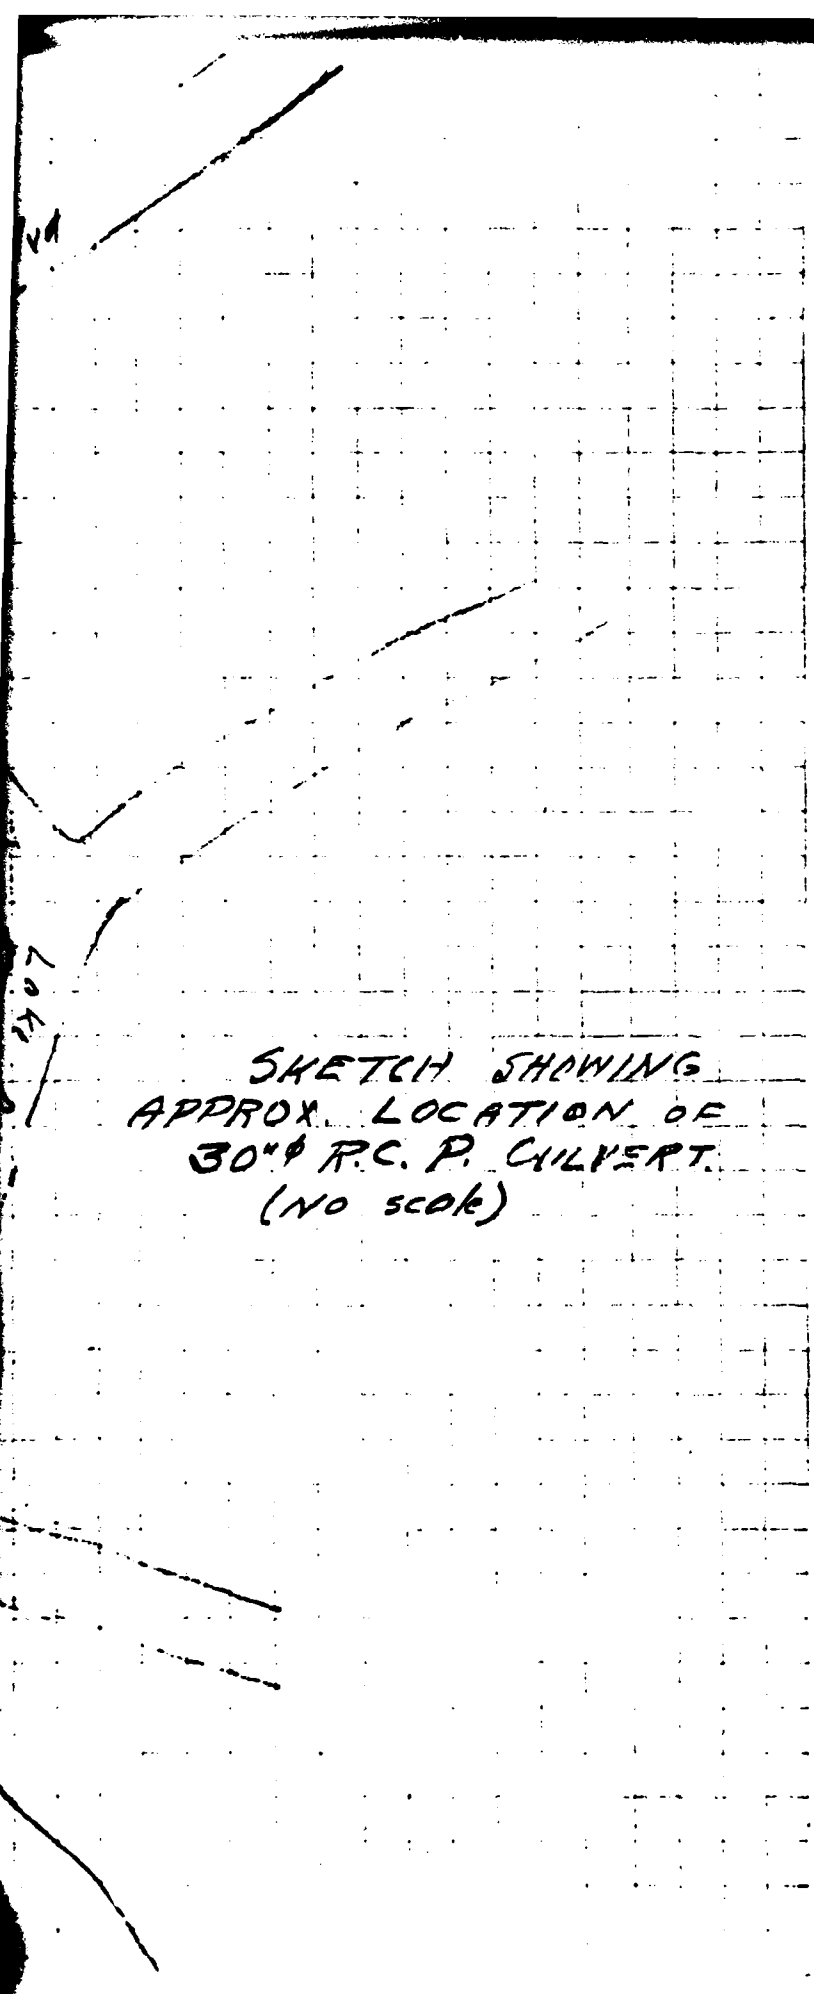
SKETCH SHOWING
APPROX. LOCATION OF
30" R.C. P. CULVERT.
(NO SCALE)

The culvert is about 250' long with a slope of about 4' in 100'. The intake is a circular masonry wall just a few feet below the spillway of the lower of the three ponds. See photo. The pipe seems to be in good condition and, based on a value of "n" equals .015 in Manning's formula, will have a maximum capacity of about 45 c.f.s. Assuming that the maximum capacity of the dam, 200 c.f.s. might be reached, it is obvious that the culvert is much too small. During the unusual floods of 1955 the culvert was greatly overloaded, the stream washing over the streets and lawns and doing considerable damage. The exact runoff, or discharge, at this time is not known.

To at least partially correct this situation I recommend that additional culvert capacity be provided. The most economical procedure might be to install a new 48" ϕ R.C.P. culvert alongside the existing 30" ϕ or to replace the 30" with a new 60" ϕ pipe. Either scheme will give a capacity of 130 c.f.s. This operation could well be carried out any time before next year's spring floods.
